Wreck of an Unknown Armed Three-Masted Sailing Ship, Gulf of Finland

Badewanne Research Reports 1-2021

18th April 2021
Copyright © Badewanne Oy
Finland

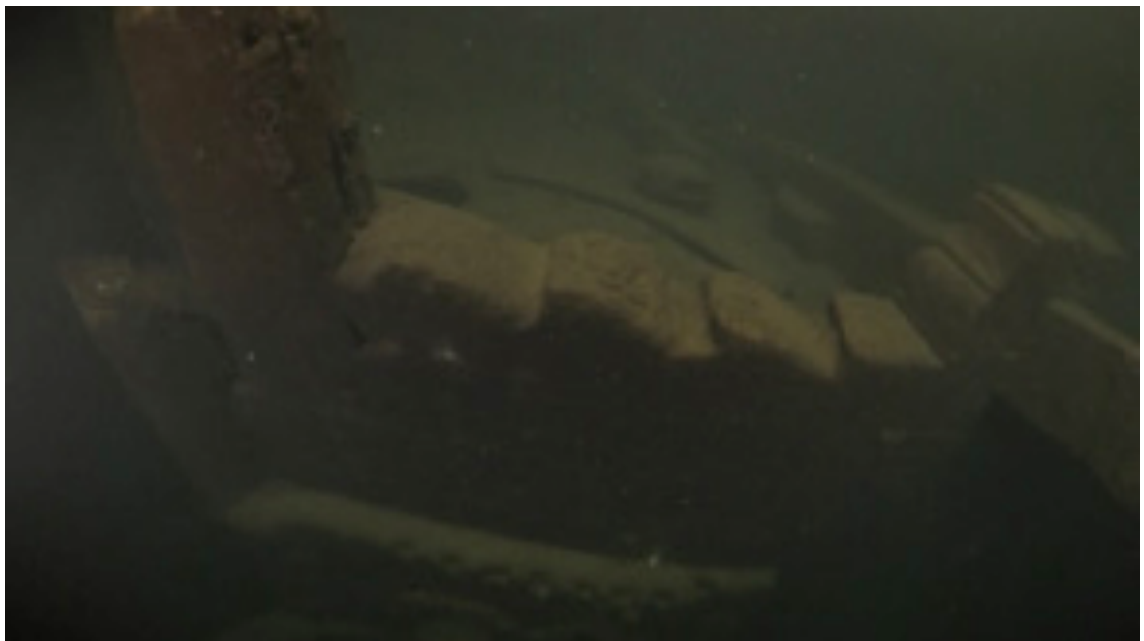
Figure 8: *The sawtooth-like shape on the gunwale. Videocapture, 26th Jul. 2018.*

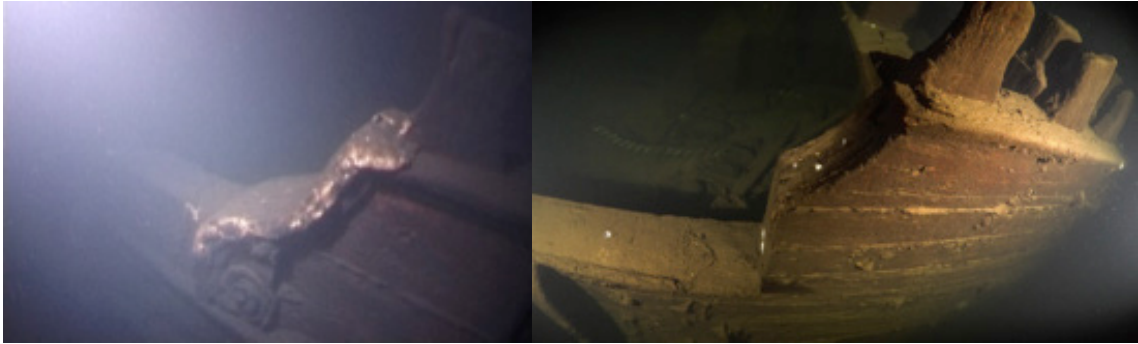
Figure 11 (left): Photo from Raasakka, Kaasinen 2006 report: Starboard gunwale at the break of the forecastle, viewed from outside of the ship (forecastle on the right). Photo copyrights P. Raasakka & J. Kaasinen.

Figure 12 (right): Starboard gunwale at the break of the forecastle as it is today, viewed from the outside of the ship (forecastle on the right). The carved ornament and the metal lining, including the wooden block (on the right) seen in Figure 8, are missing. The current situation and the difference on both sides is visible in Figure 12. Videocapture 13th November 2020.

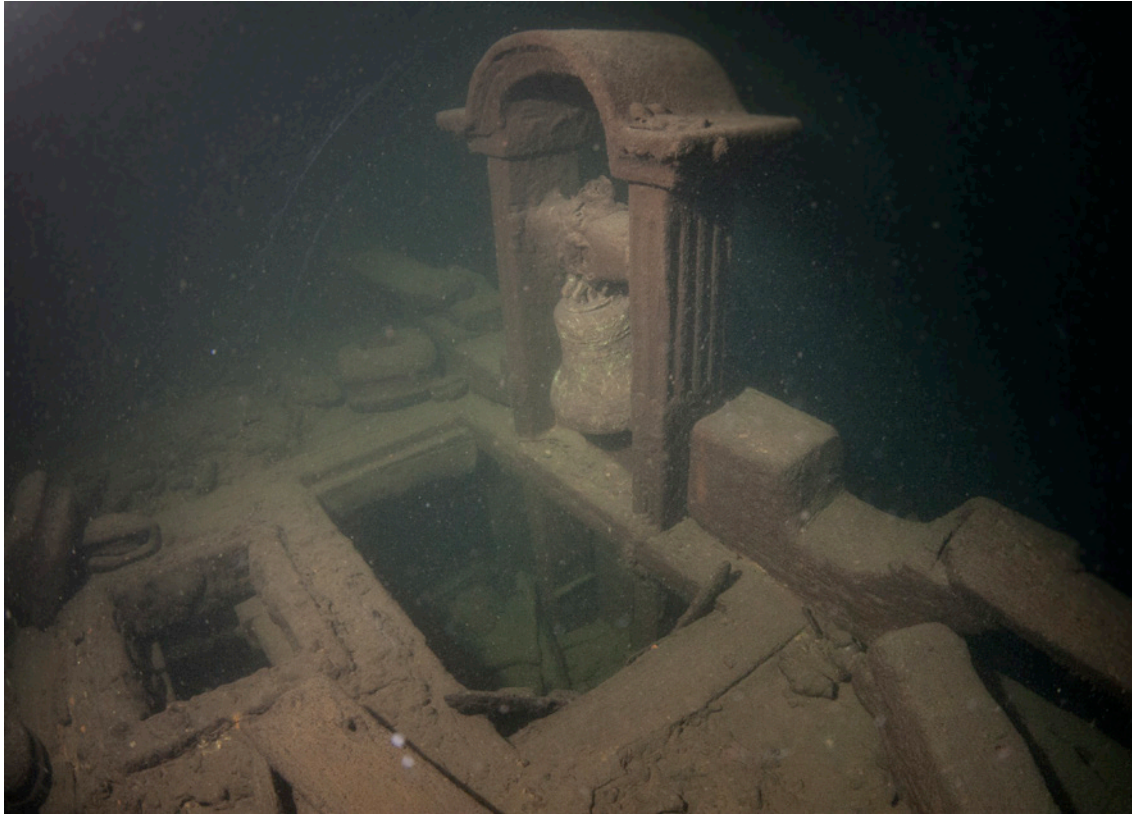
Figure 18: *The belfry with the bell in 11th August 2007 (view towards starboard-stern). In July 2011 it was observed, that the bell had fallen into the hatchway, afore the belfry. Whether it fell due to natural causes, by accident, or in purpose, is unknown.*

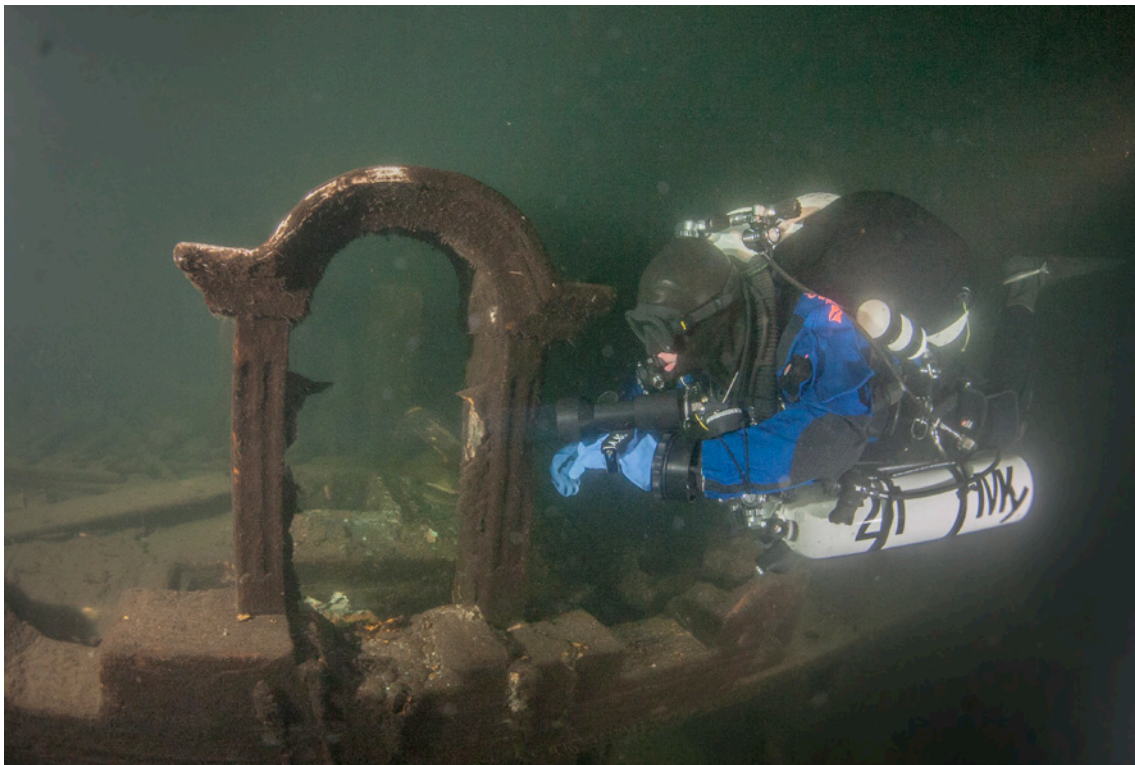
Figure 19: *The damaged and empty belfry in 11th September 2011.*

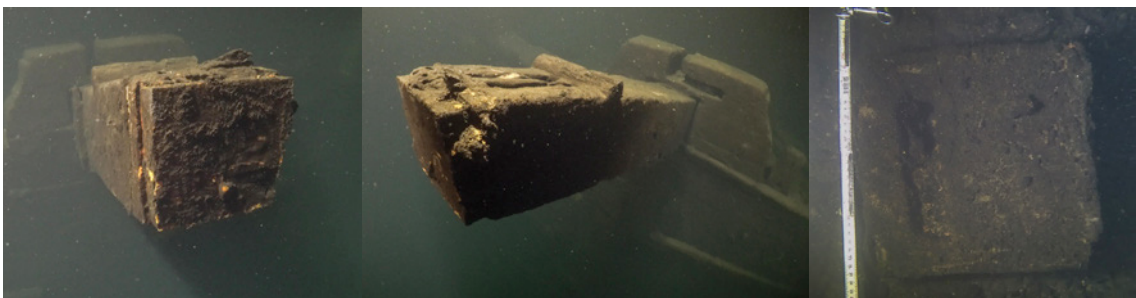
Both catheads are structurally intact. At least the cathead on the portside had originally a cat/lion-faced figure on the end. This figure has since then fallen down or disappeared from the site. It is possible that the figure lays now on the seafloor just below the cathead. A similarly shaped flat object was found on the port side during 2019. It is probably the missing figure that has turned upside down.

Figure 21 (left and center): *The port side cathead without the cat/lion faced figure. The end of the Cat-heads have two slots with embedded sheaves. Videocaptures 26th July 2018.*

Figure 22 (right): *An object on the port side found on the seafloor almost below the cathead. The measurements are approx. 30 cm x 30 cm. This is probably the missing cat/lion faced figure turned upside down. Video: Tommi Toivonen, videocapture 6th August 2019.*

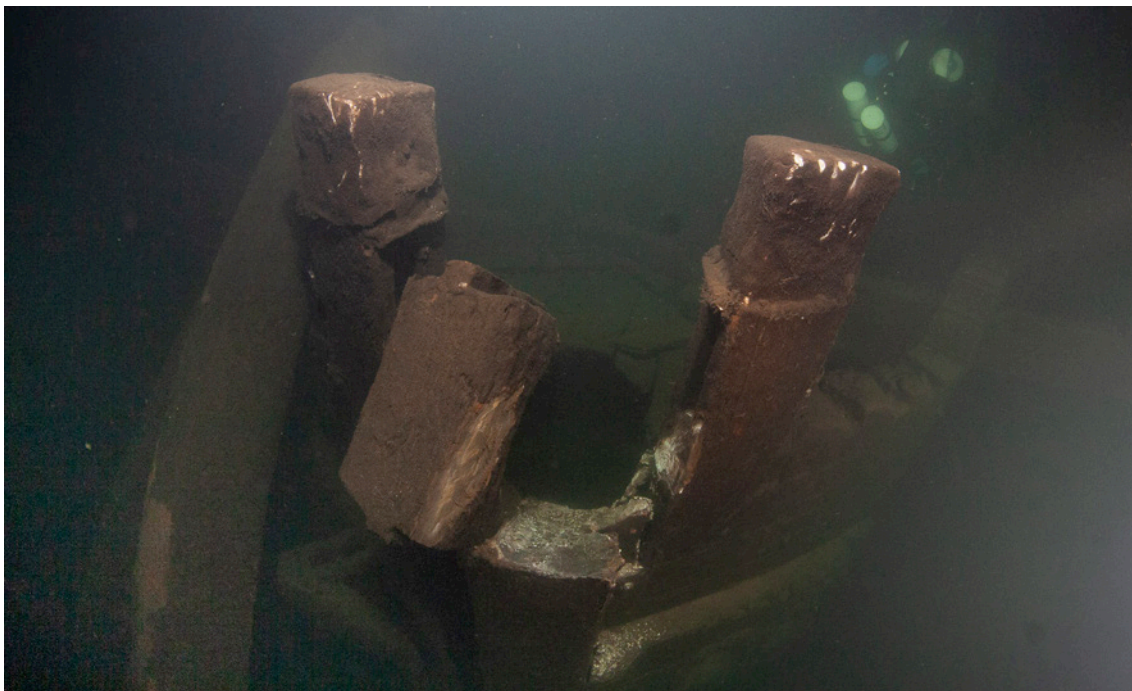
Figure 24: Bitts in the bow, after the bowsprit had disappeared. The small crossbeam beside the bitt on left has fallen away after the picture was taken. Photo 11th September 2011.

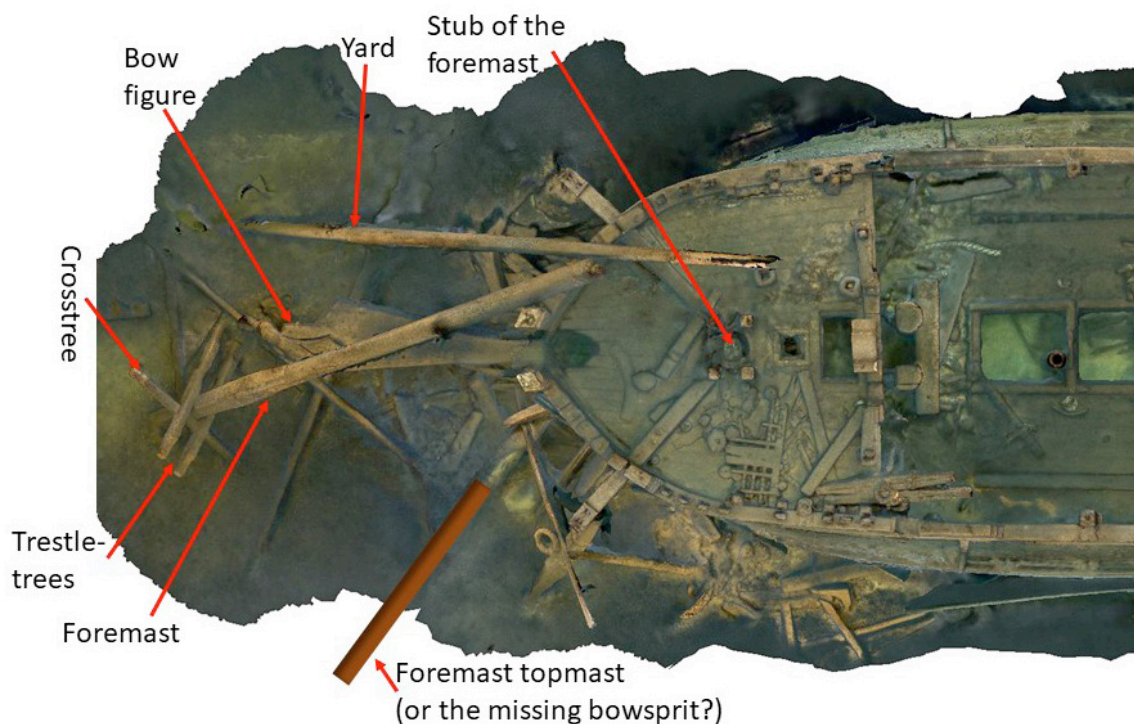
Figure 26: An orthometric caption from the 3D photogrammetric model shows the changes in the bow area of the wreck as observed on the 11th September 2011. The current location of the bowsprit is still unknown.

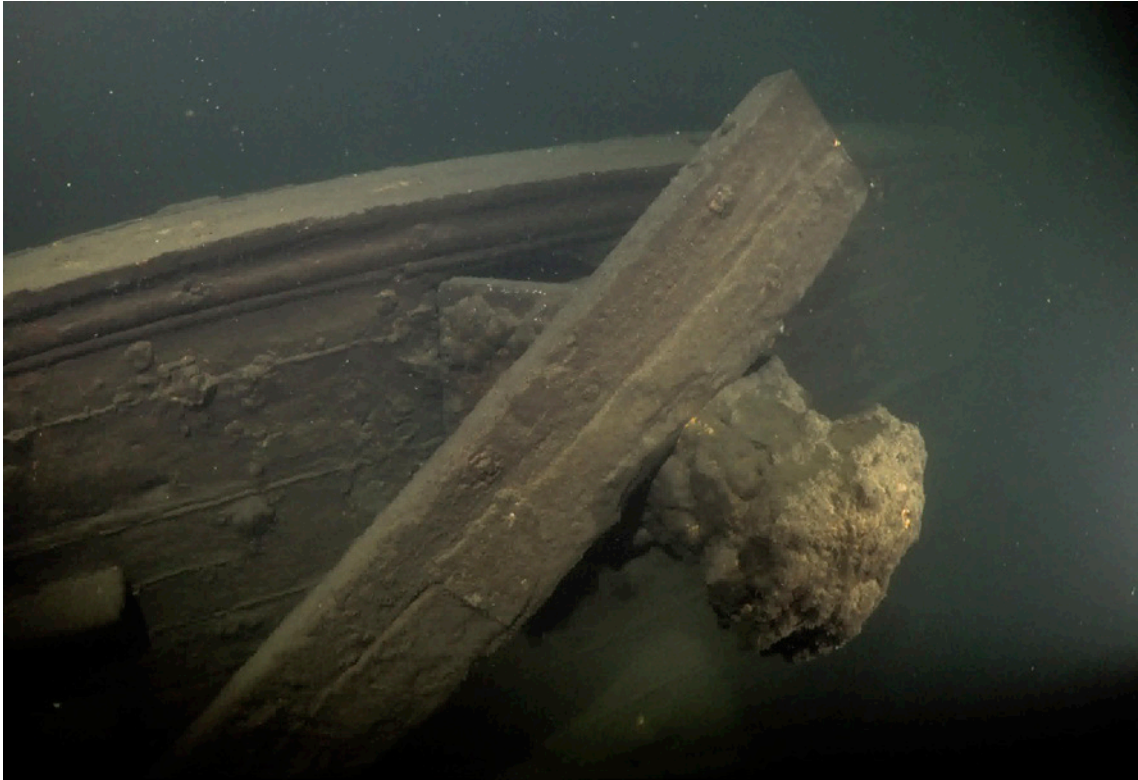
Figure 41: *The same gun today. A loose plank has appeared from somewhere, and it has been fallen over the gun. The origin of this plan, and how it was moved is unknown. Videocapture 23rd July 2019.*

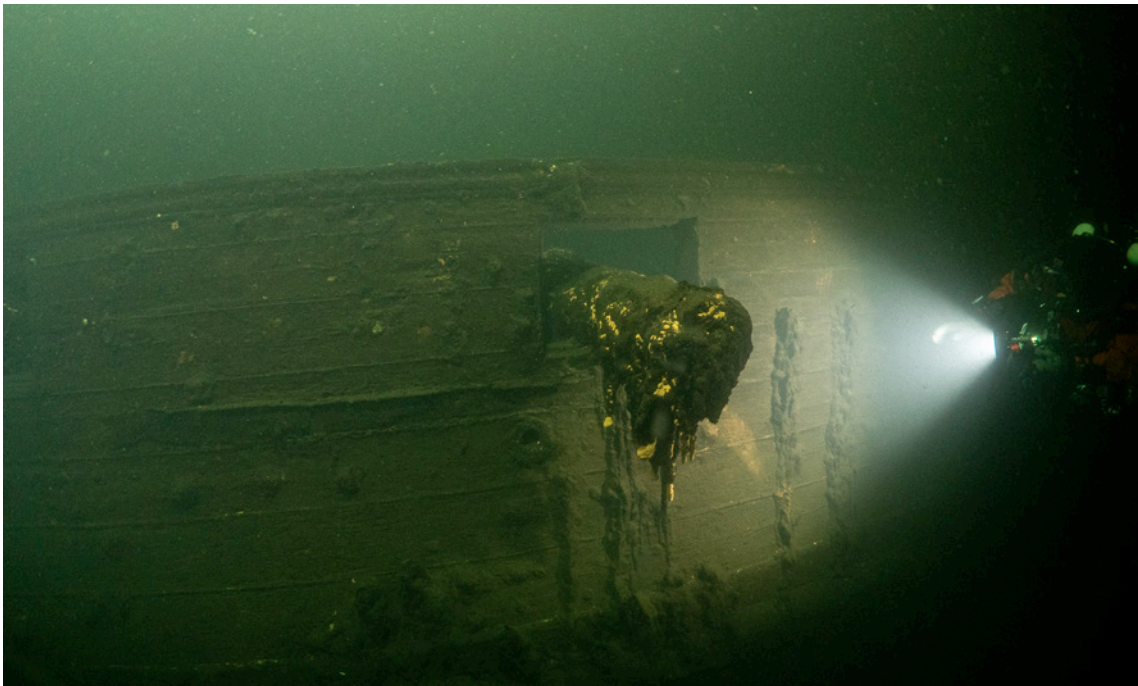
Figure 42: *The second gun on the port side. The gunport lid has been missing since the discovery of the wreck. Photo taken 24th August 2019.*

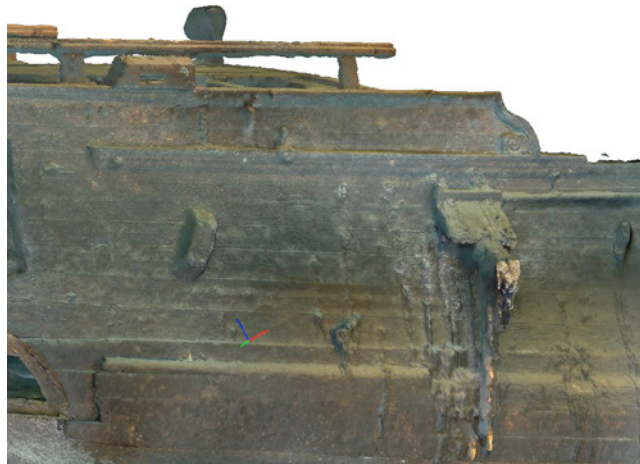
Figure 43: This on gun the starboard side closest the stern has almost slid out through the gunport. The gun points downwards in apporox. 35 degree angle. The lid on this gunport opens from above the gunport. This same gun is shown from the deckside in the figure 45. Note the ornament carving in the gunwale break. Three planks of the main wale are visible. 3D photogrammetric model.

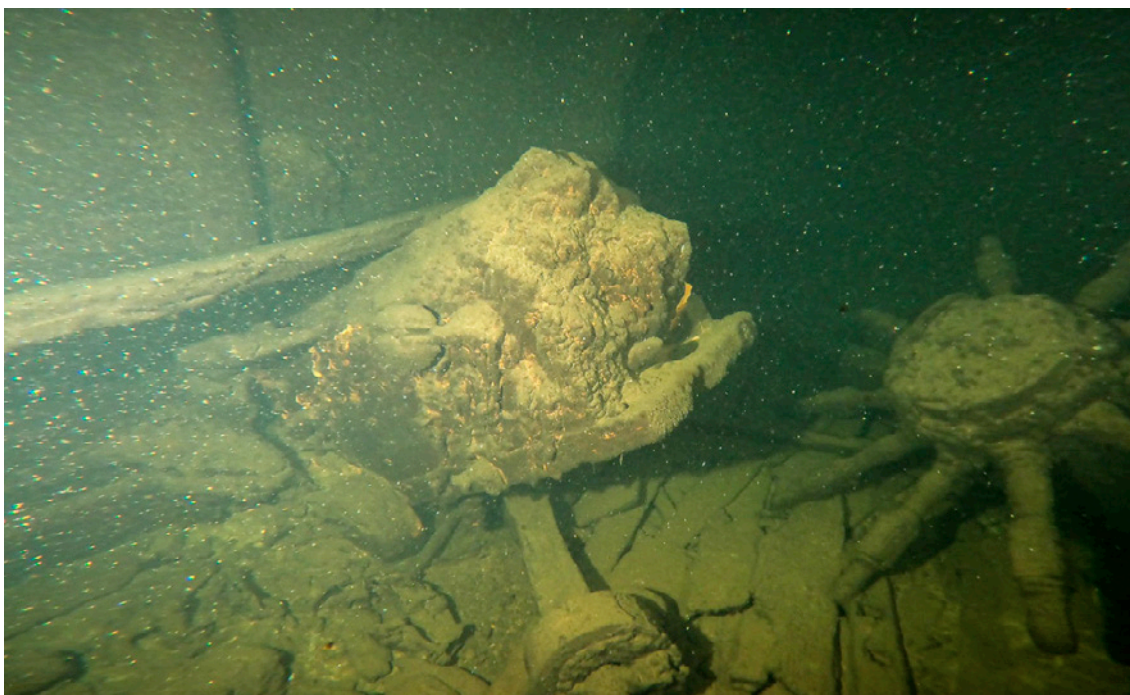
Figure 45: The gun closest the stern in the starboard side has tilted and almost slid out through the gunport. Rear axel of the carriage has detached. Videocapture 13th October 2020, video Mikko Koskinen.

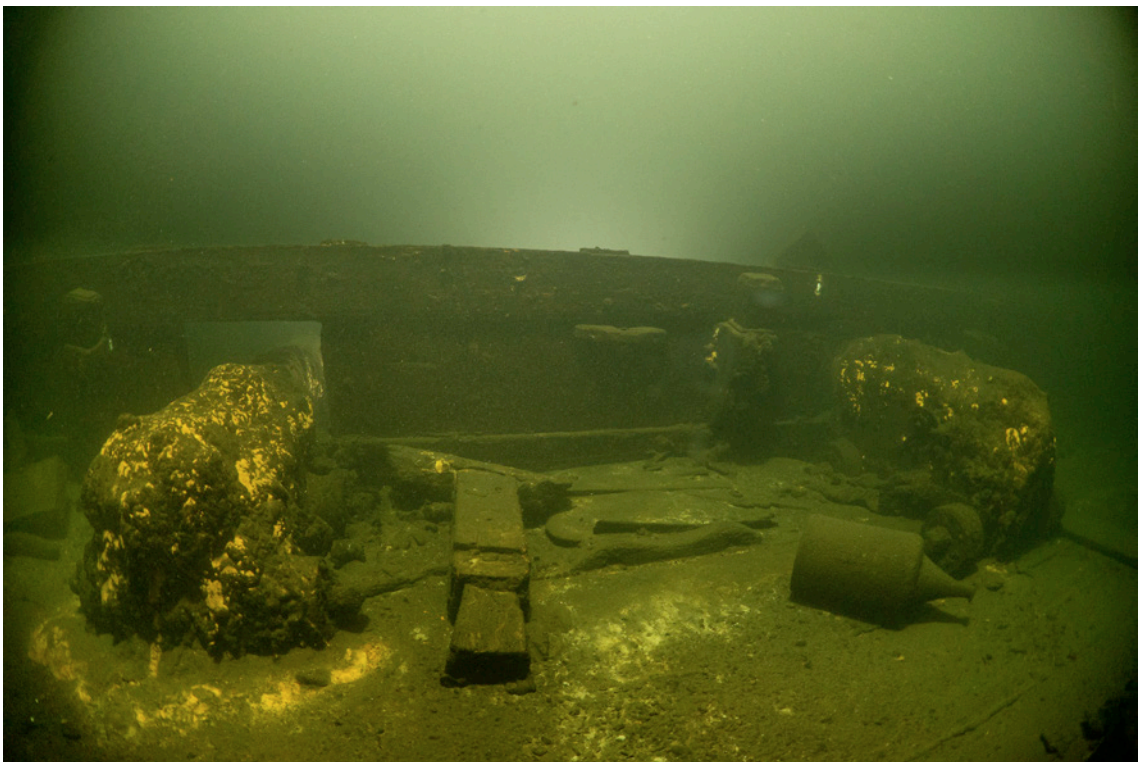
Figure 56: The port side gun closest to the stern. The marks on the right next to the upper edge of the gunport mark the location where the mizzen channel has been, and a deadeye is still hanging from it on a remains of a rope. The channel has fallen down and is probably on the bottom below. The channel has fallen before the discovery of the wreck. Videocaption 23rd July 2019.

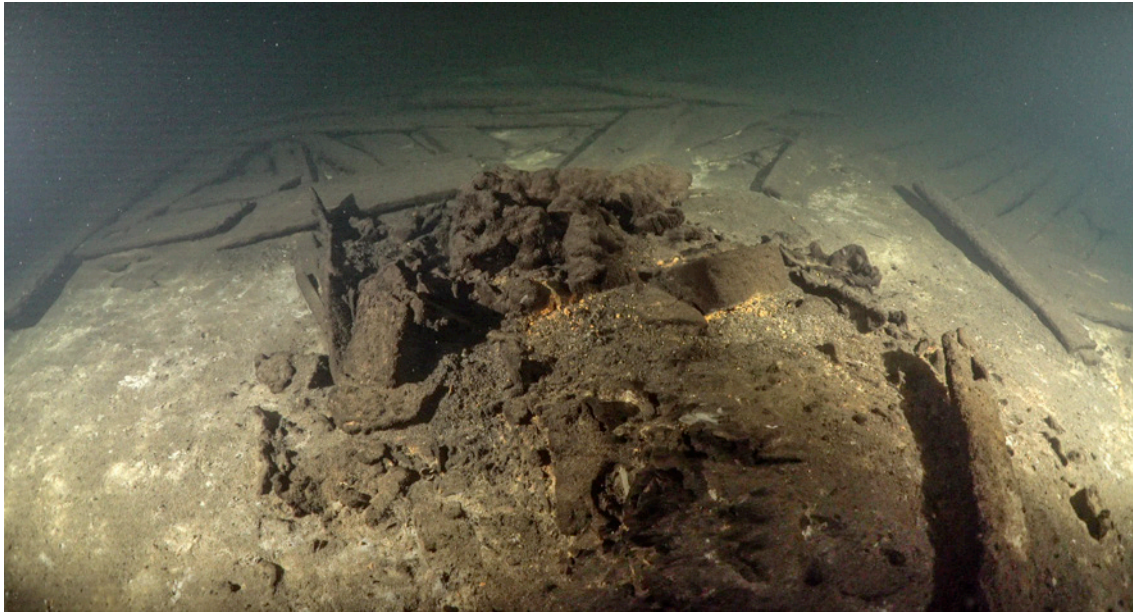
Figure 51: Remains of something, possibly a stove inside the stern cabin. Videocapture 25th August 2019.

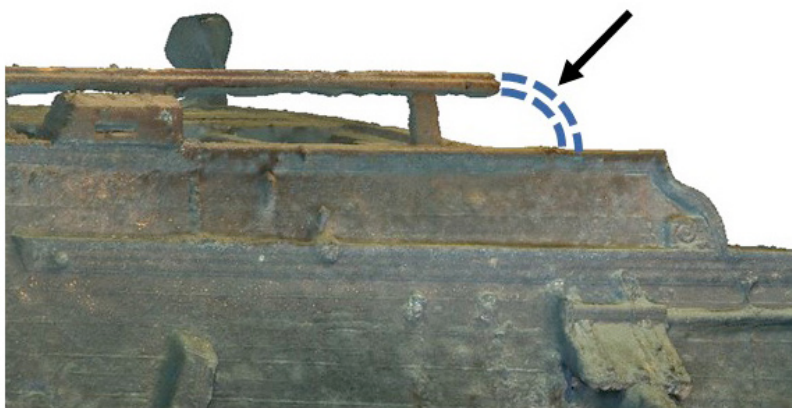
Figure 60: Five rails were closed from each end by a curved rail piece, when the wreck was discovered. Today, they are missing. Othometric 3D model viewcapture.

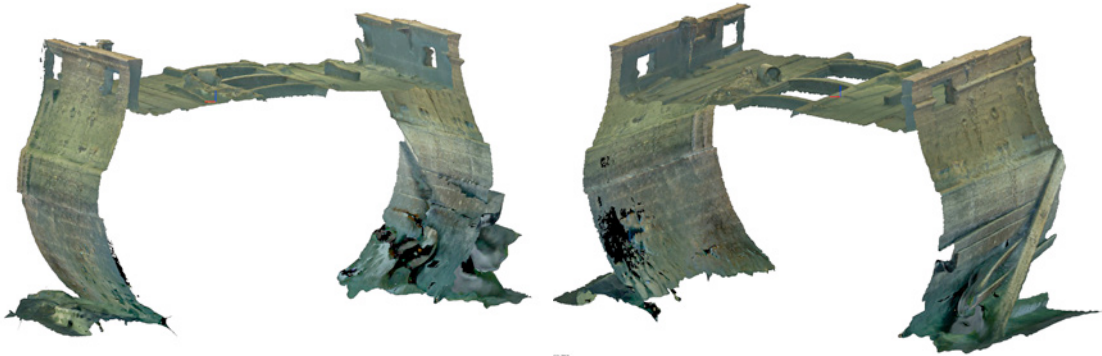
Figure 61: *Orthometric 3D cross-sections close to the widest point of the hull. The starboard side is shown on the left, and the port side on the right. The hull is widest at the main wale. The main wale consists of three planks. There is a narrow strake above the main wale. The hull is practically intact around the mid-ship area on the starboard side. on the port side, there are some loose planks below the main wale.*

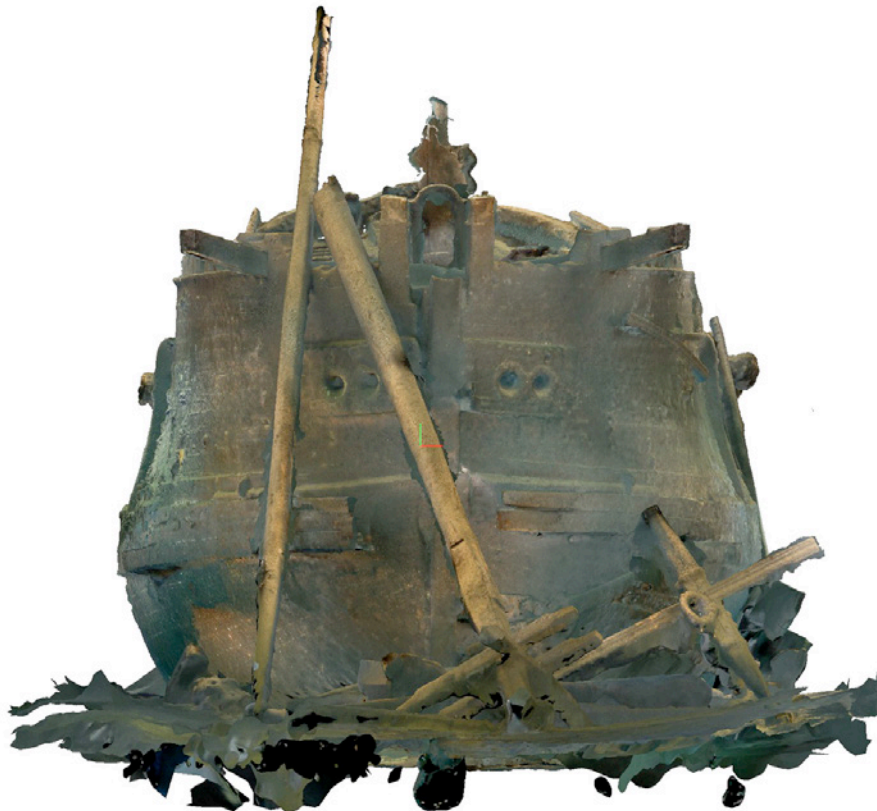
Figure 62: *An orthometric view from the bow (3D model). There is an anchor on the bottom below the port side cathead. The main wale planks have detached from the stem post. The lowest section of the broken foremast leans down from the gunwale, down to the seabed. Trestletrees and a crosstree are still attached to the foremast. The long boom on the left coming down from the gunwale is a yard. Originally (when the wreck was discovered) it was located diagonally over the forecastle. After the discovery, the fore mast has been relocated as well, as it used to be more on the left.*

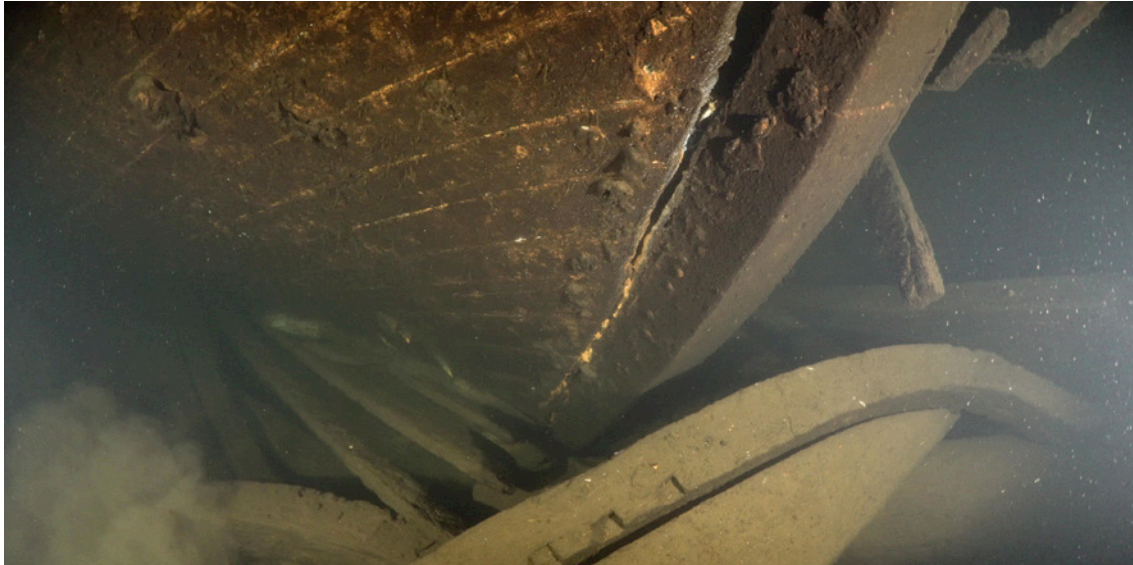
Figure 63: *The stem post at the seabed. If there has been a gripe, it has fallen away, and is below the fallen parts in front of the stem post. A knee of a head, with the figurehead lies near at the seabed. The keel can't be very deep inside the seabed. Photo 30th August 2020.*

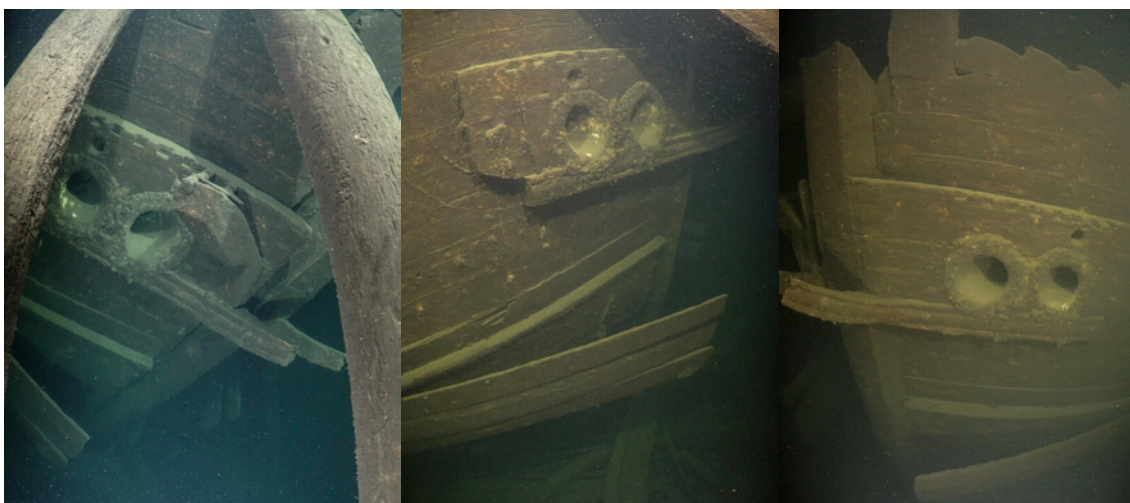
Figure 64 (left and center): *Hawse linings and hawse holes on the starboard side of the bow. Hair brackets below hawse holes and lining are still partly intact. Main wale planks have become loose close the bow and have detached from stem post. Videocaptures 12th August 2020.*

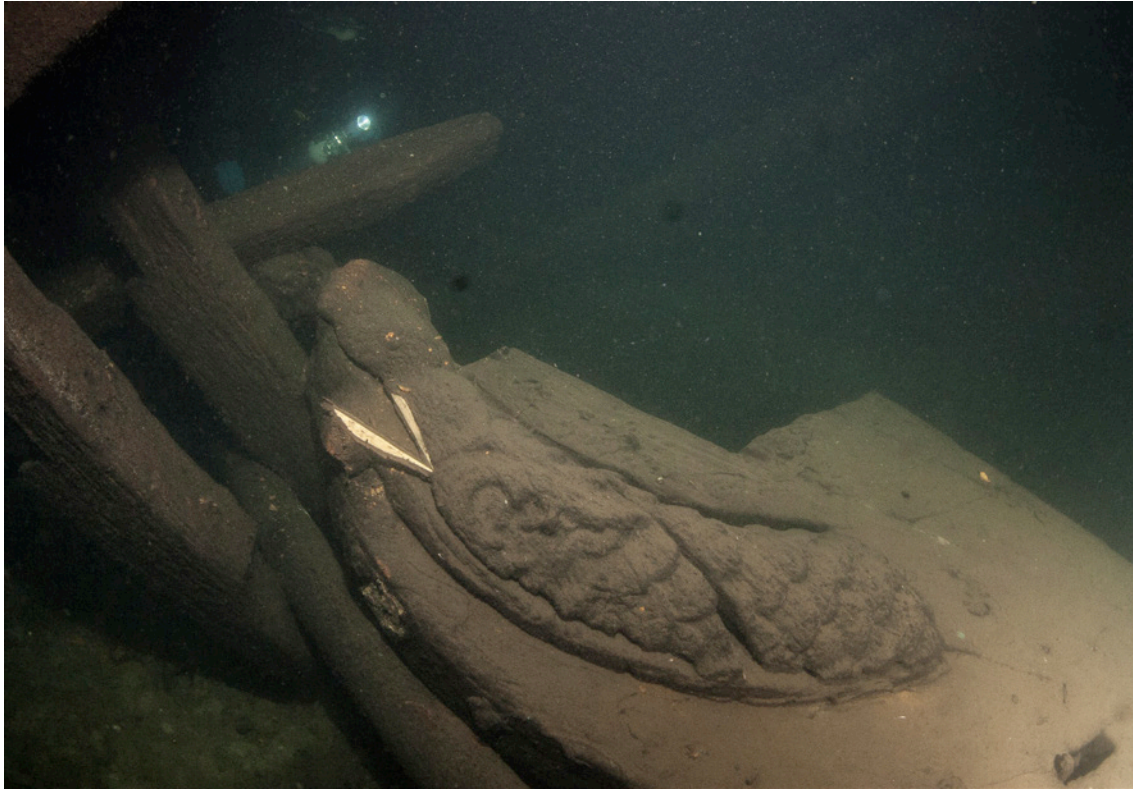
Figure 75: A fresh damage in the figure head was observed on 11th September 2011. The fore mast has been relocated and the trestletrees are now in the left. Photo 11th September 2011.
