# THE CHURCH OF ST JOHN

Helsinki, Finland

The Restoration of  
the Cast Cement Ornamentation  
of the Façades  
1990 - 1991

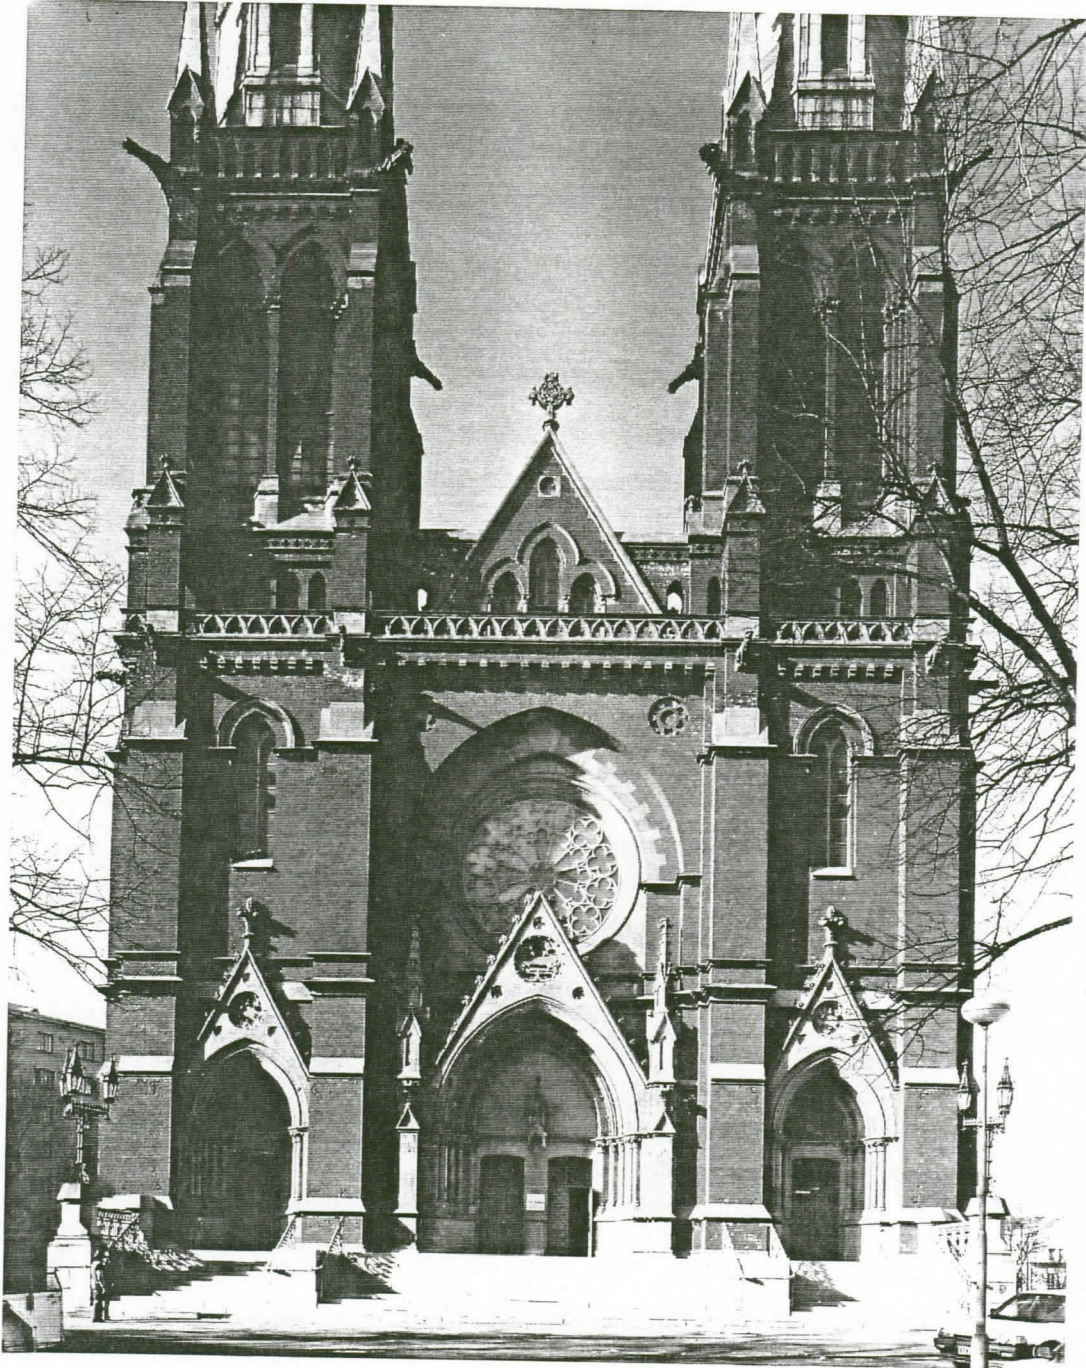
*The starting point*  
WEST FRONT BEFORE THE RESTORATION  
SPRING 1990

THE FINIAL ABOVE THE MAIN PORCH IS MISSING. OTHERWISE THE DAMAGES CANNOT BE USUALLY SEEN FROM GROUND LEVEL.

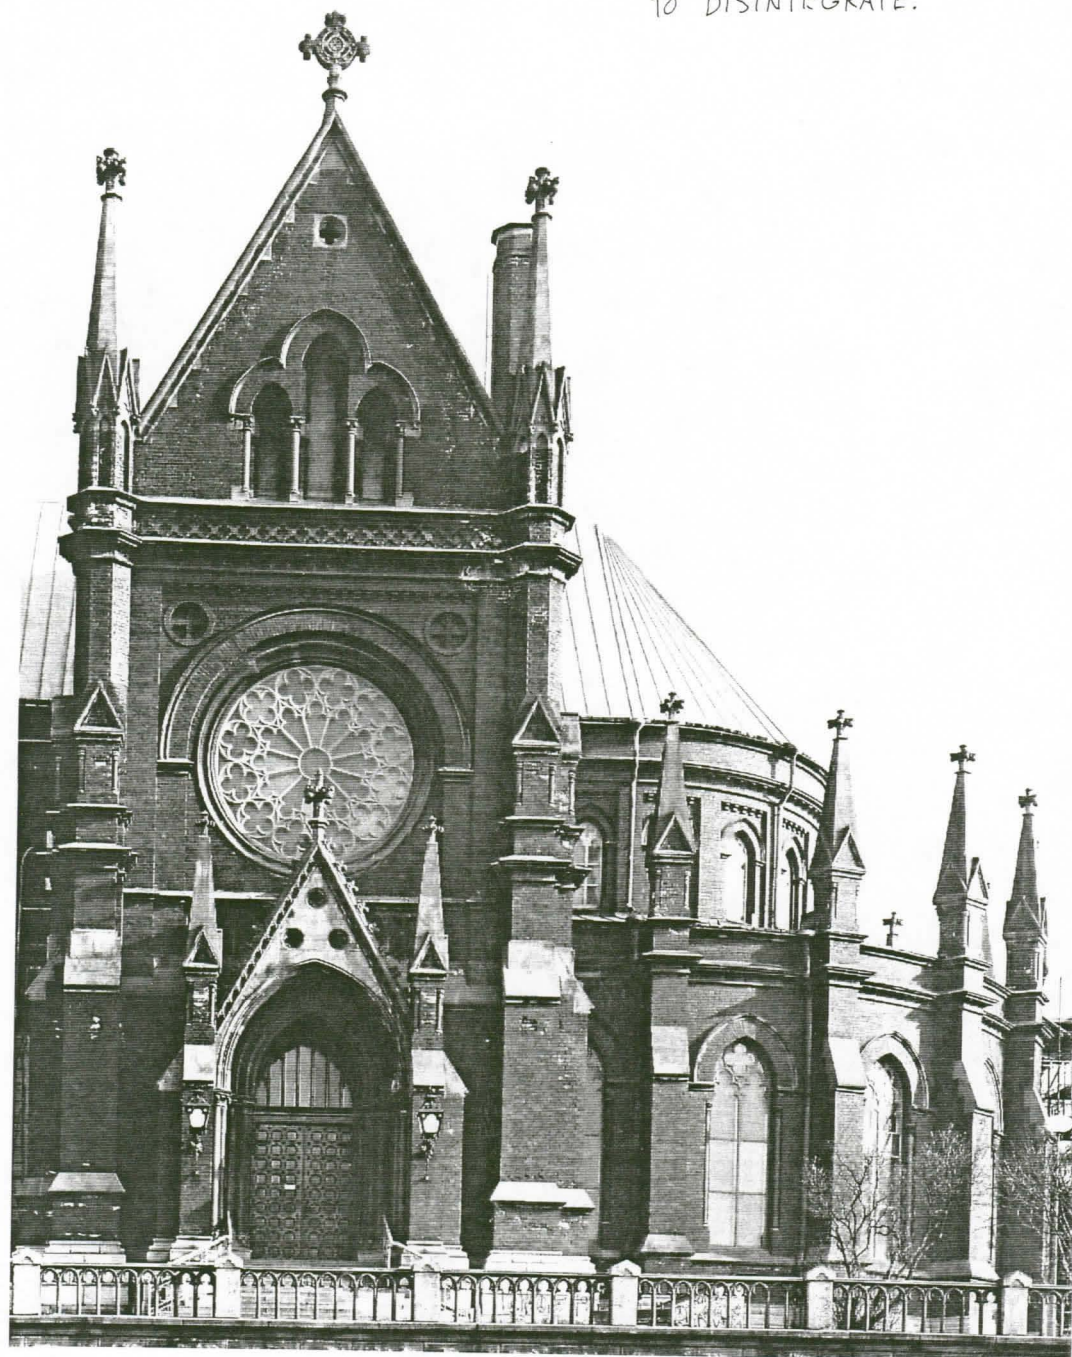
*The starting point*  
THE CHOIR BEFORE THE RESTORATION  
SPRING 1990

EVERY PINNACLE STILL HAS  
ITS NEW CONCRETE SHELL FROM  
THE 1950'S WHICH HAS STARTED  
TO DISINTEGRATE.

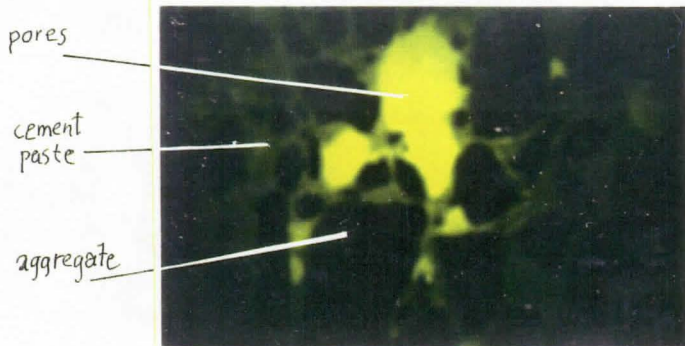
Concrete S. 100 ("normal" CONCRETE)

The bad workability (työstettävyyds) of the fresh concrete had led to inhomogeneity in the pore distribution. Some of the pores are also too large. The concrete is not dense enough and its frost-resistance is uncertain.

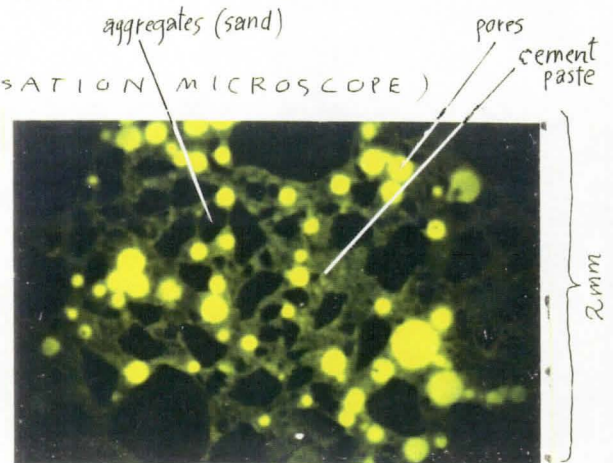
"The church concrete" (FESCON OY)

Because of good microproportioning, the distribution of the fine aggregate and the pores in the concrete is homogeneous. Since the pores are small they act as protecting pores. The cement paste itself is dense without any cracks. Such microproportioned concrete has a good durability.

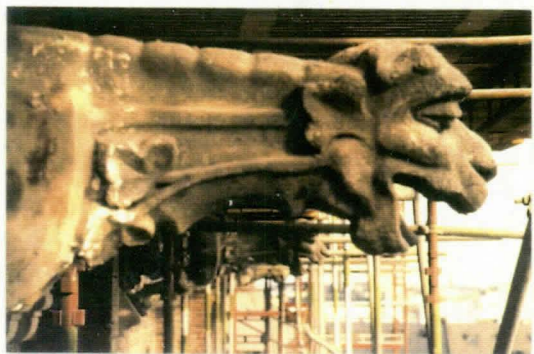
BEFORE THE INVESTIGATIONS: THE LOWER GARGOYLES ARE SEEMINGLY INTACT...

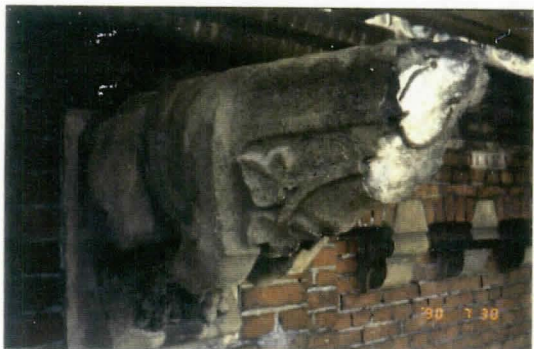
UNTIL ONE OF THE HEADS WAS DIS-LODGED BY A SLIGHT BUMP! A RUSTED IRON RING HAD CAUSED CRACKING. THE DEEP CARBONATION CAN BE OBSERVED.

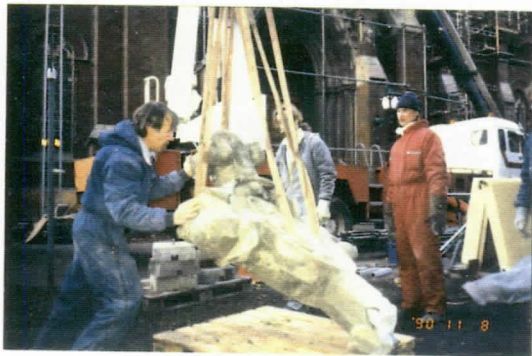
TAKING DOWN A RING-CROSS. THE UPPER PART, WHERE AN IRON RING HAD BEEN USED AS REINFORCEMENT, IS BADLY DAMAGED.

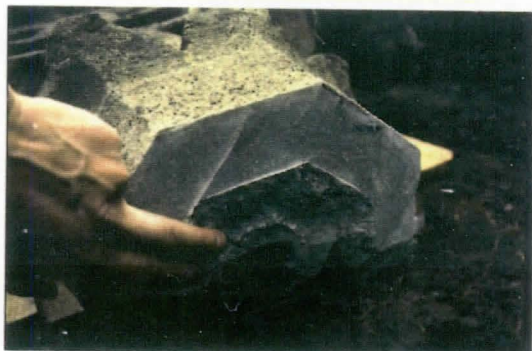
THE CENTRAL STEEL BAR AND THE CAST CEMENT MATERIAL OF THE LOWER PART WERE IN PERFECT CONDITION.

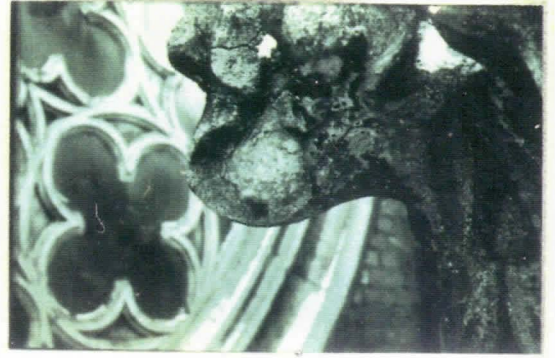
...AND REALITY

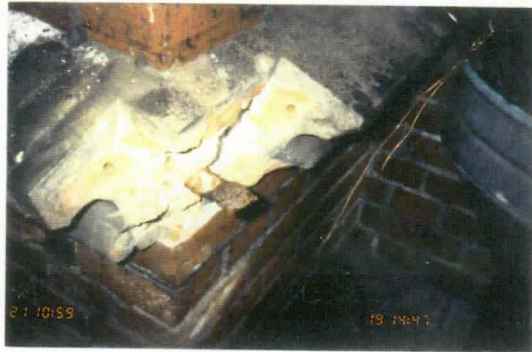
A RUSTED PIECE OF REINFORCING IRON HAS BROKEN THE CORNER OF A MOULDING. THE CORNER HAS BEEN CUT OFF.

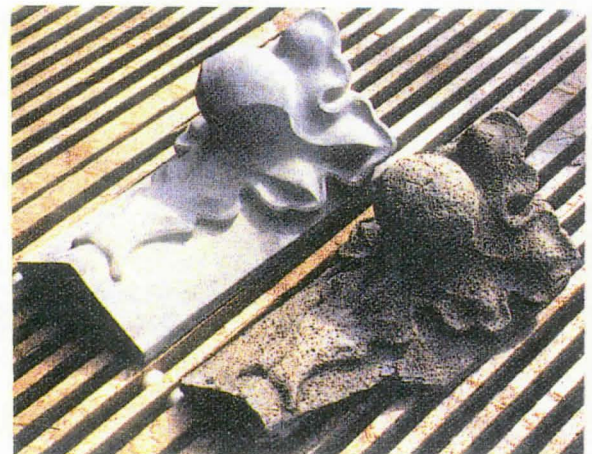
A NEW CROCKET AND A DETERIORATED ONE

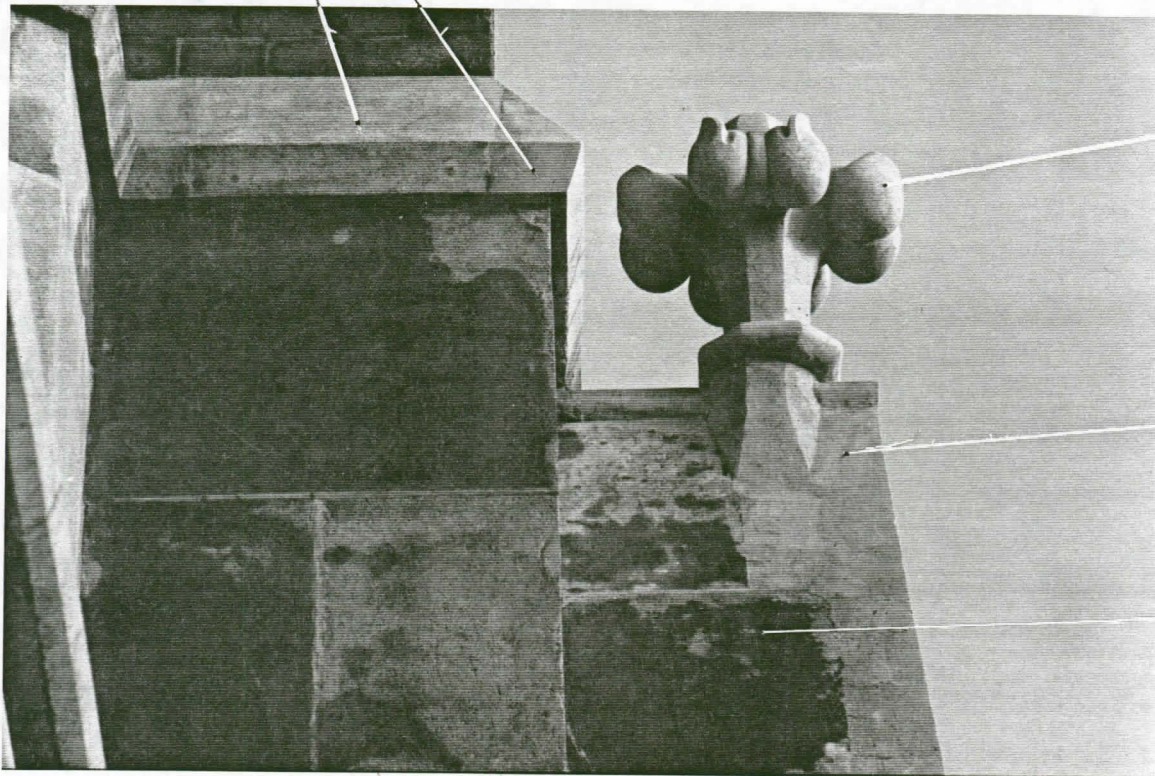
RE-CAST  
FINIAL  
IN  
GOOD  
CONDITION

NEW  
SURFACE:  
DRY

ORIGINAL  
SURFACE:  
IN PLACES  
WET

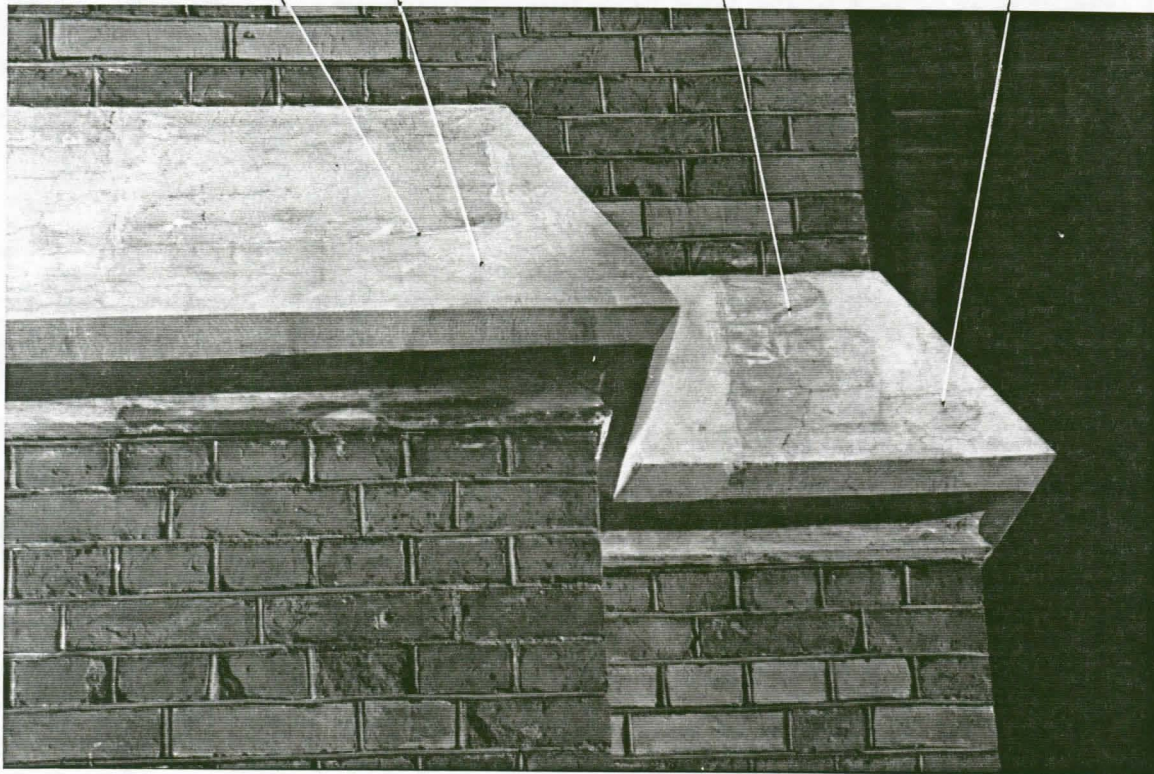
NEW CORNER

HAIRLINE FRACTURES  
OPENED AND FILLED  
WITH GROUT: NO  
CRACKS

HAIRLINE  
FRACTURES  
BOTH IN OLD  
AND NEW  
SURFACES

SEAM VISIBLE  
BUT WITHOUT  
CRACKS
