Maritime archaeological
site survey
Huis te Warmelo 1708-1715.

Research report

Helsinki-Tallinn 2017

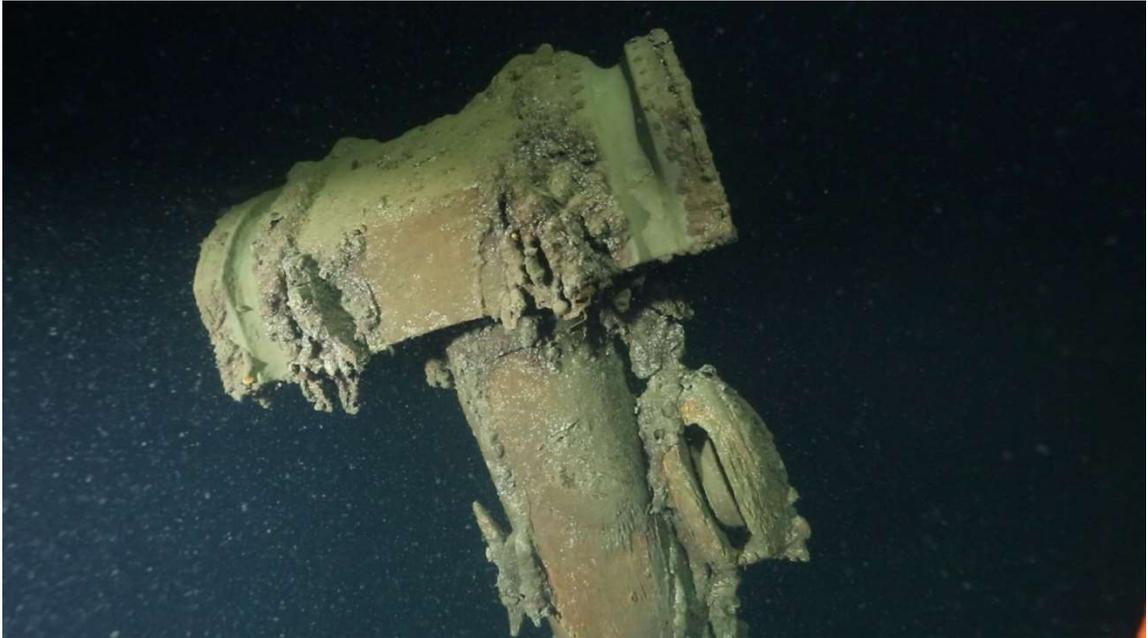
Fig. 4. The top of the fore mast. Video frame capture: Ivan Borovikov.

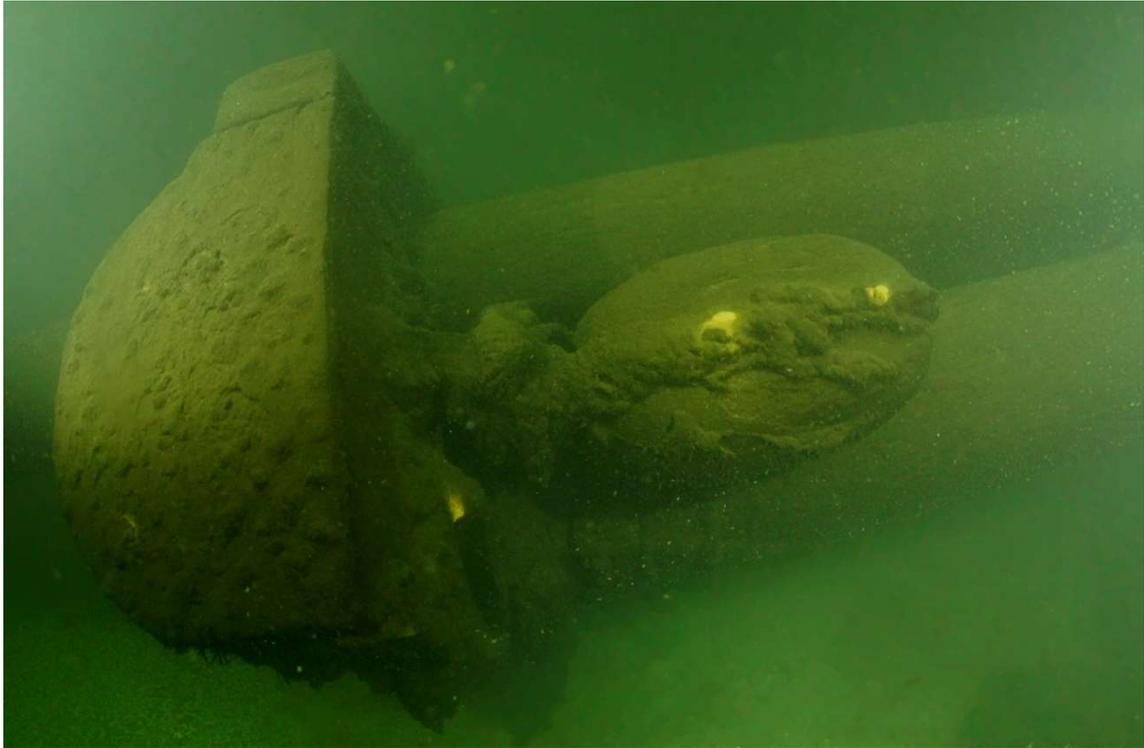
The timber of the wreck observed to be in remarkably good condition. The ship proved to be a very well kept warship showing no damage from battle, fire or shipworm. The hull, decks, masts and armament are still present. The fore mast up to the first extension is still standing up right (Fig. 4.). The main mast and mizzen are fallen to the port side of the wreck (Fig. 5, 6).

Fig. 6. Detail of the main mast at the seabed. Video frame capture: Kari Hyttinen.

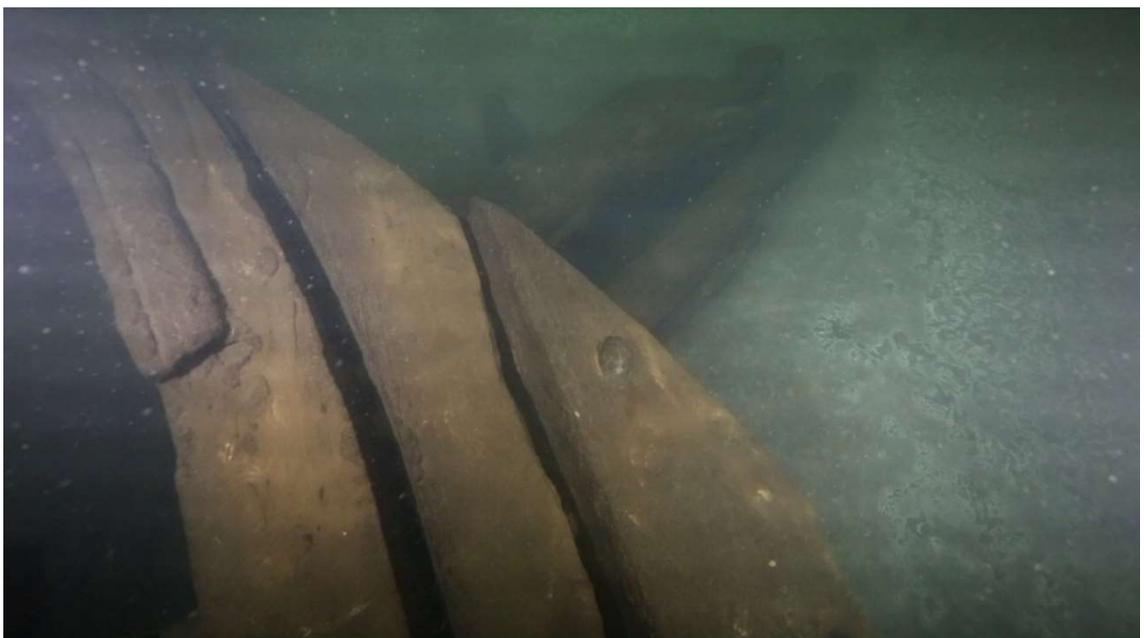
The wreck is partly buried in the seabed, which has provided excellent conditions for preservation. Two deck levels are above the floor surface. The wreck is in the sediment up to the hull's waterline on the starboard side and up to the upper (main) gun deck on the port side. The bowsprit has tilted down so, that the front end of it is inside the sediment. The beakhead has fallen to the seabed and the figurehead is partly under it (Fig. 7).

Fig. 7. The detail of beakhead. Video frame capture: Ivan Borovikov.

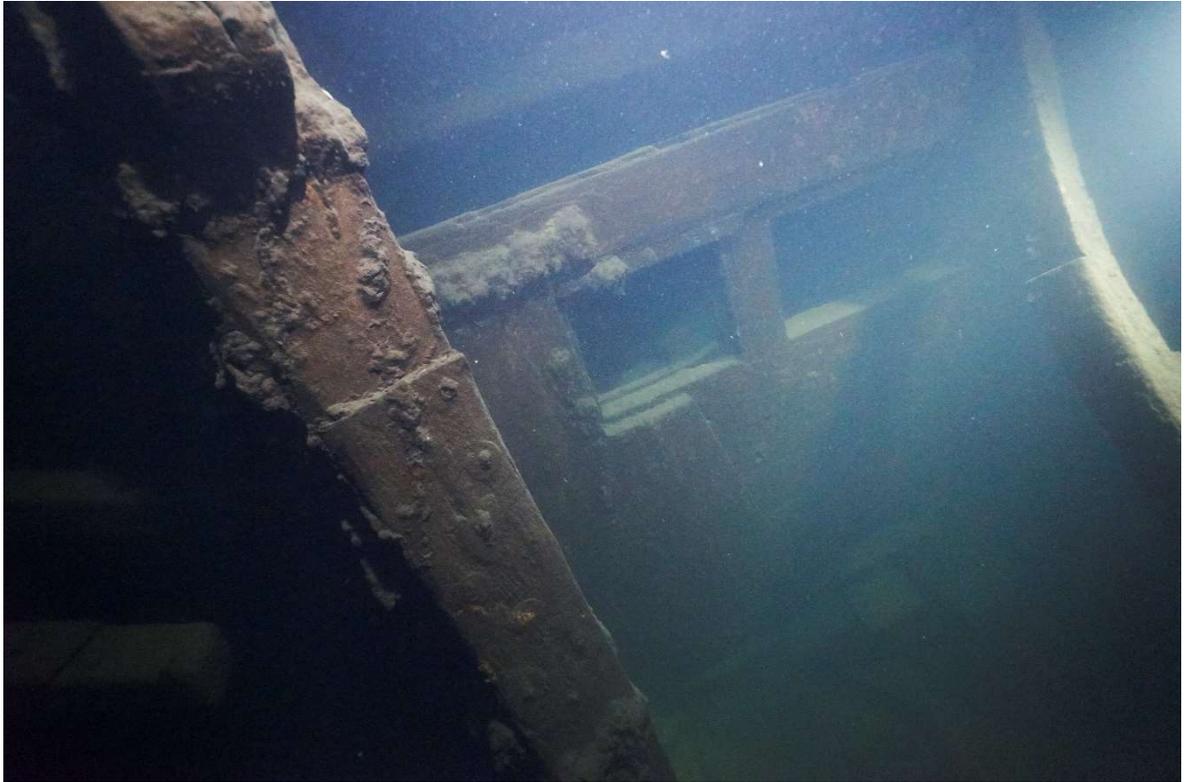
The whole stern up to wing transom is in place. The aft castell has collapsed behind the stern and most of it is inside the sediment. The stern post, rudder and tiller are in place (Fig. 8). The starboard outer side planks have fallen to the seabed.

Fig. 8. View of the stern and rudder. Photo: Janne Suhonen.

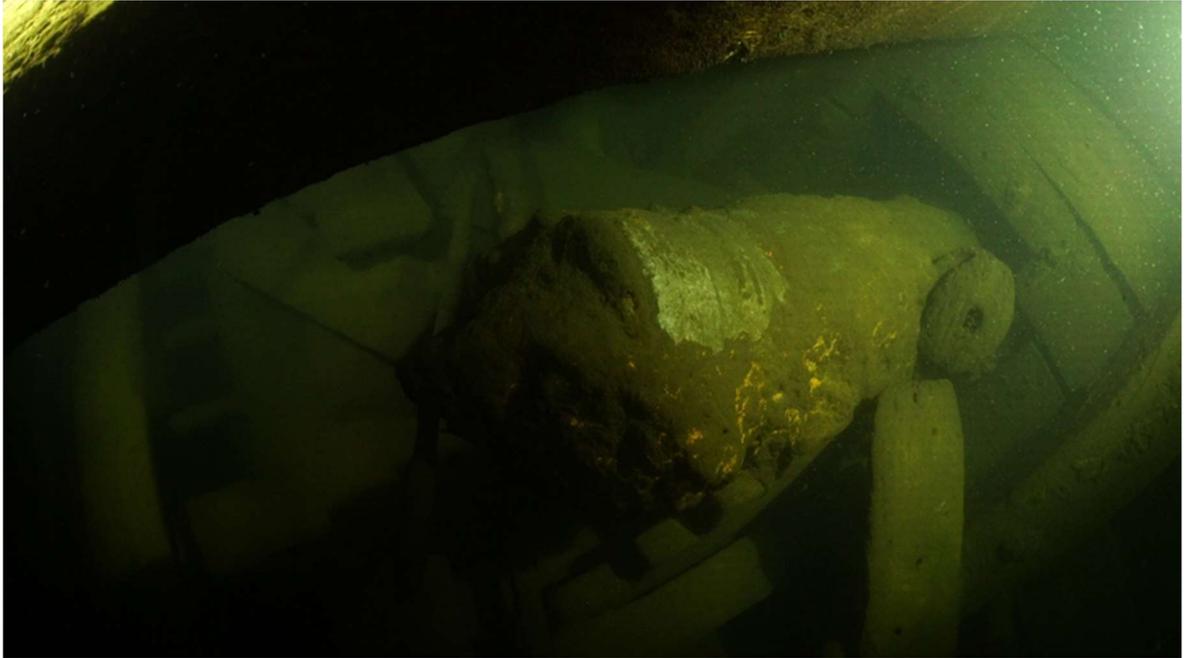
Between Subzone's dive to the wreck site in 2014 and Subzone's first research dive on 29th of June 2016, damage to at least two cannons had occurred. Someone had scratched the cannons probably trying to find markings (Fig. 9.)

Fig. 9. Scratching on a cannon on port side main gun deck under the large binding strake behind capstan. Video frame capture: Kari Hyttinen.

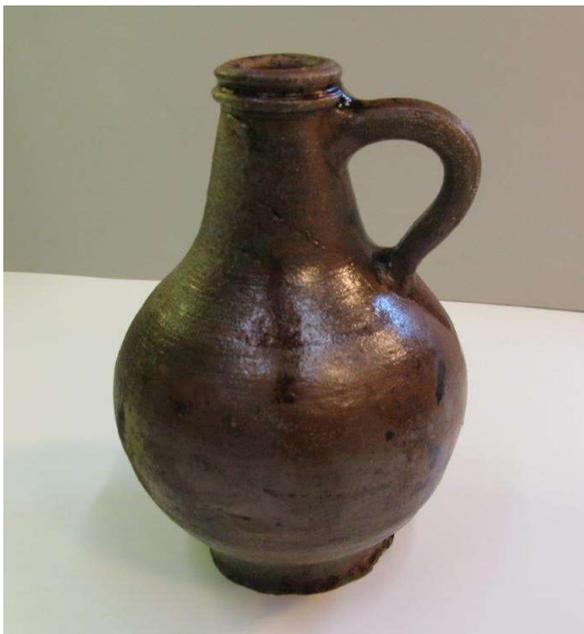
The second known looting took place on 30.07.2016. The group of divers visited the wreck site and one diver had lifted an artefact from the Huis te Warmelo wreck (Fig. 10). A jug was lifted from the wreck during a photographing session without National Board of Antiquities permission, but taken immediately to the National Board of Antiquities. A jug belongs now to the collection of the Maritime Museum. The National Board of Antiquities handled the incident with the diver involved, and it was decided not to take the case further. According to diver the jug was on the deck, under a fallen plank, only partly visible.

Fig. 10. Frechen stoneware jug from the wreck (1675-1725, Bartels 1999). Photo Immi Wallin.

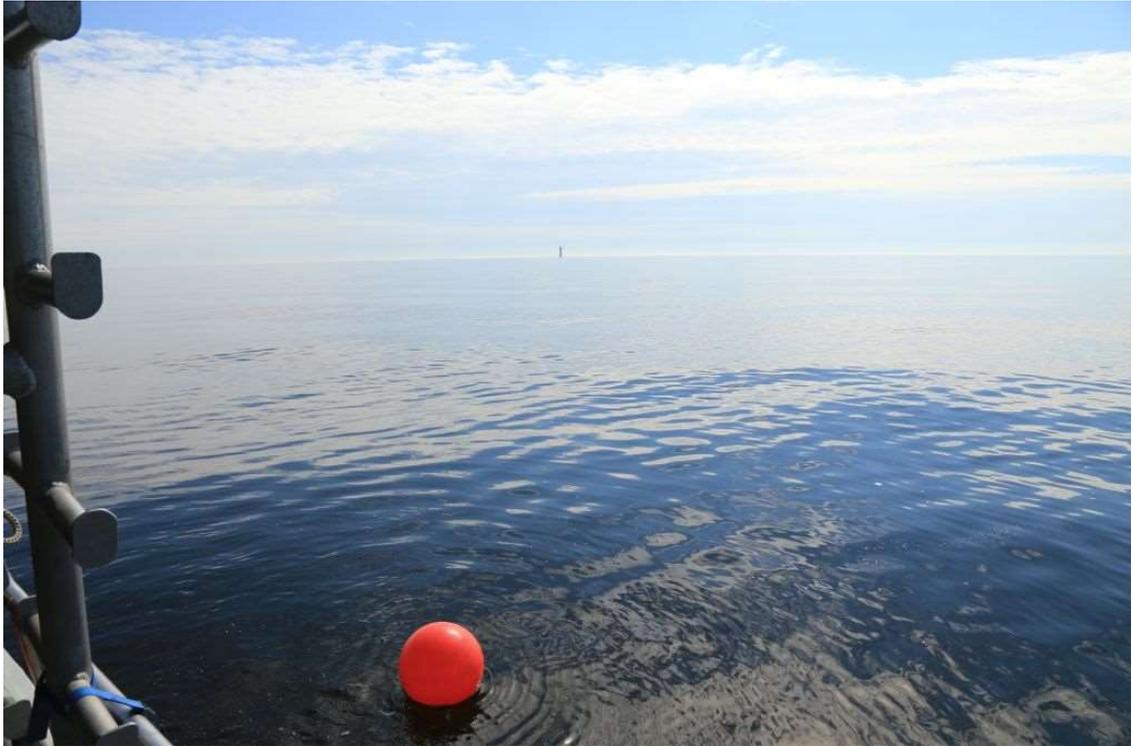
Fig. 19. View to the shot line buoy with Kalbådagrund lighthouse on the background.
Photo: Maili Roio 29.06.2016.

29.06.2016 A diving shot line was outside the wreck in front of the bow on starboard side.

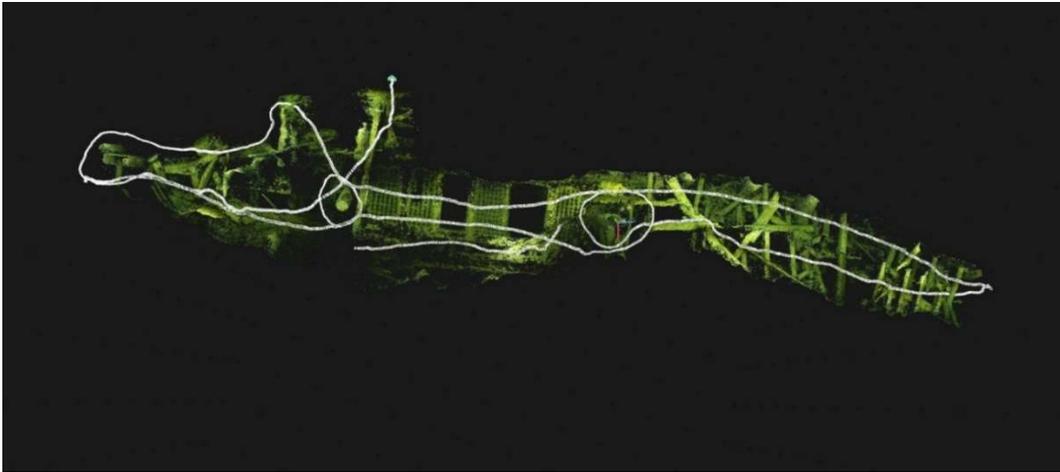
Fig. 23. Screen capture of partial 3D model showing the route of the camera for one dive. Image: Kari Hyttinen.

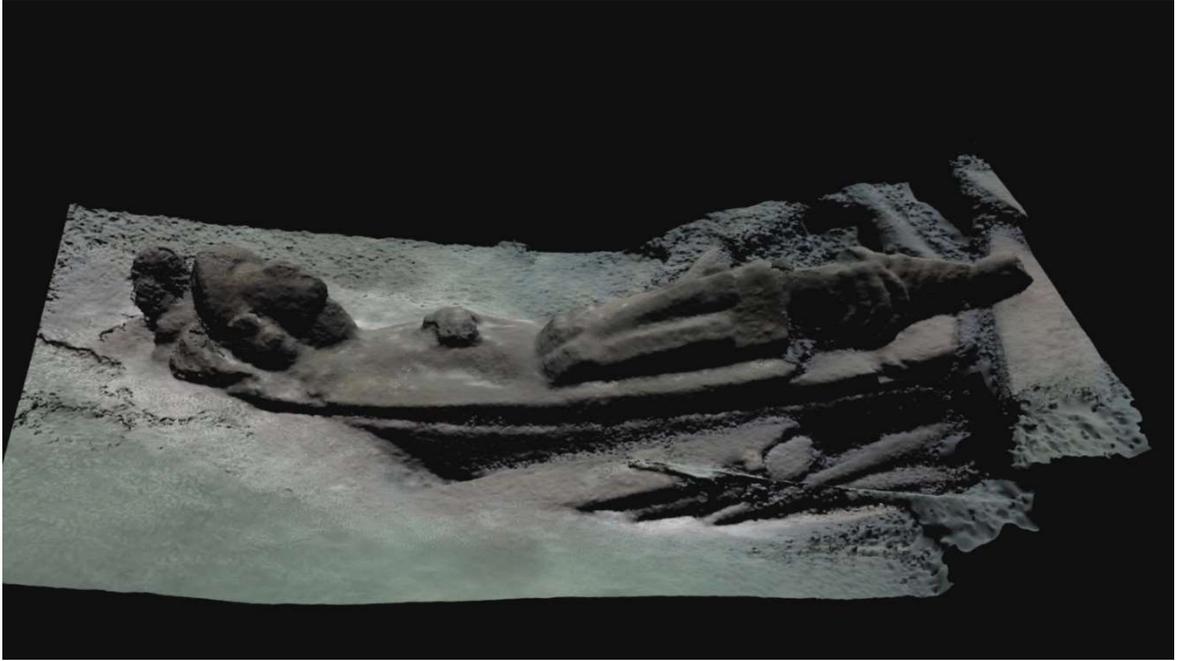
Fig. 27. Image of 3D model of stern decoration. Image: Kari Hyttinen.

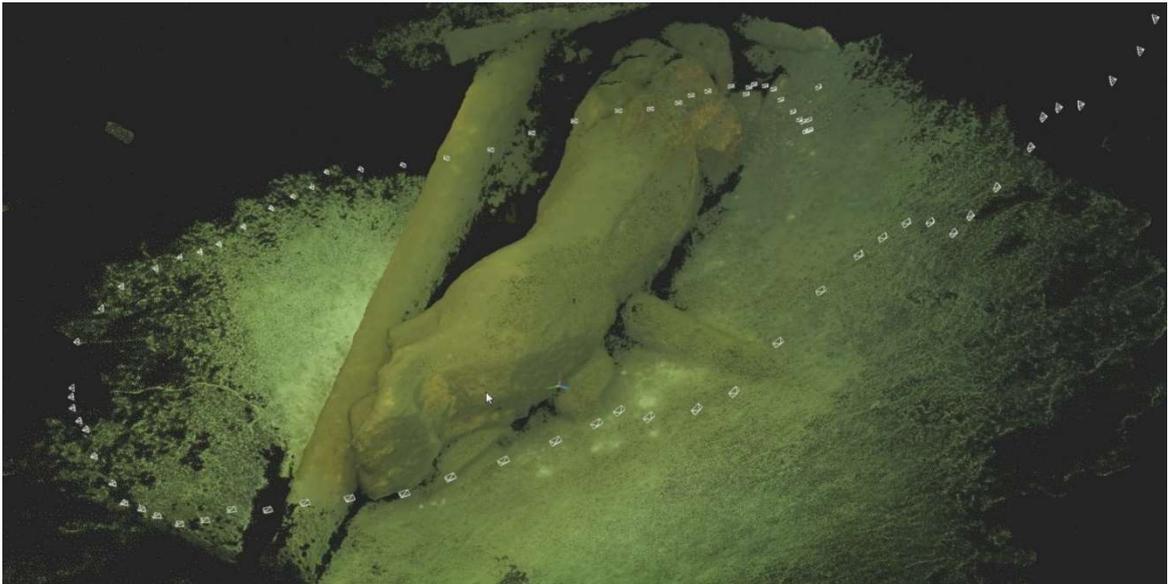
Fig. 28. Image of 3D model of figure head. Image: Kari Hyttinen.

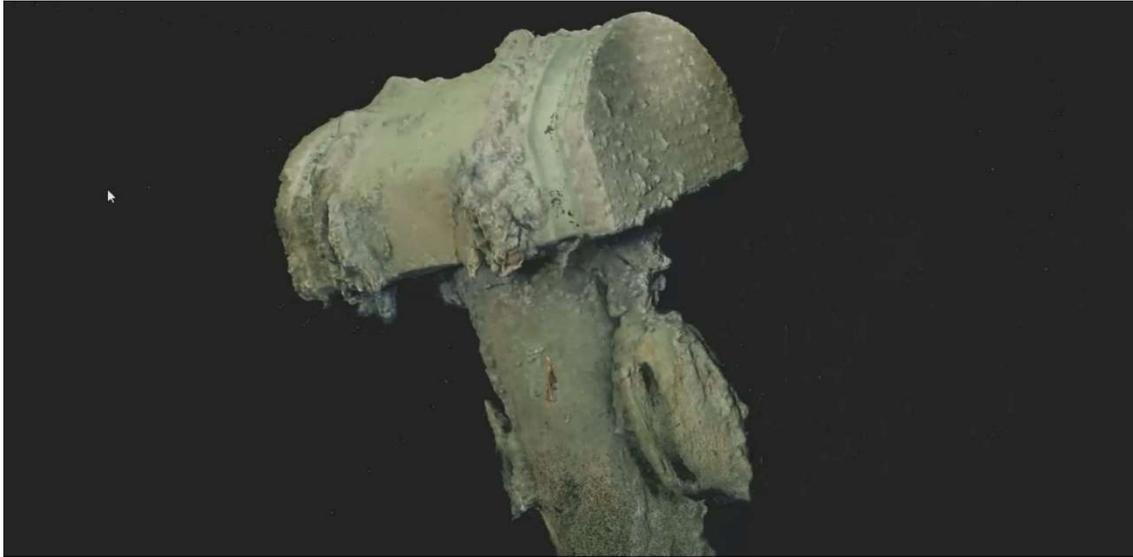
Fig. 29. Image of 3D model of top of the fore mast. Image: Kari Hyttinen.

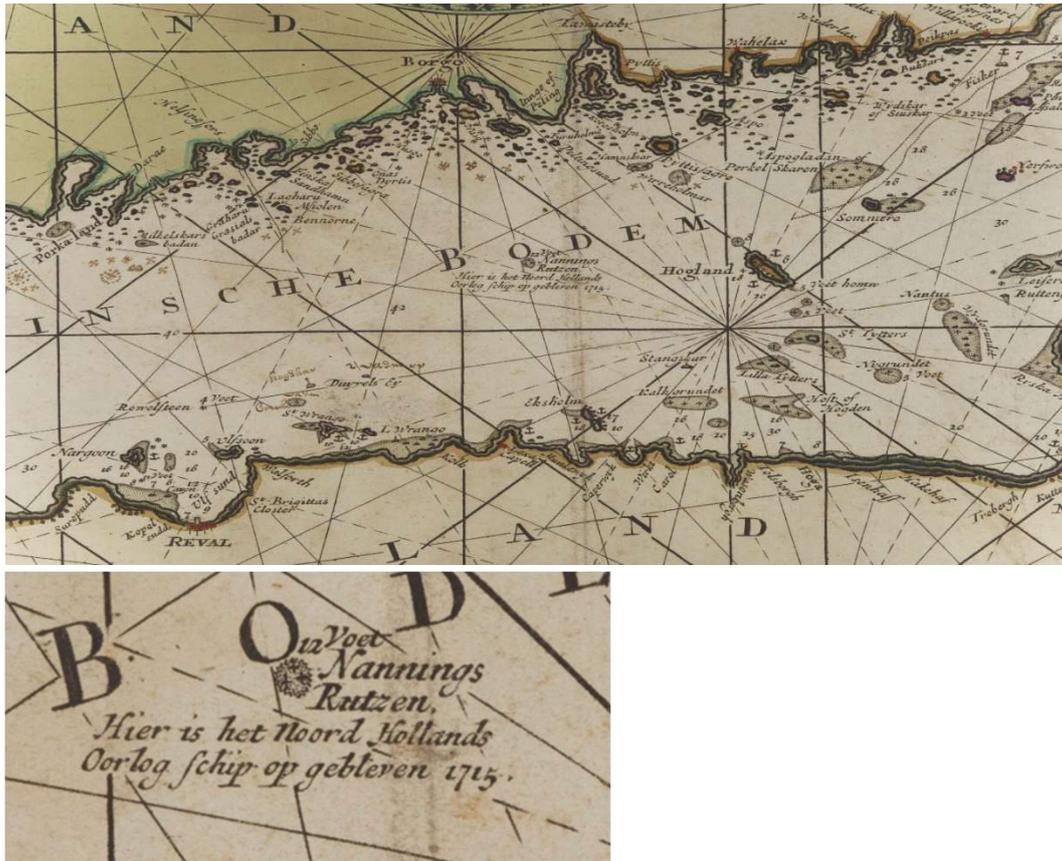
Fig. 30. The location of the sunken man-of-war on the nautical chart about 1720 (S.0429(08)).

The name of the shallow on the Dutch map is Nannings Rutzen (Fig. 30). The report from British man-of-war, Mermaid, that participated the same convoy as the Huis te Warmelo, is telling that about 40 NM from Gogland the Dutch frigate hit a submerged rock and sunk shortly afterwards (ADM 52/236). The name Nannings Rutzen is not known in other maps, but the location is the same as Kalbådagrund location. Distance from Gogland to Kalbådagrund is 40 NM.

The location of the wreck corresponds with the historical data of the location where Huis te Warmelo hit the shallow when coming from Gogland and drifted to South-West with the wind from North-East. The wreck is located 1,1 NM from Kalbådgrund to the West. The bearing from the shallow to the wreck is 243-273 degrees depending where on the shallow the ship hit it. The logbook of British man-of-war Assistance, that participated the convoy, tells that the wind was from North-North-East and North-East (ADM 52/128).

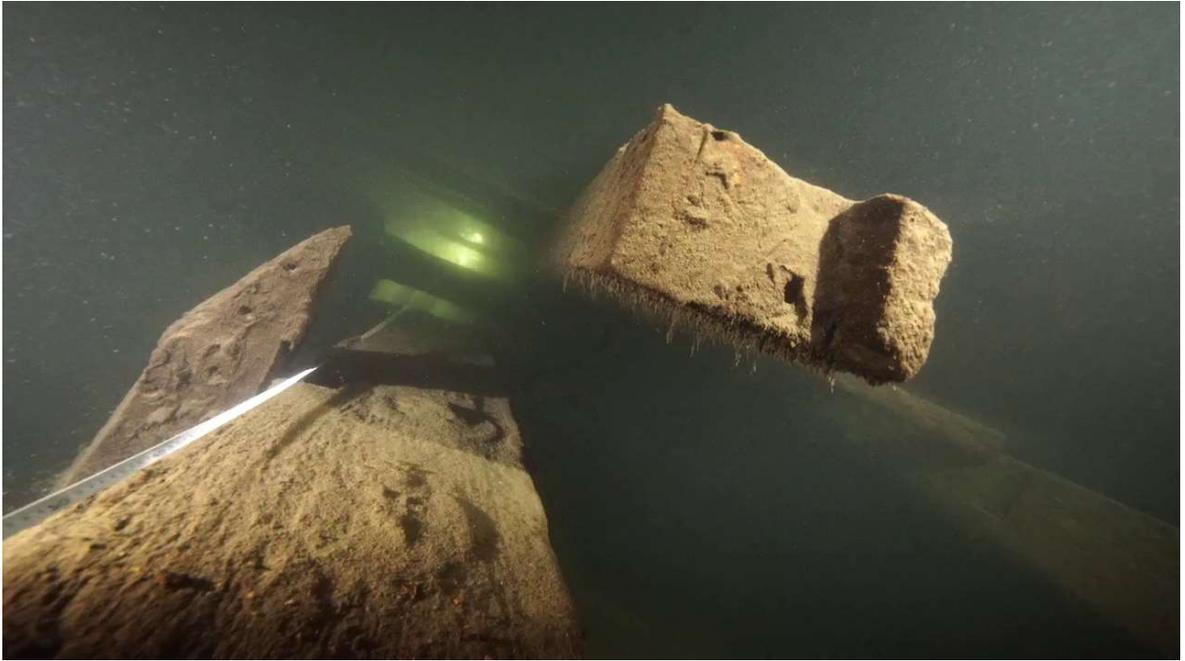
The wing transom was also measured with tape measure and the length is 7 meters. In the tender the length of the wing transom in 6.94 meters.

Fig. 32. Measuring of the wing transom. Video frame capture: Kari Hyttinen.

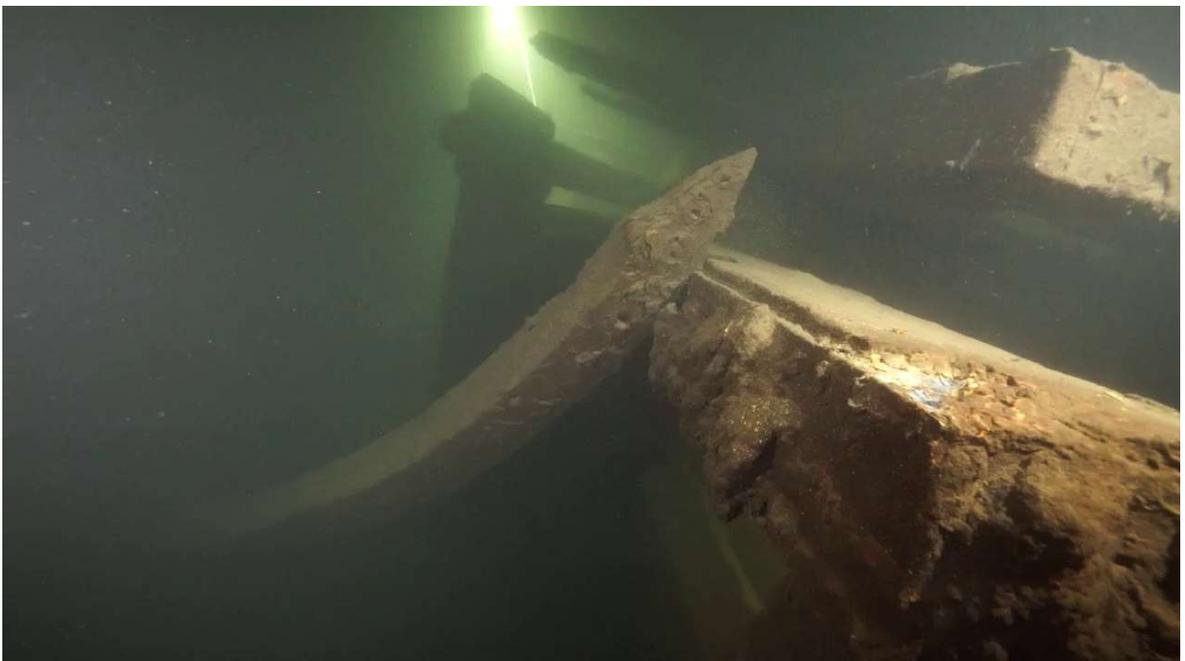
Fig. 33. Wing transom, stern post, rudder and tiller. Video frame capture: Kari Hyttinen.

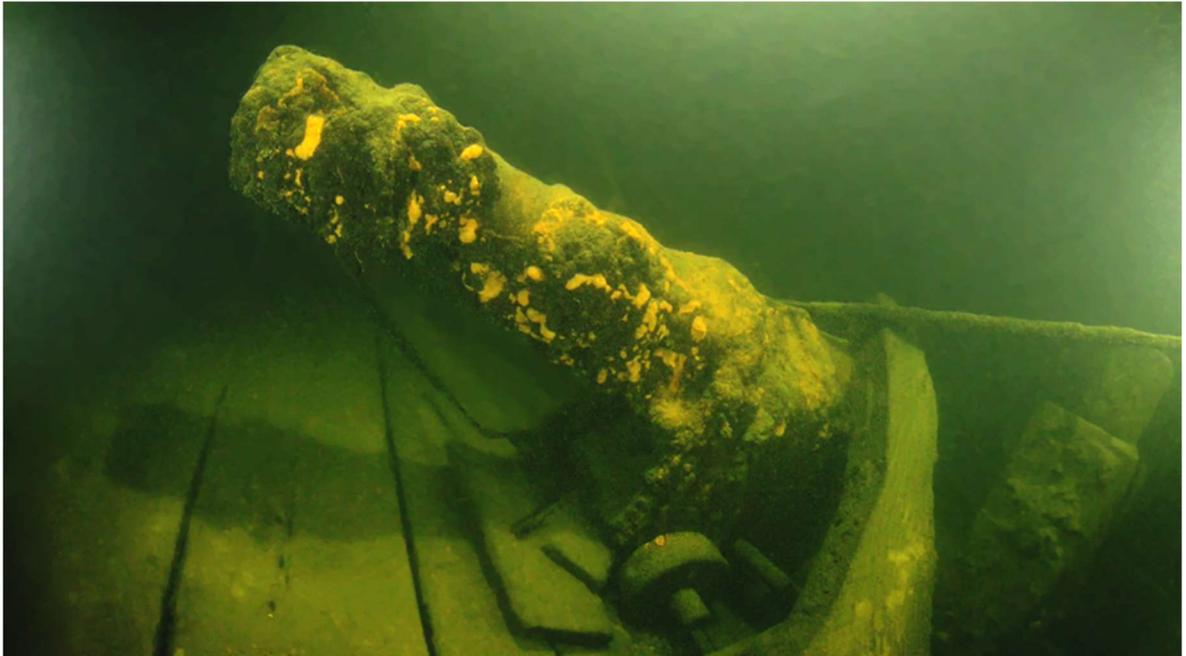
There are 17 cannons on the upper deck visible and probably rest of the cannons among collapsed aft castle and other structures as well as on the lower gun deck. All observed cannons are made of iron.

Fig. 34. Cannon on the starboard side near the fore mast. Video frame capture: Kari Hyttinen.

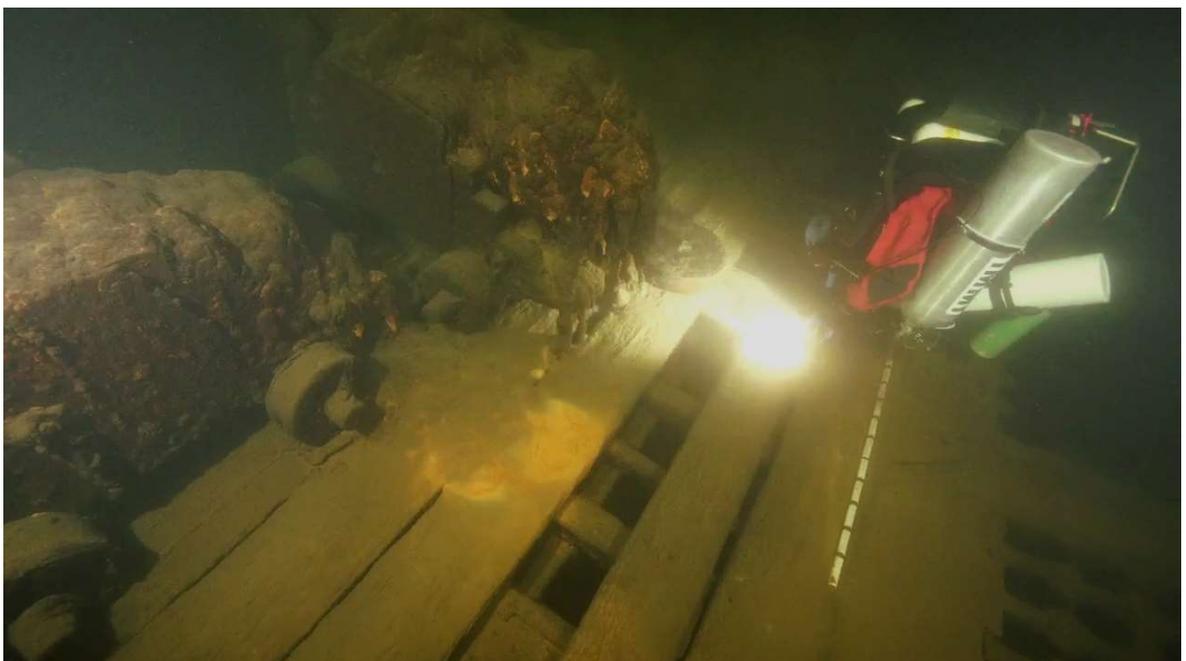
Fig. 35. Cannons on the starboard side. Video frame capture: Kari Hyttinen.

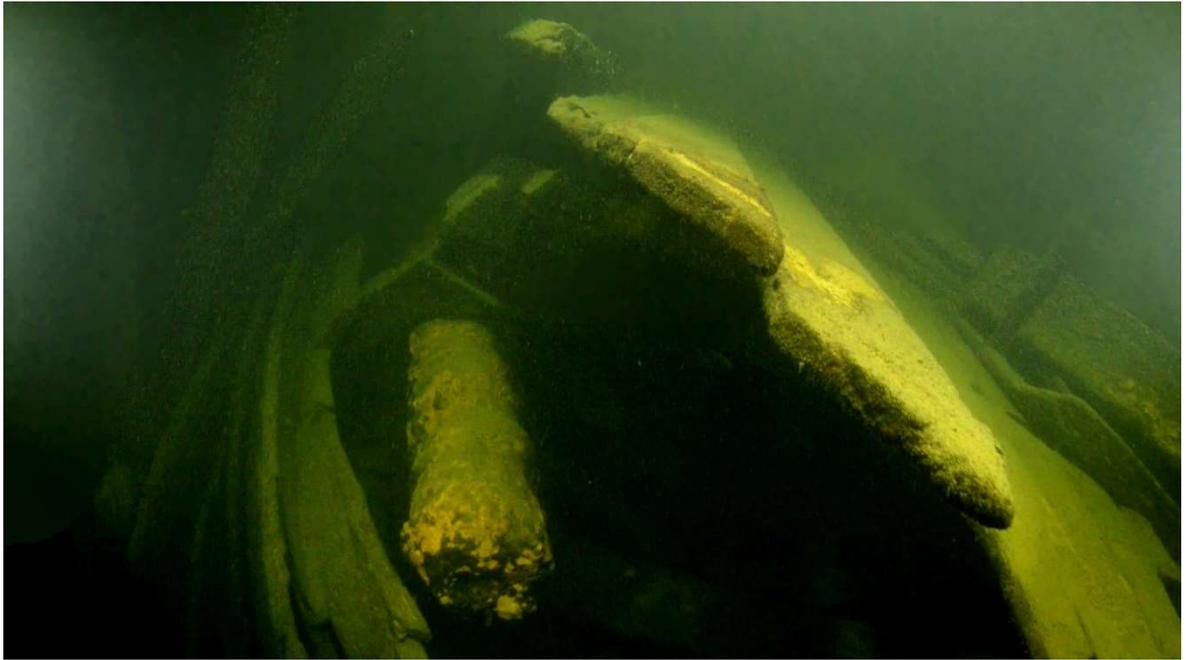
Fig. 36. The bow chase cannon. Video frame capture: Kari Hyttinen.

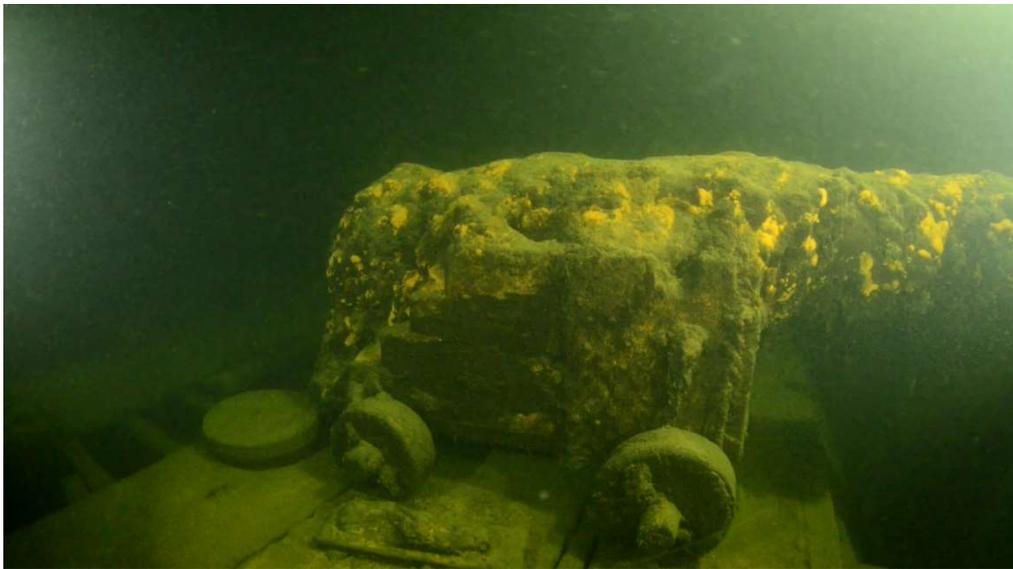
The cannon carriages are very likely Dutch type of carriages because the structure of the bottom and sides are made out of one piece (Nico Brinck e-mail to Michiel Bartels, 19.01.2016).

Fig. 37. The cannon carriage. Video frame capture: Kari Hyttinen.

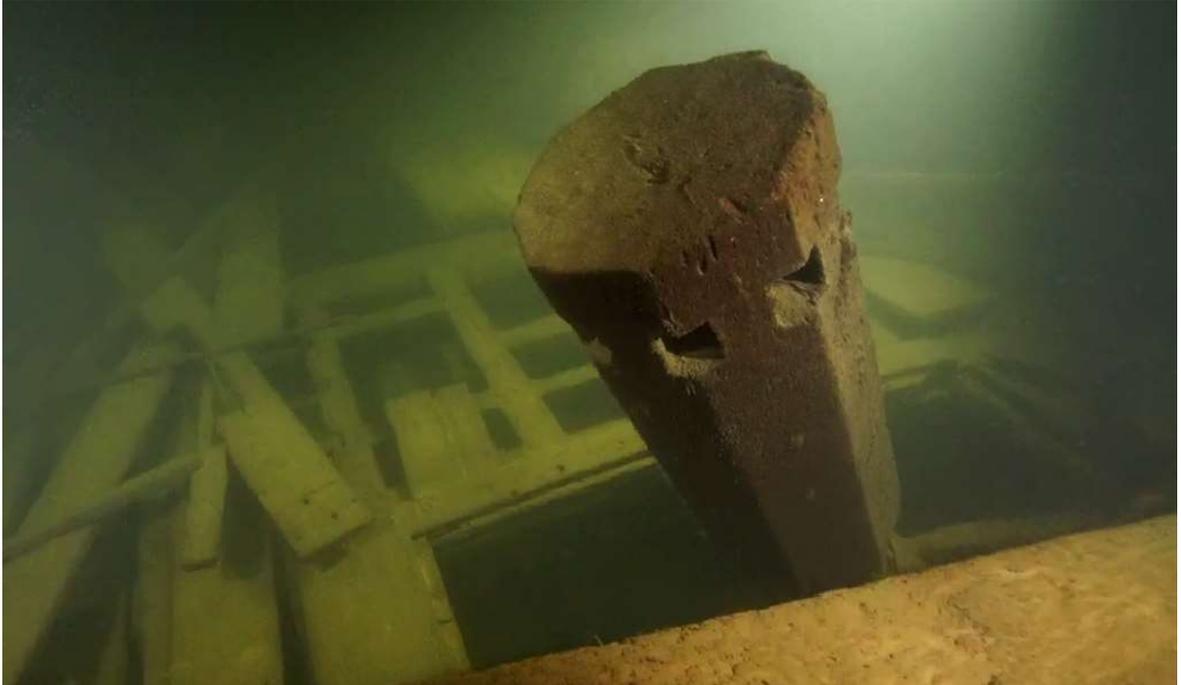
According to specifications for building the Huis te Warmelo - large English capstan [spil, kaapstander] with 10 half holes, an upper English capstan with 8 half holes (Admiralty Archives 3256).

Fig. 38. The upper part of the capstan behind the foremast with 8 holes. Video frame capture: Kari Hyttinen.

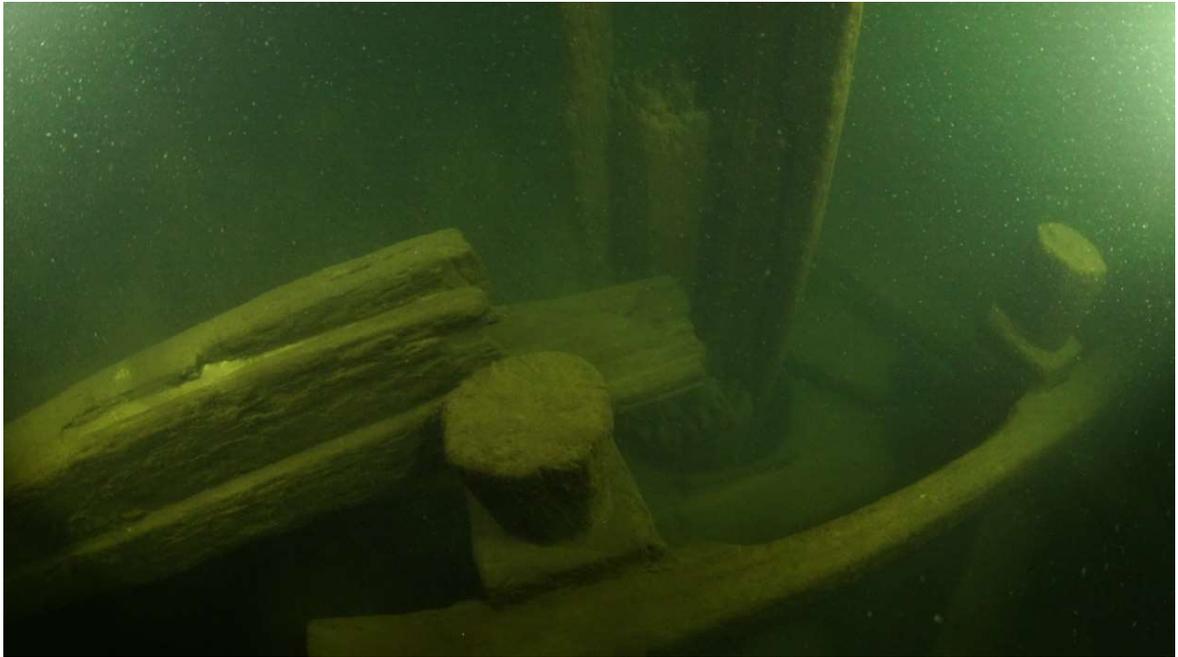
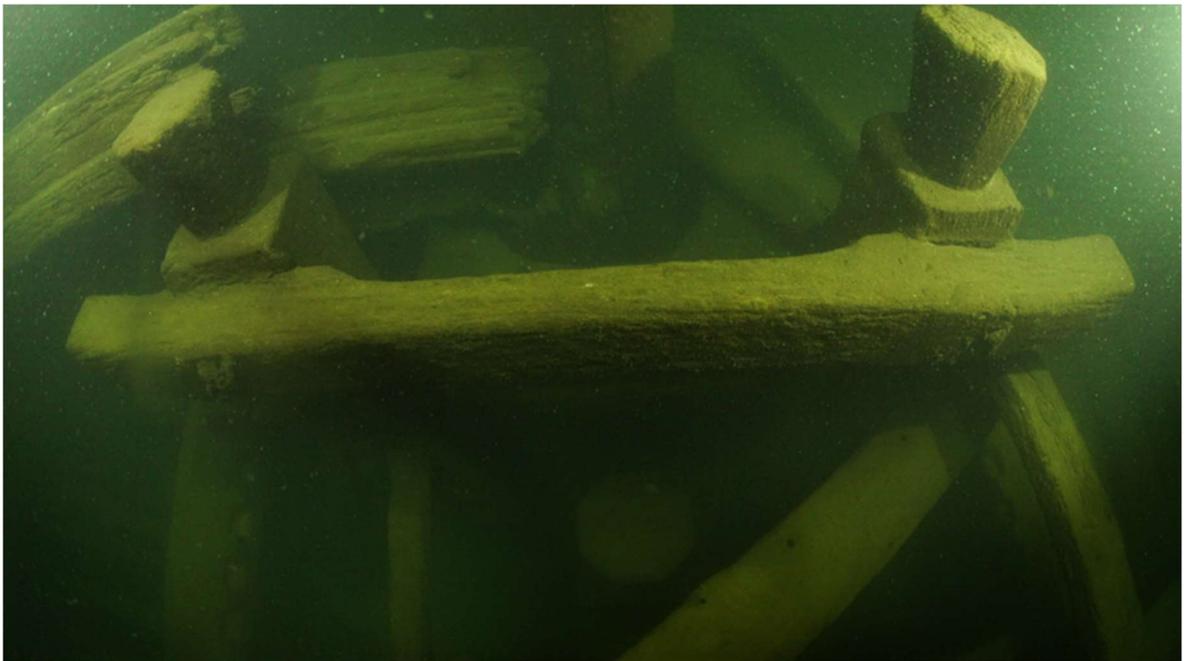
The timber heads are mostly octagonal. The octagonal timberheads seem to be peculiar to the Dutch (Laughton 2013, 256).

Fig. 39. Jeerbitts behind the main mast. Video frame capture: Kari Hyttinen.

Fig. 40. Jeerbitts behind the main mast. Video frame capture: Kari Hyttinen.

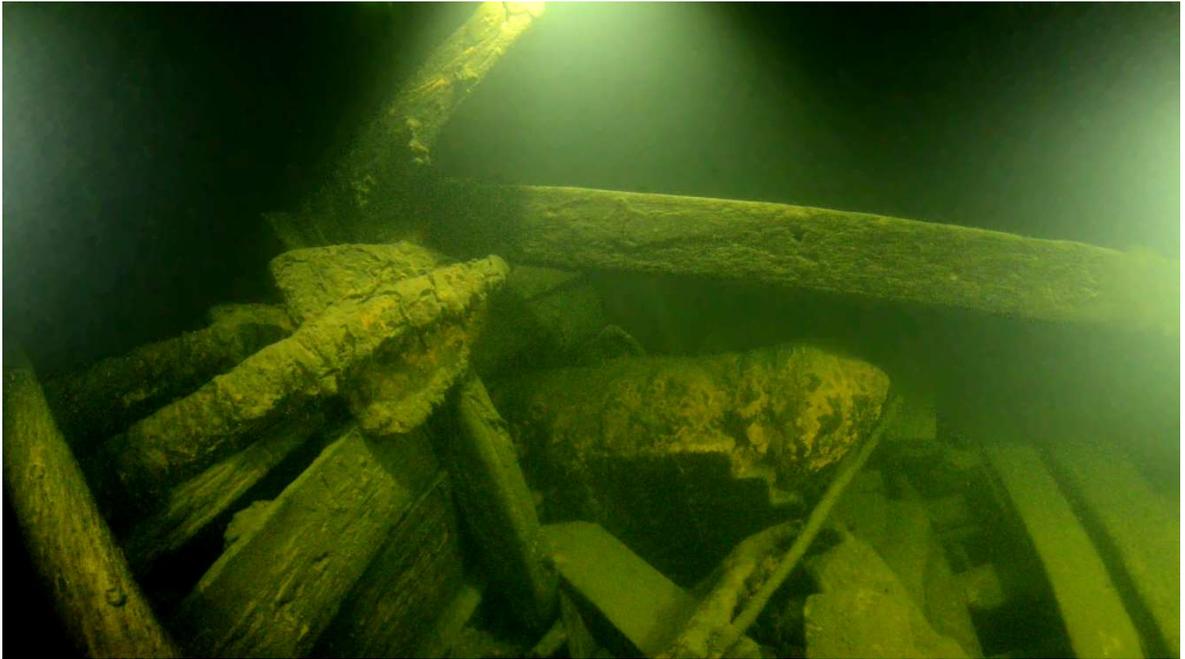
There are five anchors with two arms and wooden stocks at least in the wreck site: two on the reeling on port side (Fig. 41, 42) one on the deck on port side (Fig. 42, 43), one on the bottom on starboard side (Fig. 45) and one inside the wreck (Fig. 44).

Fig. 41. Anchors on the reeling on port side. Video frame capture: Kari Hyttinen.

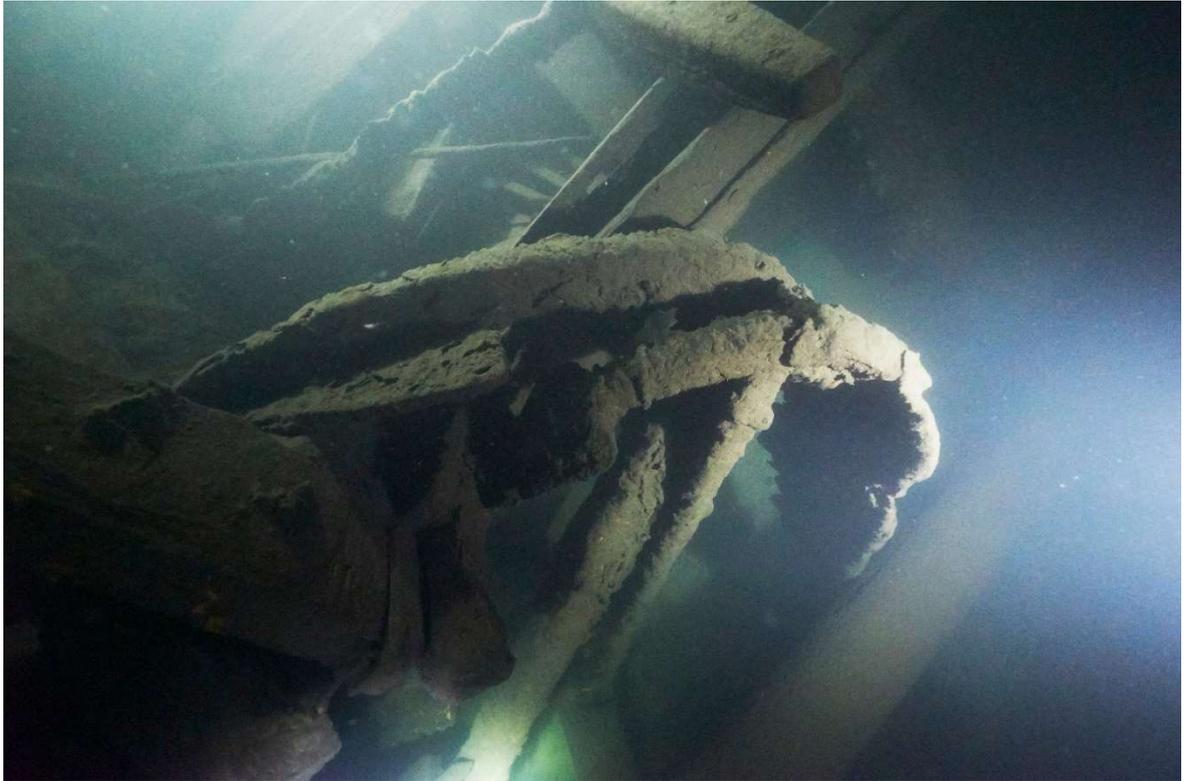
Fig. 42. Anchors on the reeling and on the deck on port side. Photo: Janne Suhonen.

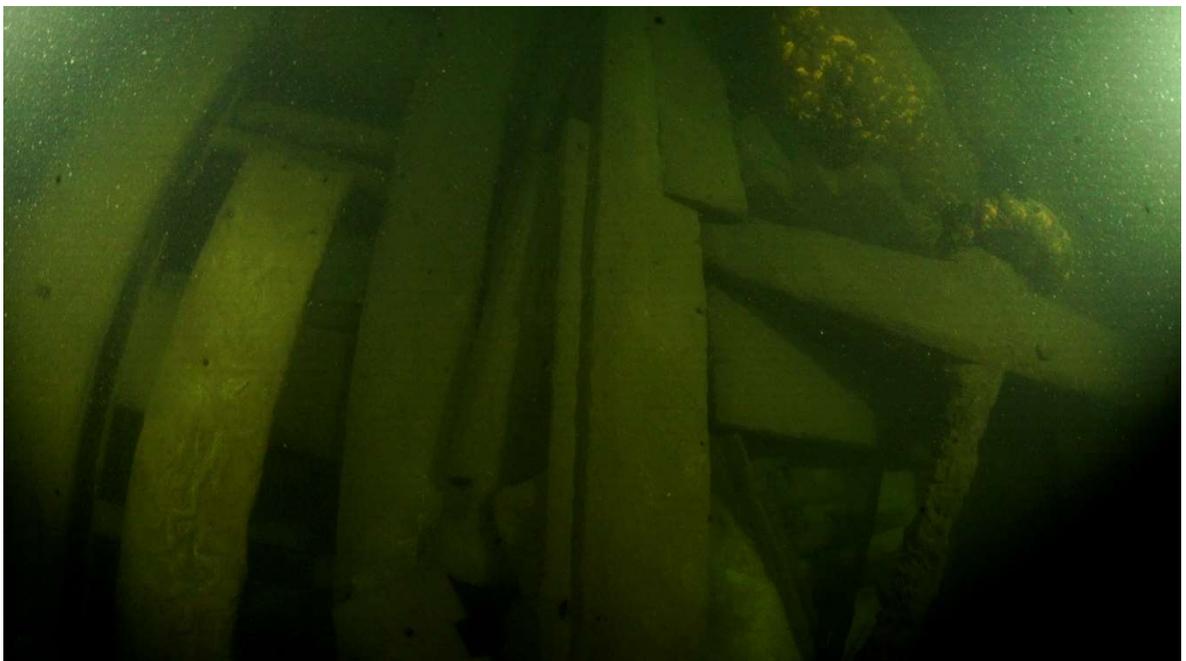
Fig. 43. Anchor on the deck on port side. Video frame capture: Kari Hyttinen.

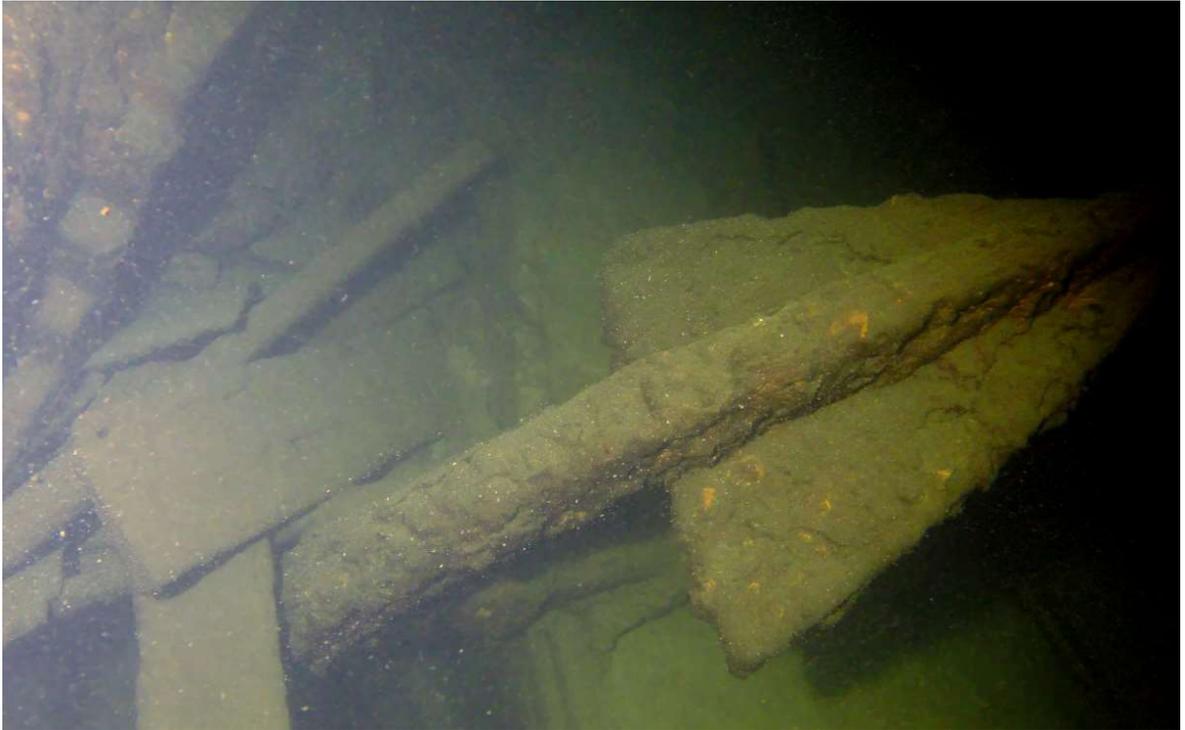
Fig. 44. Anchor inside the wreck. Video frame capture: Immi Wallin.

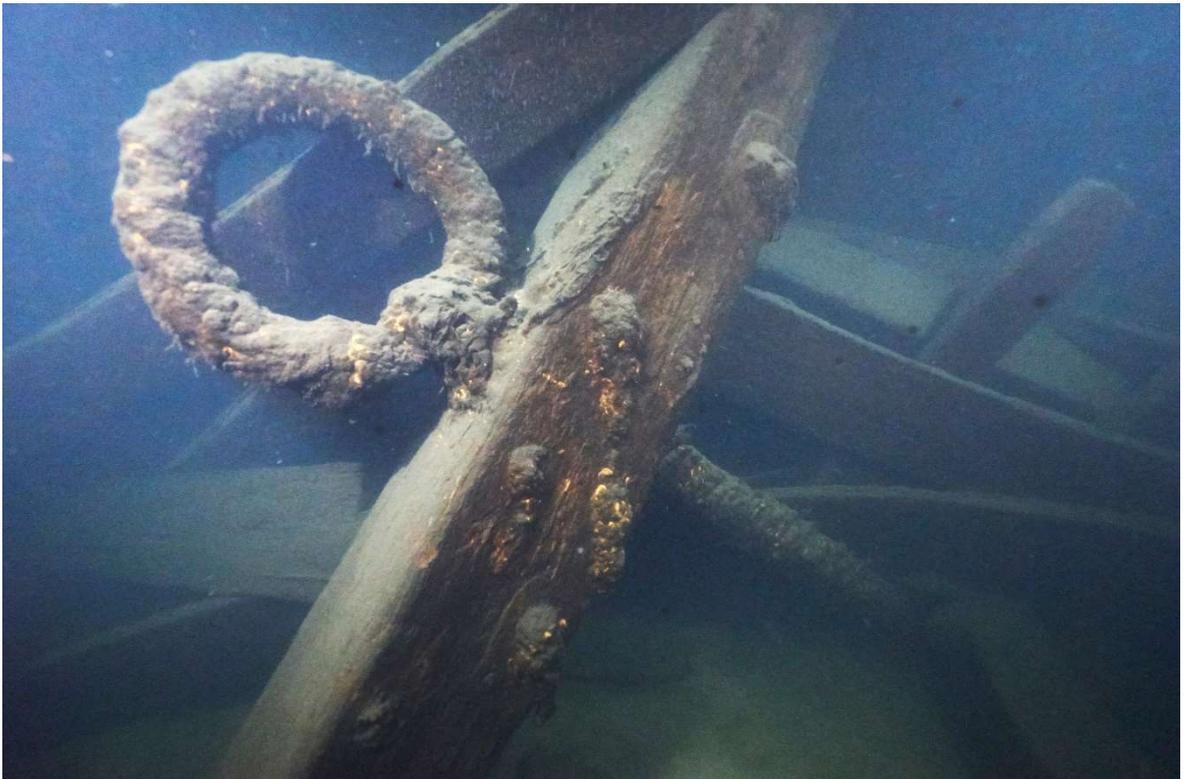
Fig. 45. Anchor on the starboard board. Photo: Janne Suhonen.

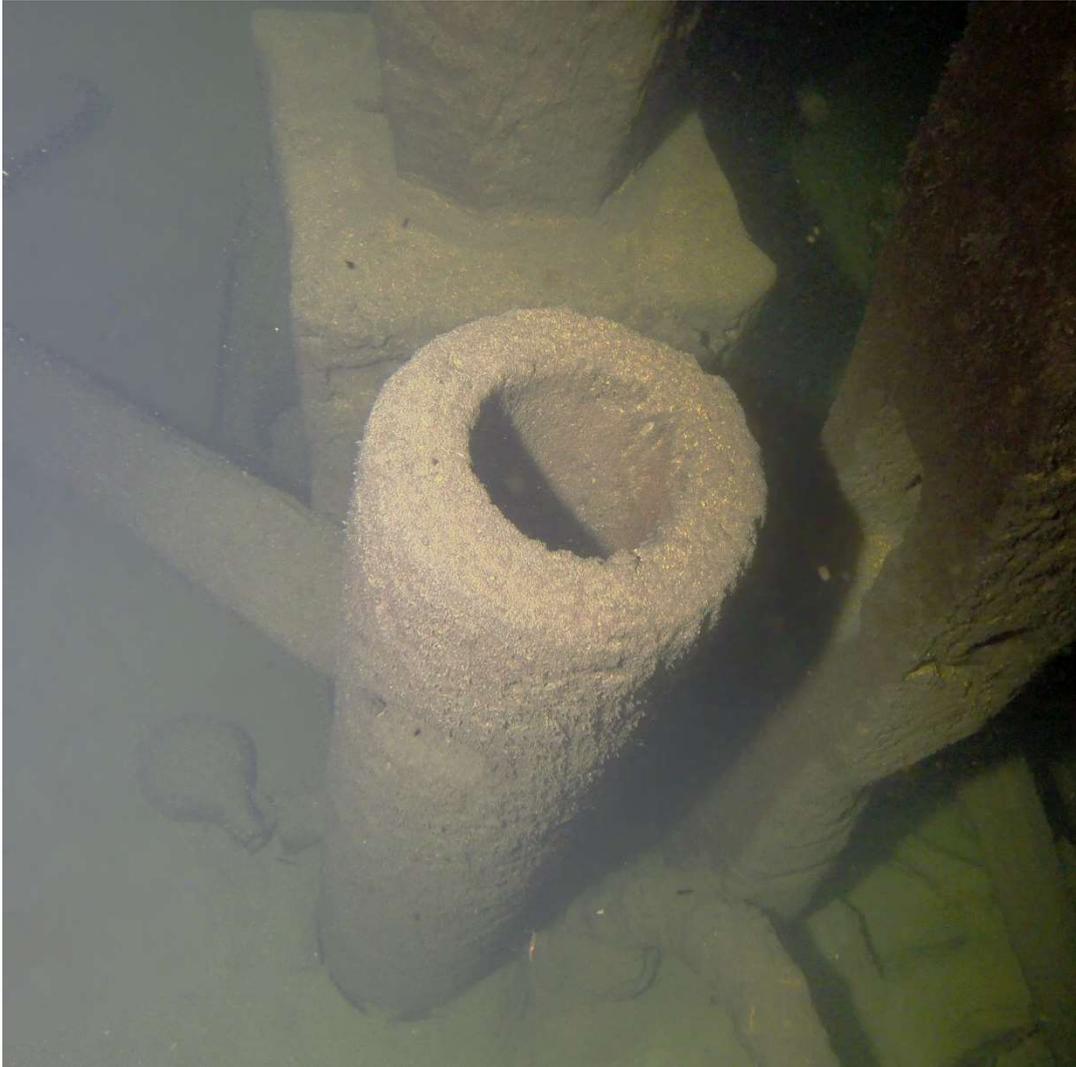
Fig. 46. Intact pump with the handle behind the main mast. Video frame capture: Immi Wallin.

The pumps were made of elm. They were bored out accurately through the heartwood, then tarred and served with canvas and rope to prevent leakages due to drying out. On the steering stand there were two pumps near the mizzenmast and one near the main mast (Hoving 2012, 153-154).
