Maritime archaeological
site survey
Huis te Warmelo 1708-1715.

Research report

Helsinki-Tallinn 2017

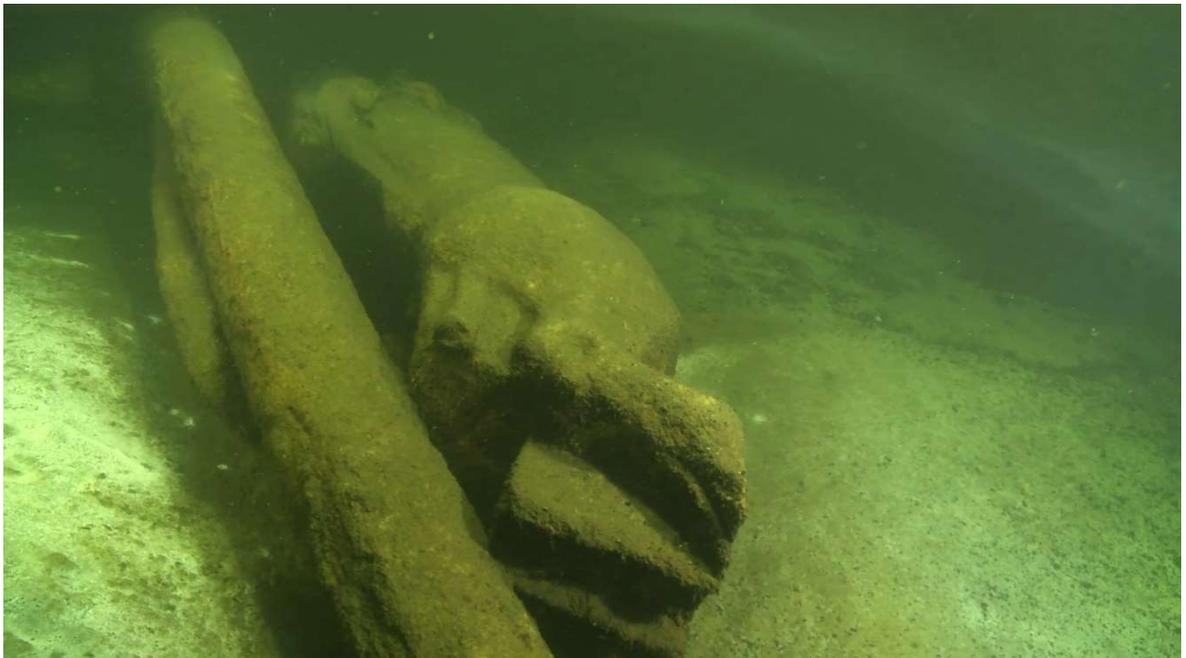
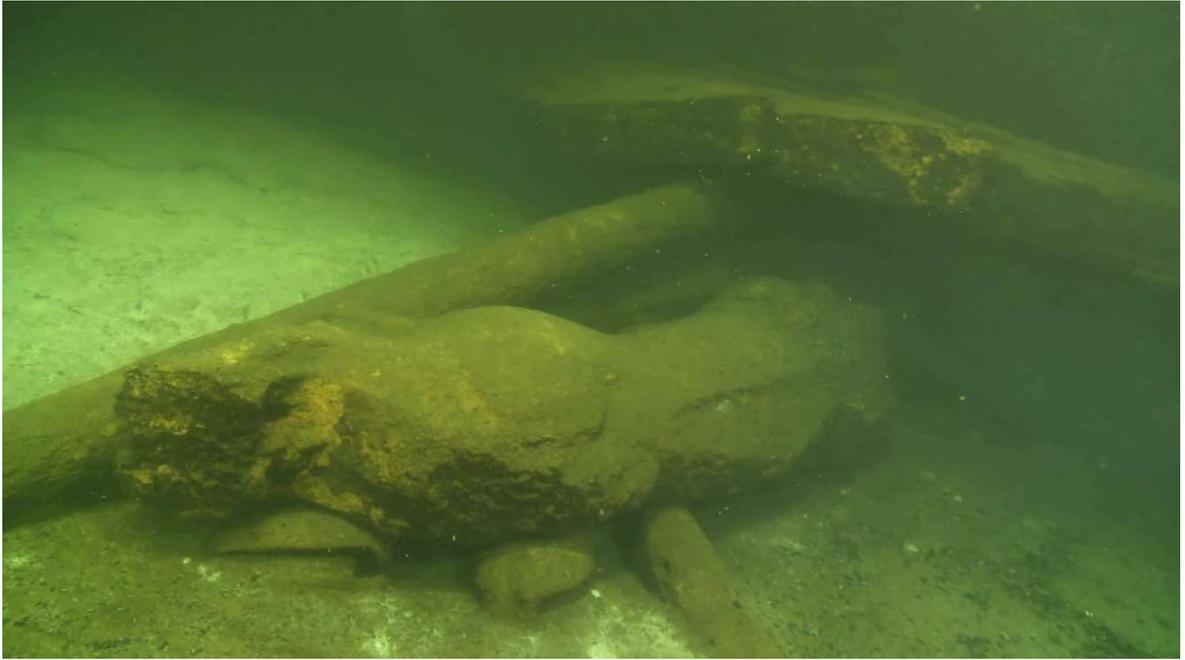
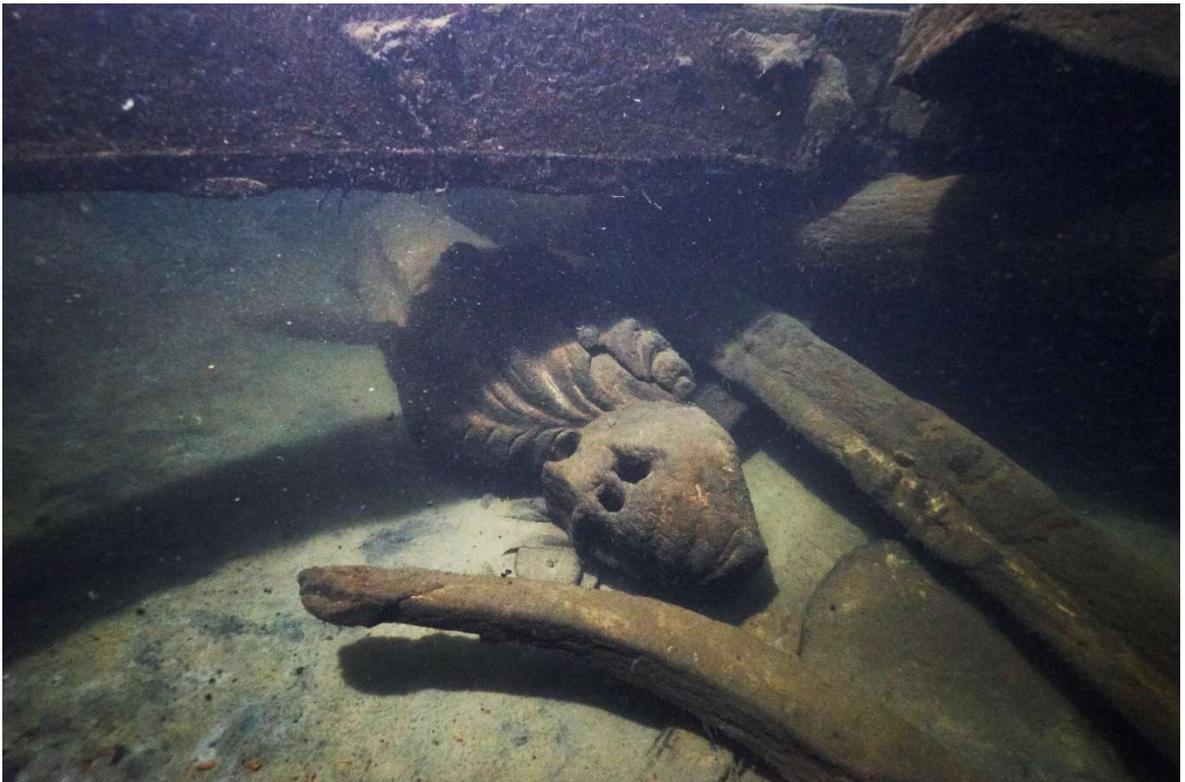
The figure head is a lion, that is located on the sea bottom in front of the bow partly under the beakhead. The figure head is in good condition and almost whole.

Fig. 47. Figure head. Video frame capture: Kari Hyttinen.

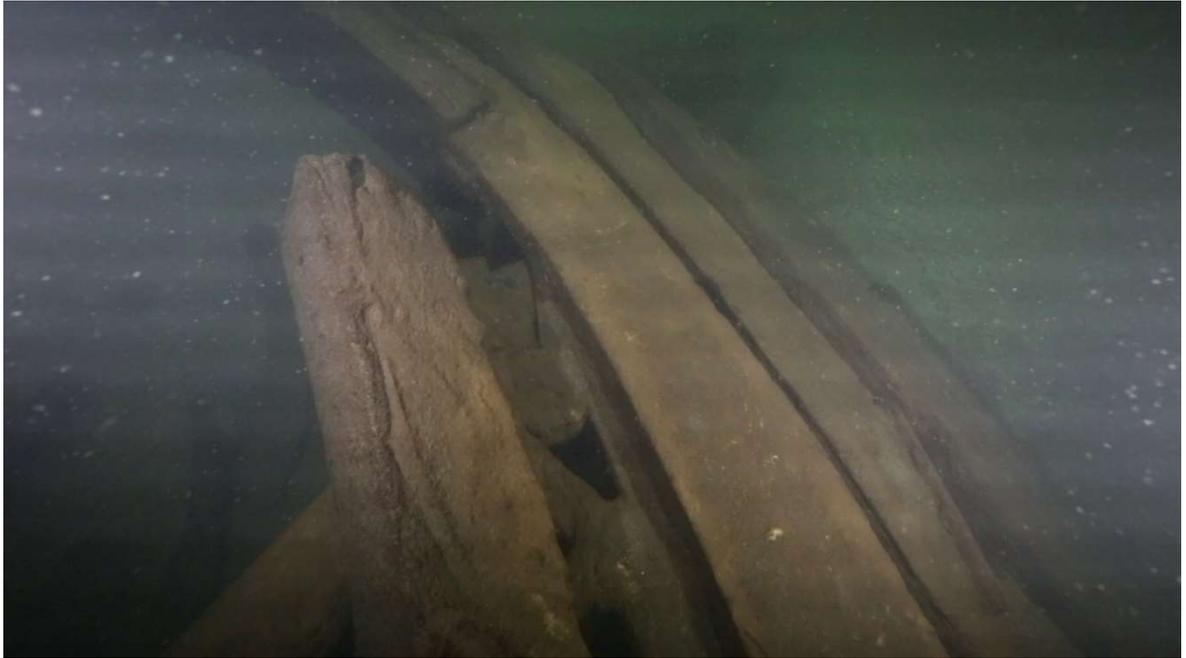
Fig. 50. The decorated beakhead is lying on the bottom in front of the bow. The lion rested on the lower spur of the beakhead. Vide frame capture: Ivan Borovikov.

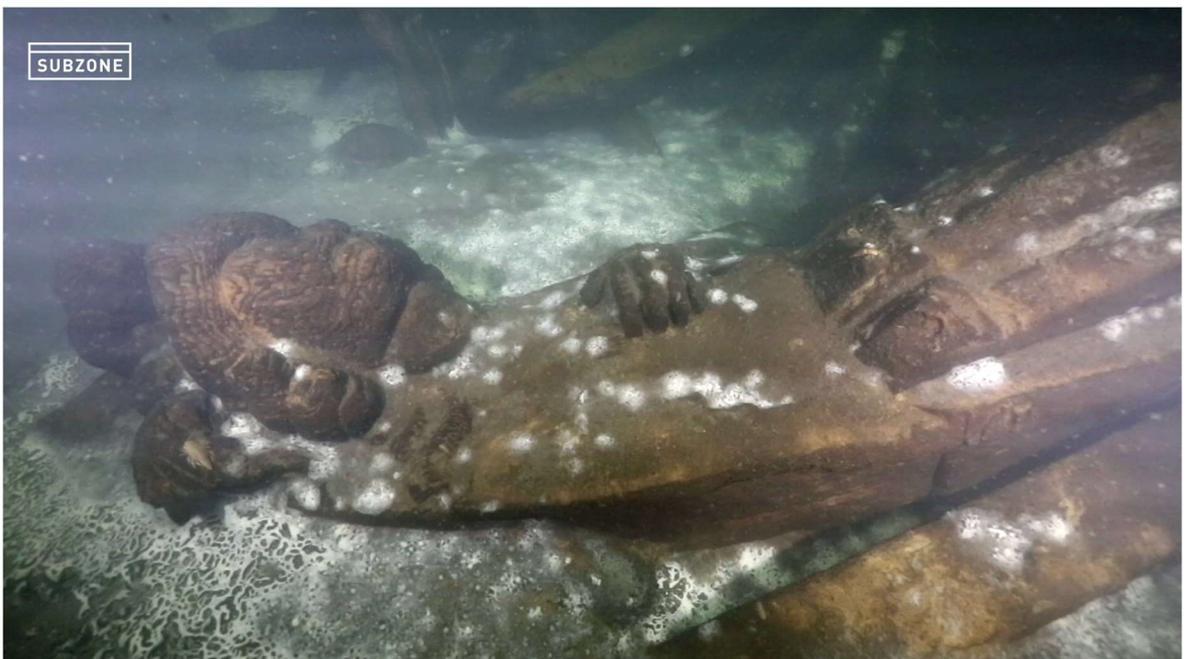
The aft castell has collapsed behind the stern and most of it and decorations are inside the sediments (Fig. 52, 53). On the bottom behind the stern is visible one stern statue (Fig. 51).

Fig. 51. Stern statue. Video frame capture: Ivan Borovikov.

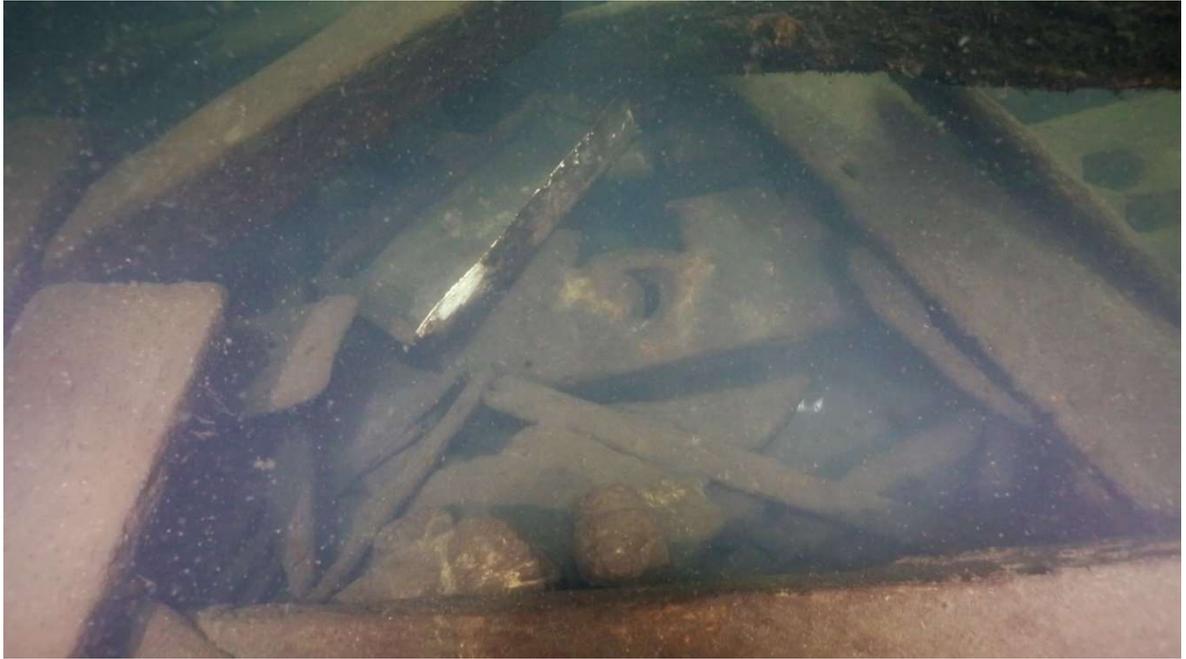
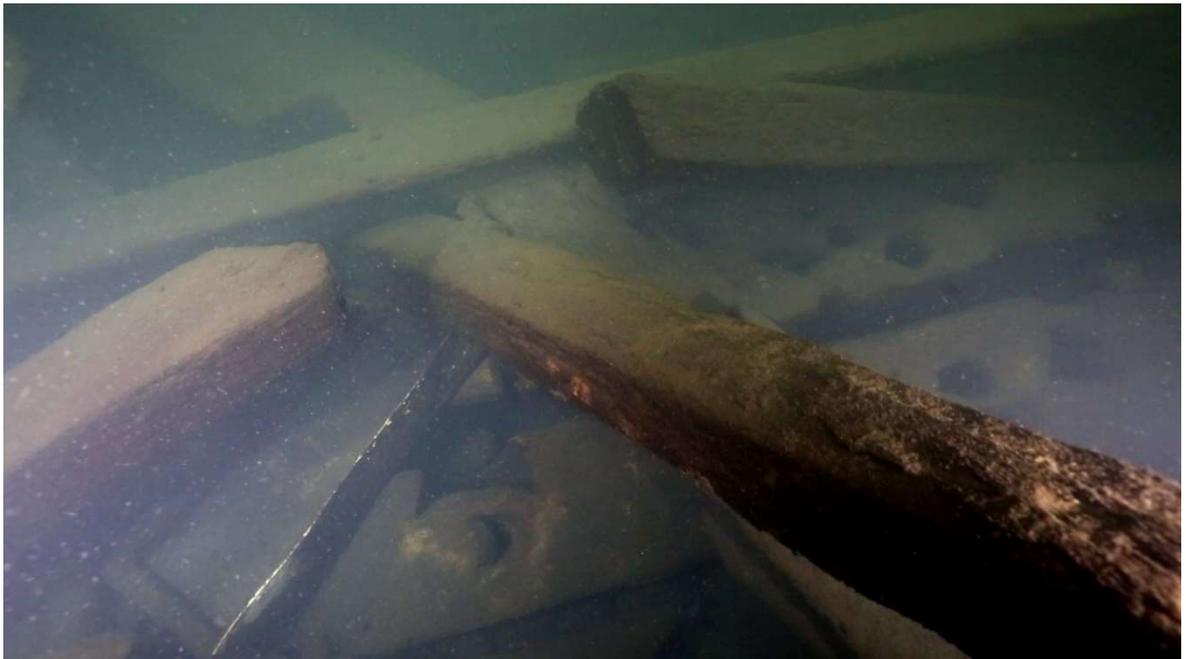
Fig. 52. Details of decorations. Video frame capture: Ivan Borovikov.

Fig. 53. Details of decorations and a dish. Video frame capture: Ivan Borovikov.

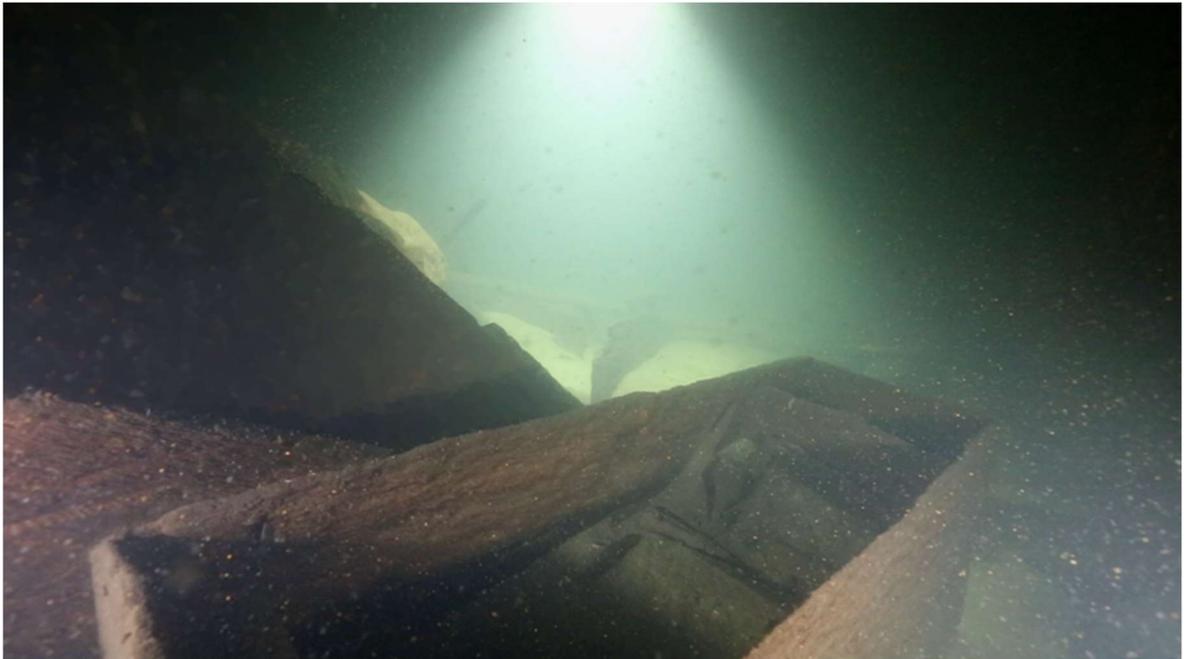
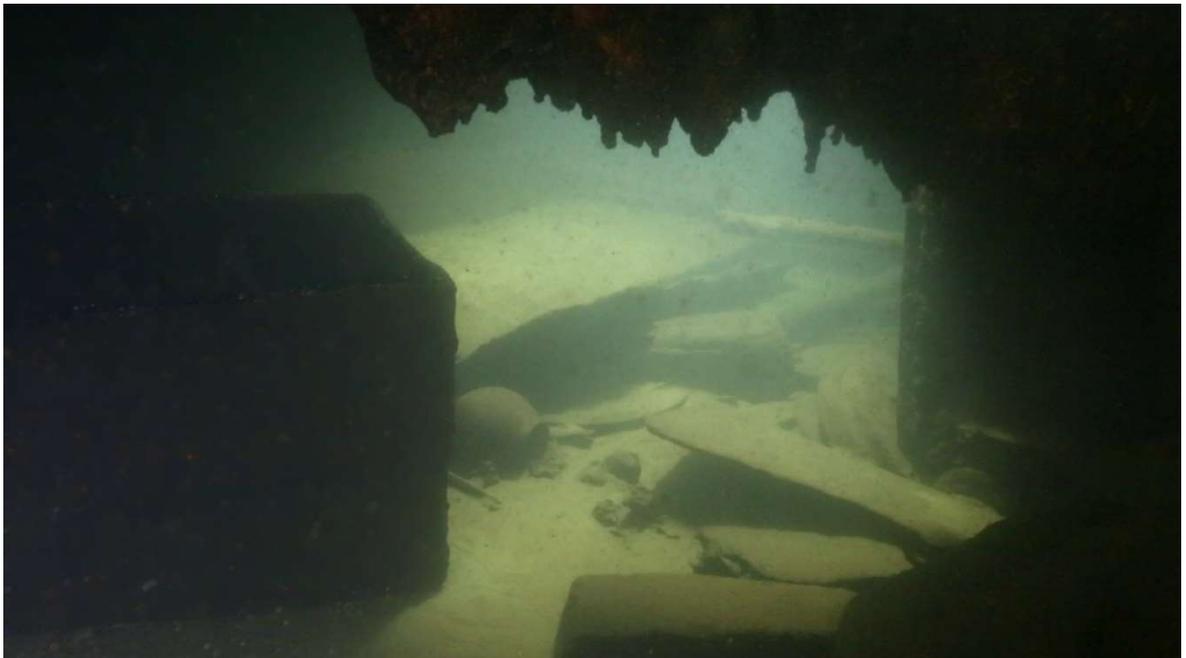
The lower gun deck has the cannons in place and lot of artefacts are visible *in situ*. This includes stone wares, boxes, plates etc.

Fig. 55. Box on the lower gun deck. Video frame capture: Ivan Borovikov.

Fig. 56. Boxes, stone ware and other artefacts on the lower gun deck. Video frame capture: Ivan Borovikov.
