Maritime archaeological
site survey
Huis te Warmelo 1708-1715.

Fieldwork report 2017-2018

Helsinki-Tallinn 2019

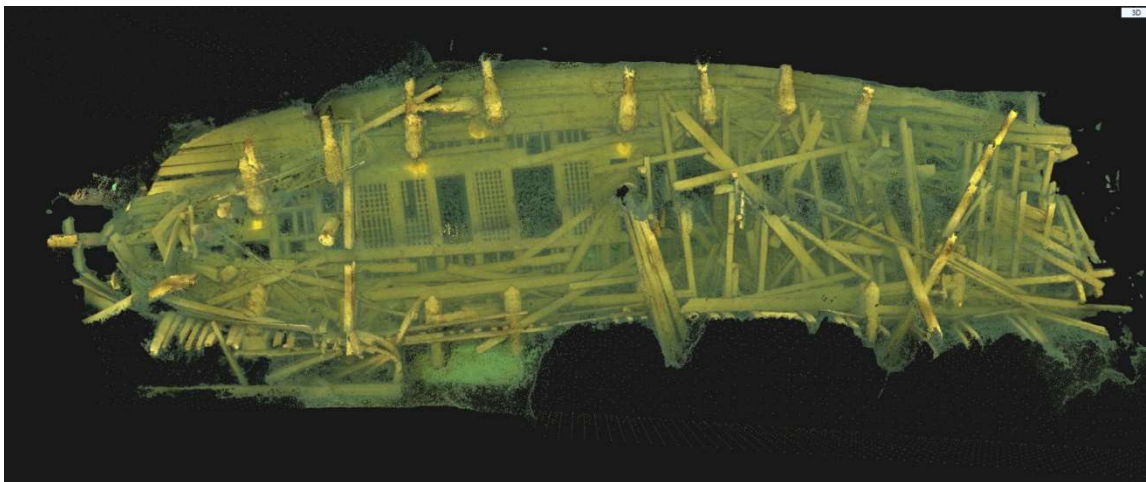
The 3D model of the wreck that was created of the data captured in 2016, was added with the data captured in 2017 and 2018. The 3D model of the wreck still needs more data to finalise the model.

The resulting 3D model has also some geometrical distortions and therefore it is not possible to get reliable measurements from the model at this stage.

However, 3D model of the main deck could be made (Fig. 5.).

Fig. 5. Image of 3D model of the main deck. Image: Kari Hyttinen.

The main task is to continue with 3D documentation and collect the high-quality data: recording the entire shipwreck site, artefacts and interior of the wreck. Collected material will be useful for the wreck monitoring in the future.

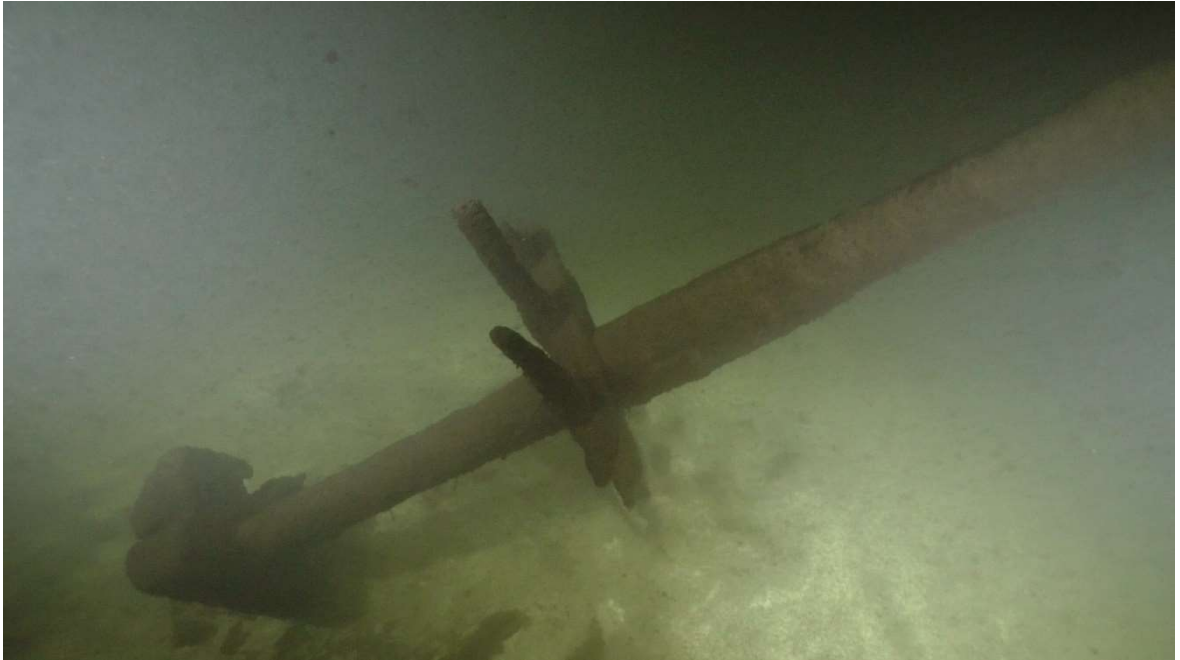
The mizzen mast that has fallen to the port side of the wreck, was documented by videography. The whole mast with two parts is attached on each other's and the cross trees are intact. The attachment of the mizzen mast and the mizzen top mast is also intact and shows the technique of the joint (Fig.6-10).

Fig. 6. Mizzen top mast with crosstrees and mastcap. Frame capture from video by Immi Wallin.

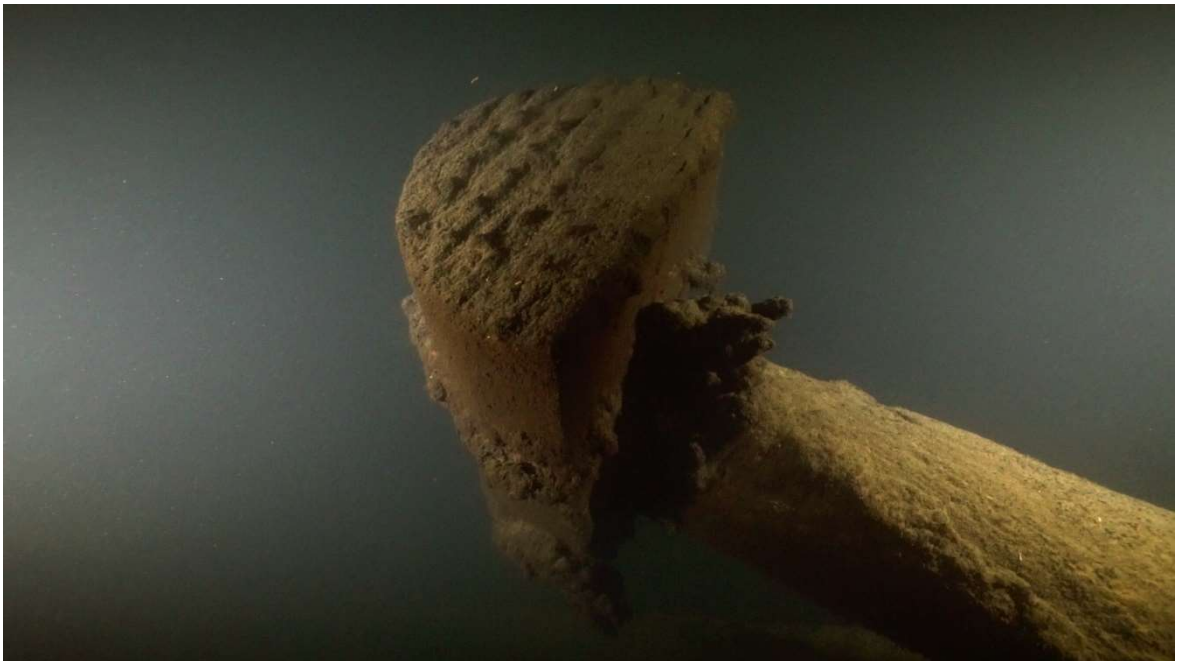
Fig. 7. Mizzen mastcap. Frame capture from video by Immi Wallin.

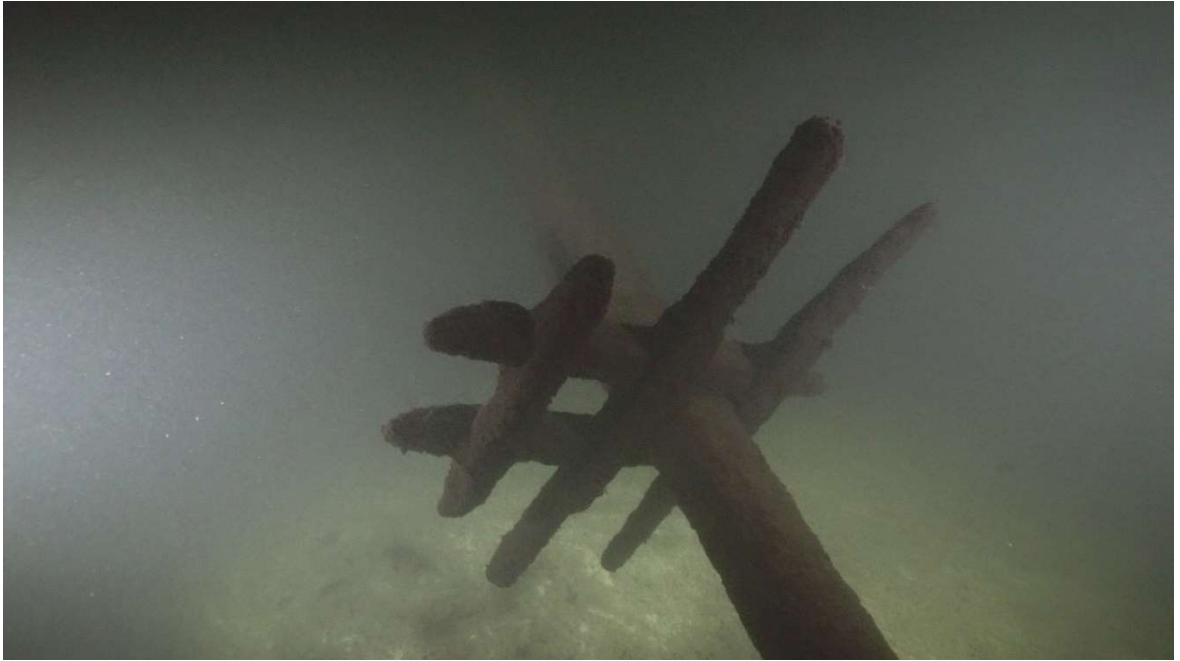
Fig. 8. Mizzen topmast crosstrees. Frame capture from video by Immi Wallin.

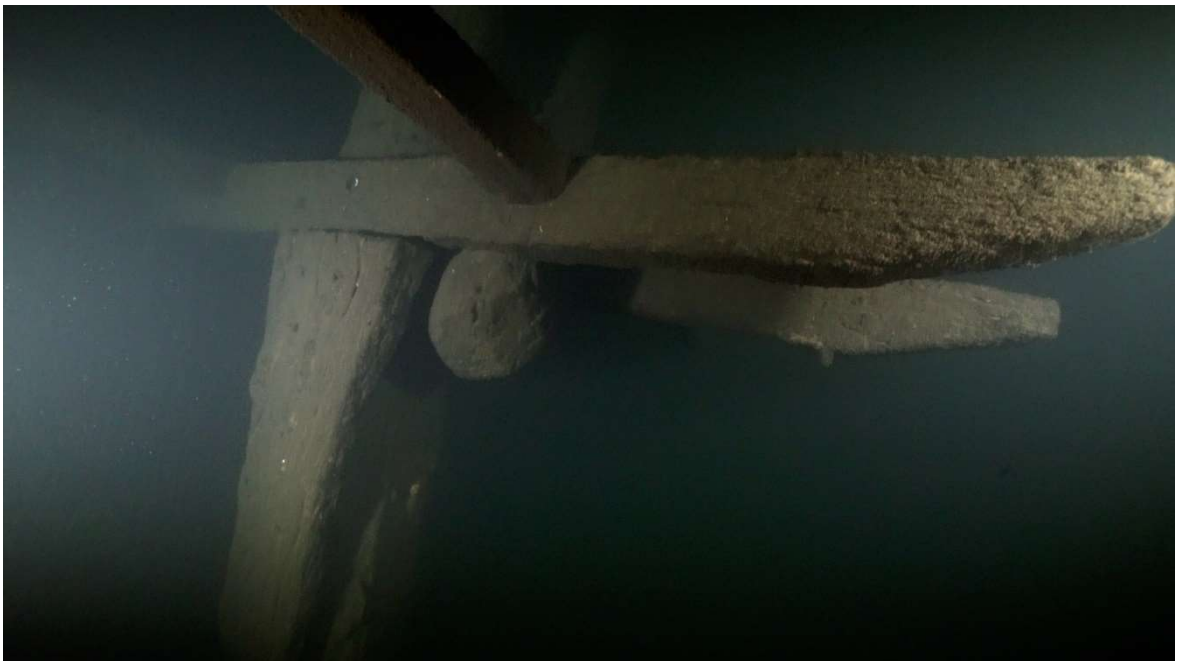
Fig. 9. Mizzen crosstrees and lower end of topmast. Frame capture from video by Immi Wallin.

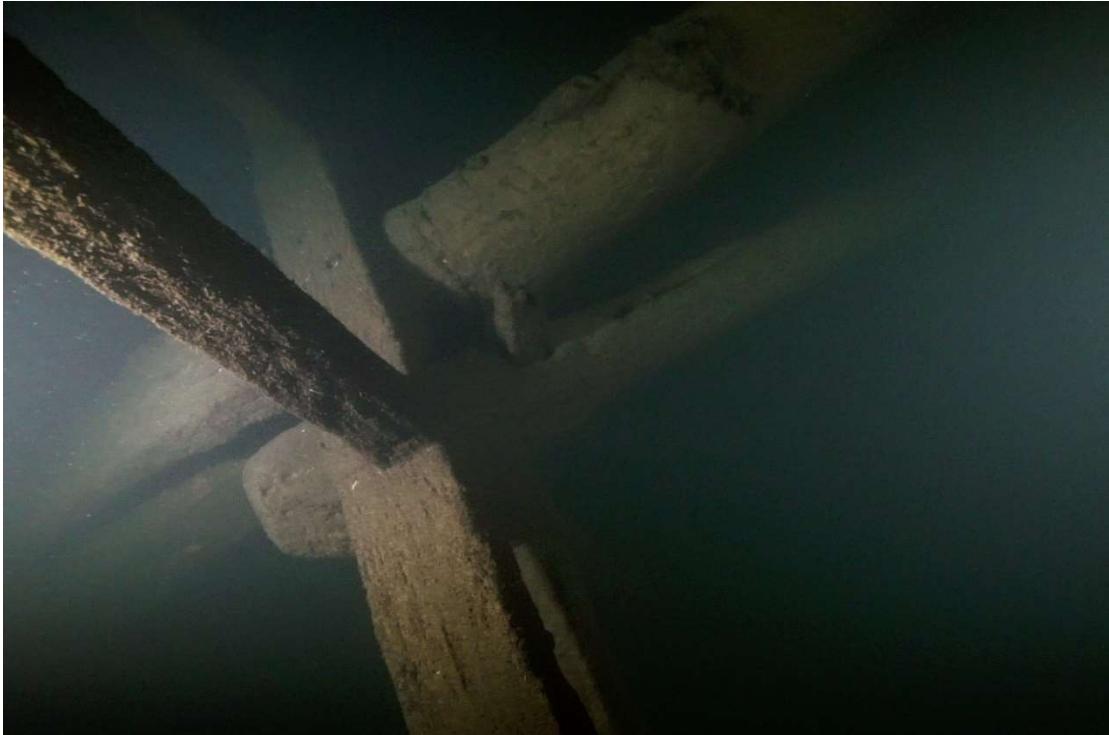
Fig. 10. Mizzen crosstrees and topmast. The chock that prevents the topmast to fall down thru the crosstrees, is also visible in the middle of the image. Frame capture from video by Immi Wallin.

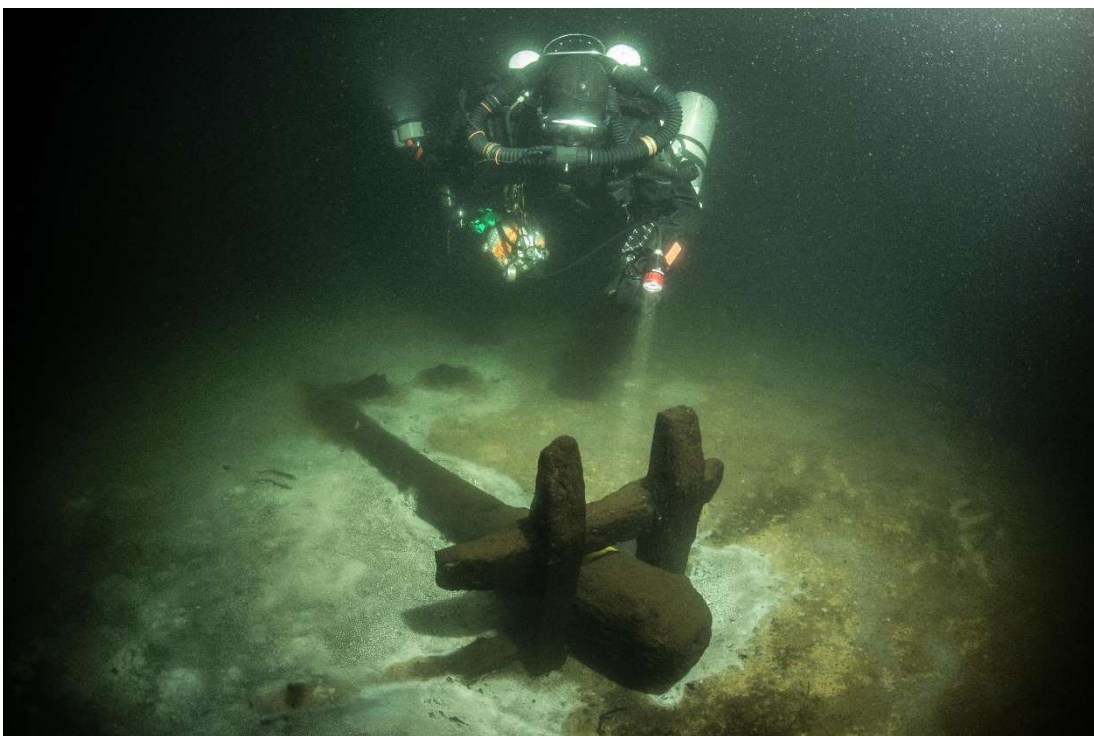
A single anomaly on the port side of the wreck in front of the fallen mainmast was photographed and identified. The anomaly appeared to most probably be the front topmast crosstree (fig. 11).

Fig. 11. The front topmast crosstree. Photo by Sami Paakkari.

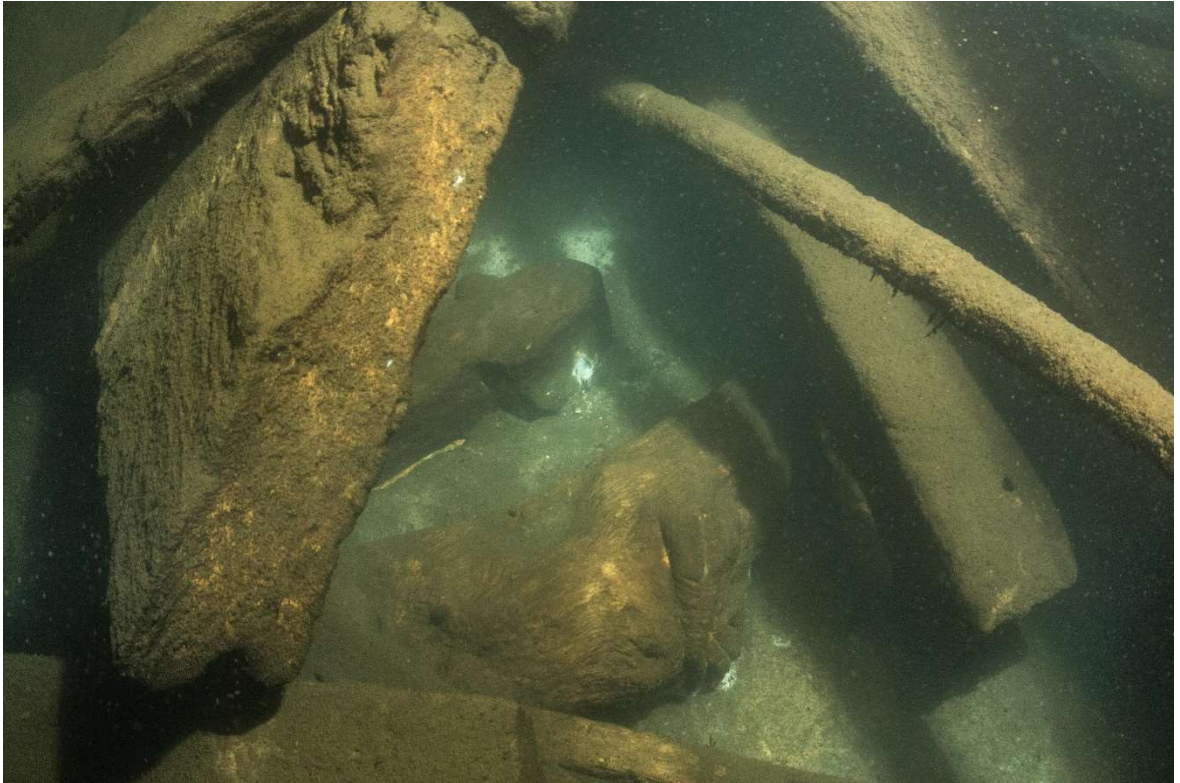
The aft part of the wreck that lays on the sea bottom, was photographed and it seems that there are more ornaments and decorations, but mostly their back side is visible (fig. 12-14).

Fig. 12. Decorations on the sea bottom behind the aft of the wreck. Photo by Sami Paakkari.

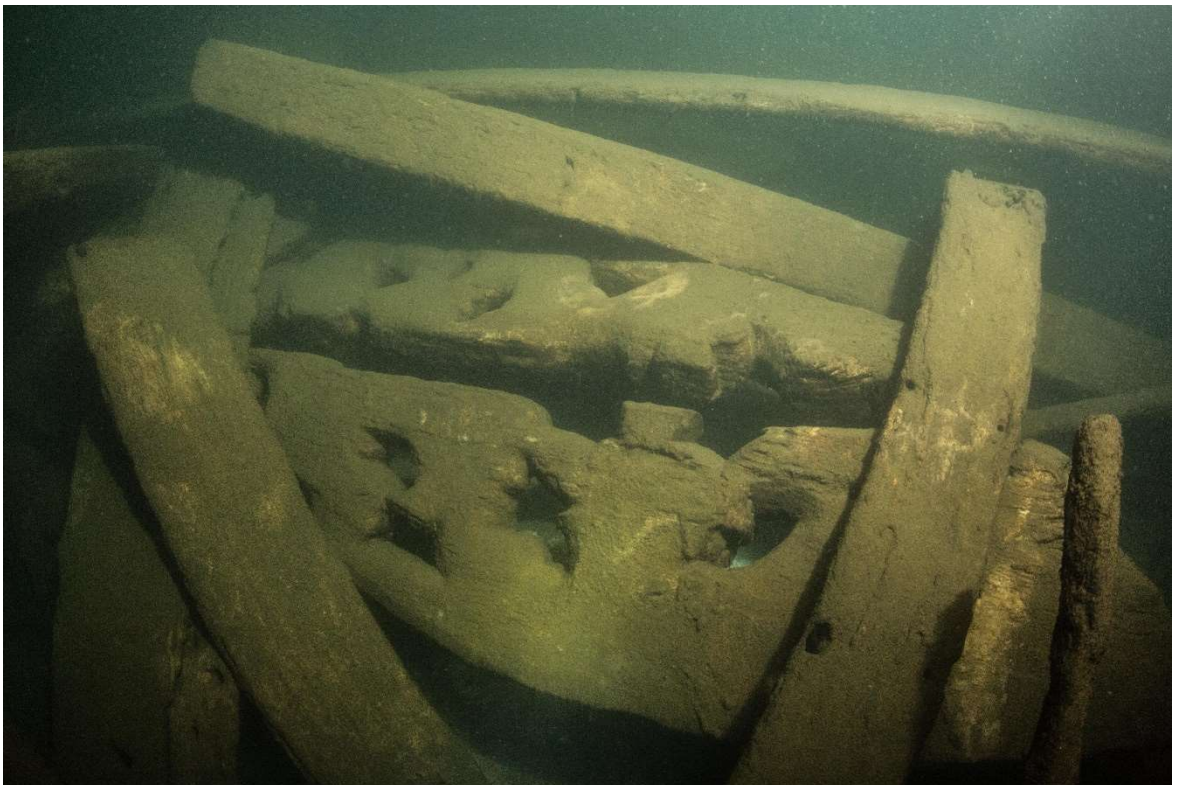
Fig. 13. Ornaments (back side of them) on the sea bottom behind the aft of the wreck.
Photo by Sami Paakkari.

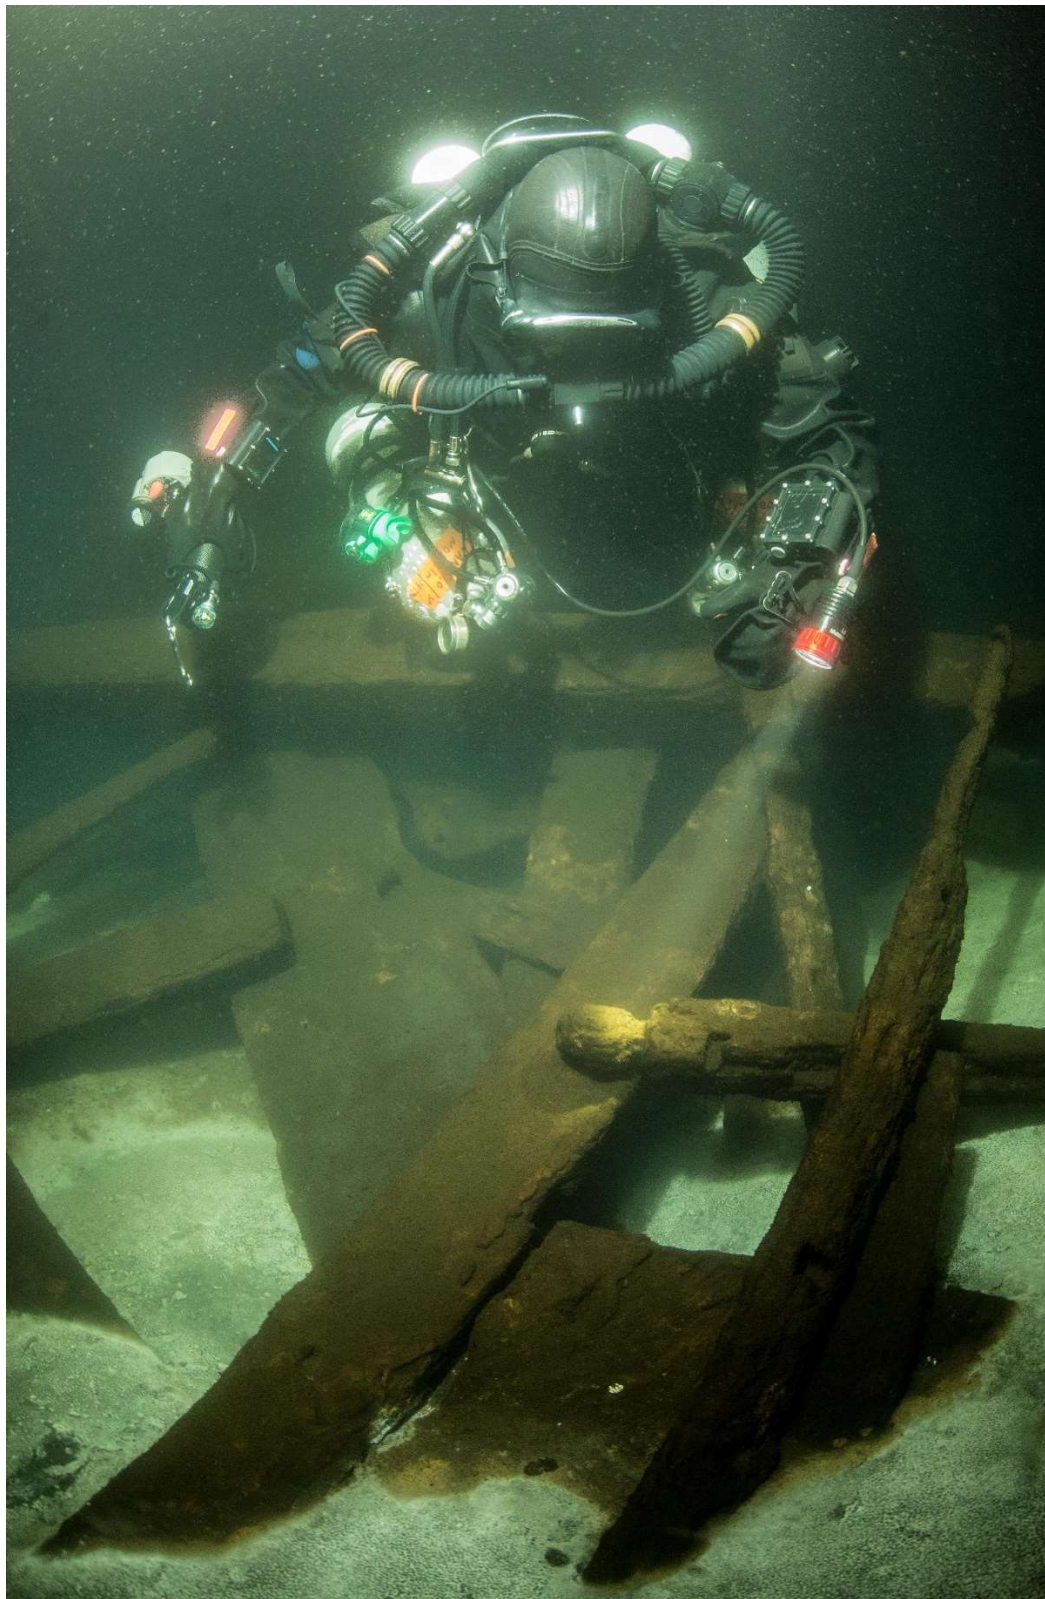
Fig. 14. Jenni Westerlund viewing parts of the aft castles that has fallen behind the aft of the wreck. Photo by Sami Paakkari.

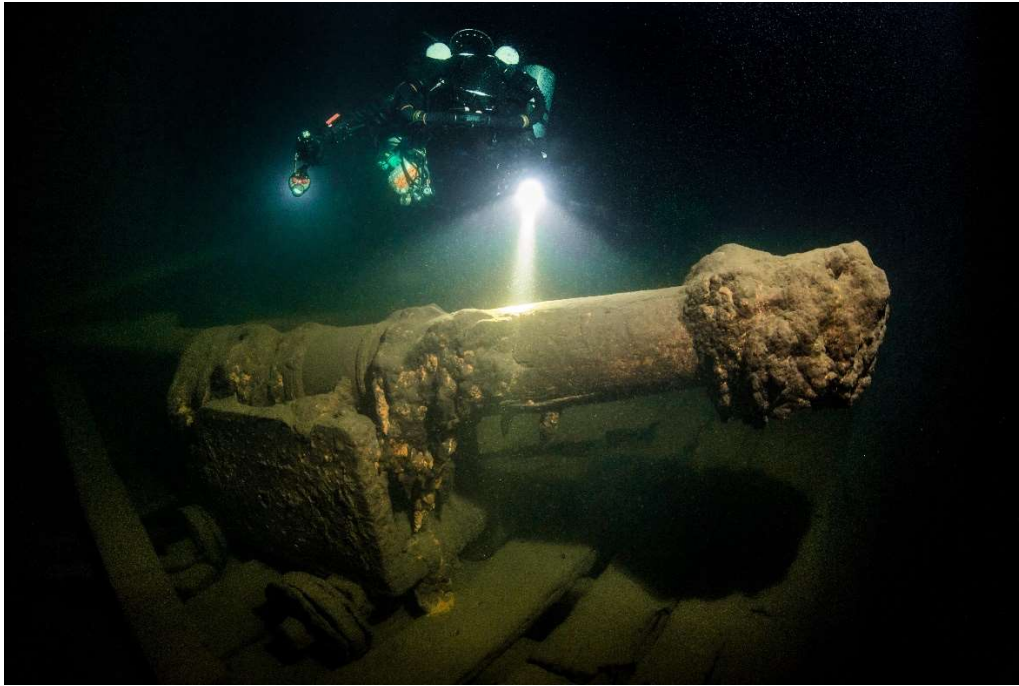
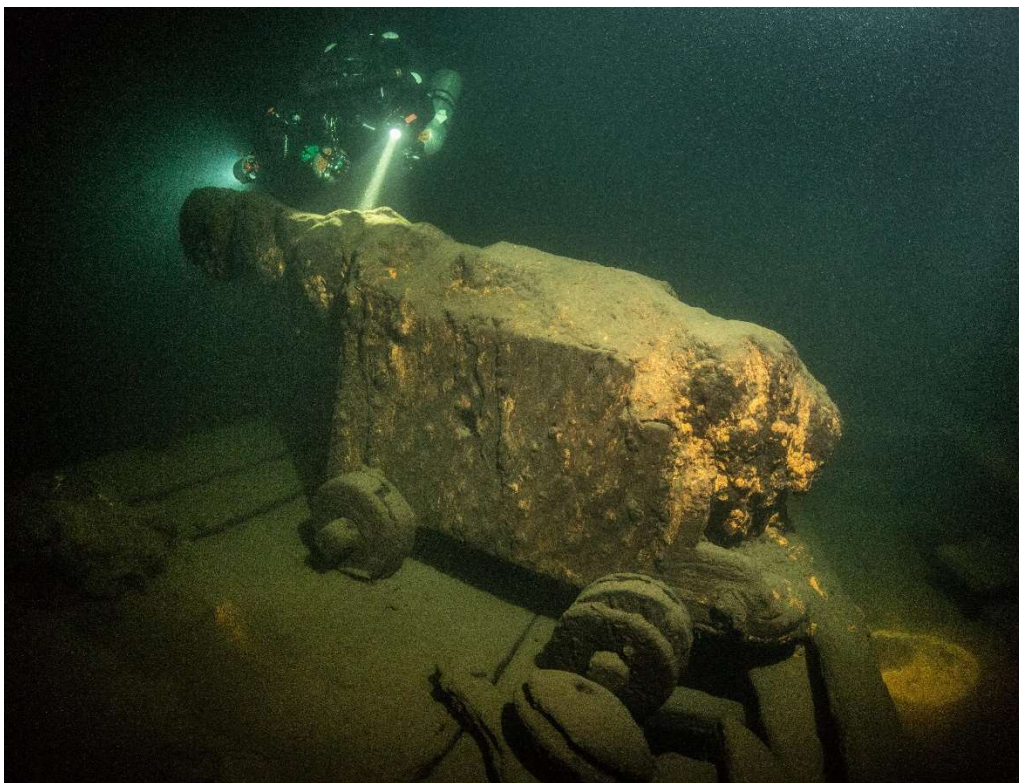
The cannons on the starboard side on the main deck were photographed with a diver. These photographs are showing the scale and can be used for presentations and articles (Fig. 15-16).

Fig. 15. Cannon and a diver on the main deck on starboard side. Photo by Sami Paakkari.

Fig. 16. Cannon and a diver on the main deck on starboard side. Photo by Sami Paakkari.
