Porkkala Wreck Park project

Confidential preliminary report on research permit MV/52/05.04.01.02/2019

By Markku Luoto, Kristin Ilves and Katja Hippeläinen dated 20.5.2020

Martime Archaeology Society of Finland
Porkkala Wreck Park Annual Report 2019

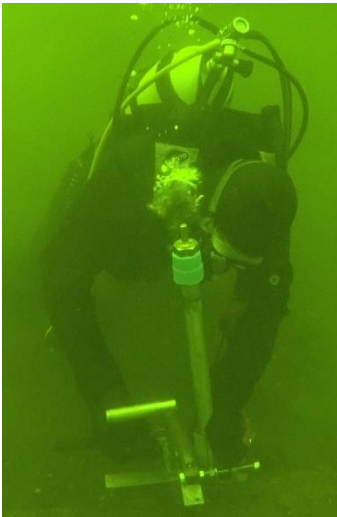
Figure 6 - 1st drilling device

Samples: During the camp, weather conditions with very strong winds were generally not suitable for diving for samples in the park and the initial goals as set and permitted for (MV/52/05.04.01.02/2019) were not met. However, five samples were still collected (see below) whereat drilling-based sampling method (as opposed to sawing-based method) was employed. Drilling device used during the camp (FIG 6) was constructed by Pekka Paanasalo, Subreering Oy.

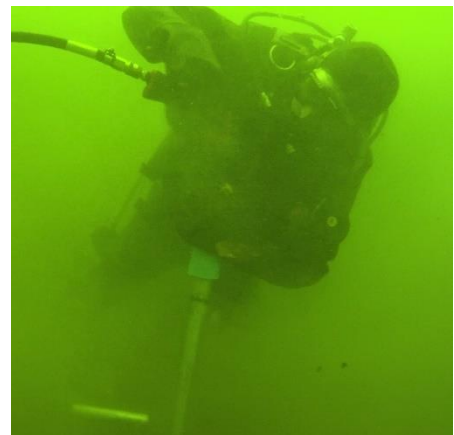
Figure 7 - Pekka Paanasalo drilling

Due to unfavorable weather conditions not allowing underwater works in the park, it was decided to test the drilling device on the Rönnskärin tykkihylky's rudder (FIG 8) when the constructor of the device, Pekka Paanasalo (FIG 7), was visiting the camp and could himself participate and evaluate the first attempts.

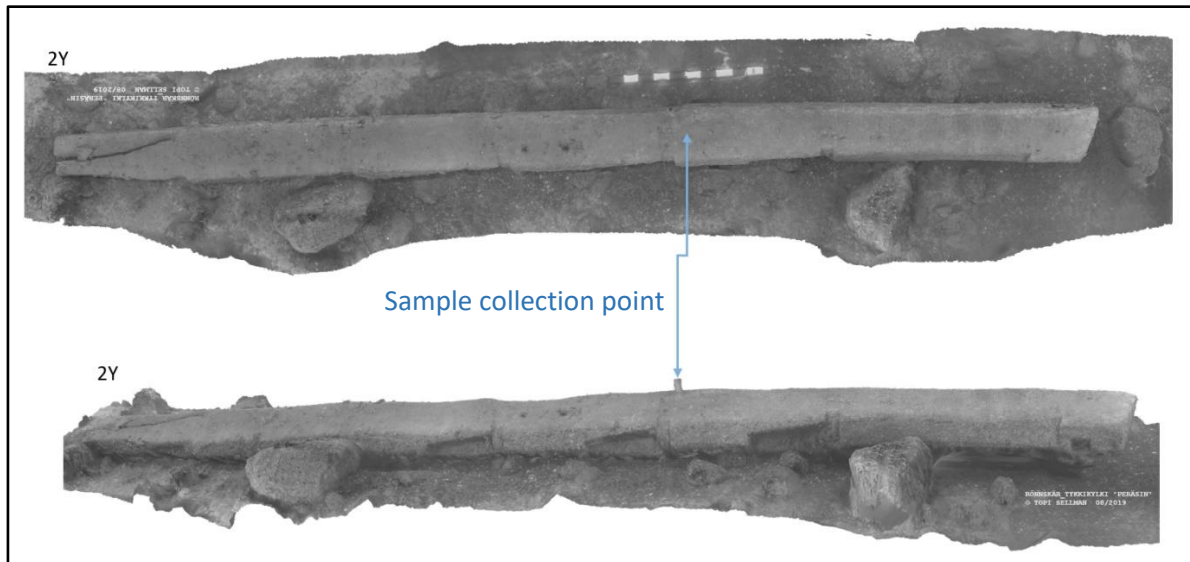
Figure 8 – The “Rönnskär rudder” (#3-2Y on maps) of which the first dating sample was drilled from

As a very first step, the device was tested by using a diver’s auxiliary air tank as the power source for the drill. Although this was enabling non-restricted movement and working under water, it was soon discovered that even an 8l/300bar tank would only give enough air to drive the drill for the first 150-200 bars and the energy for getting out a sample was exhausted too quickly to be a prolific working method. Therefore, the idea to continue using divers’ auxiliary air tanks for the drilling was discarded and the work was continued after re-positioning the research vessel on top of the wreck so that the surface air cable and, thus, on-surface power supply through a generator would reach the spot for sampling. After 90 minutes of drilling, the first sample was acquired. However, the sample did not penetrate the whole of the chosen wreck part, but broke off before reaching its entire length. A grey plastic tube was inserted into the drilling hole in order to mark the sampling point from other holes in the wood of the wreck. On surface, the sample consisting of 3 pieces (the sample was broken during the drilling process) was extracted from the core. The lack of winch or other means to apply more pressure to the drill was determined as a major weakness of the first tryout of the prototype drilling tool.

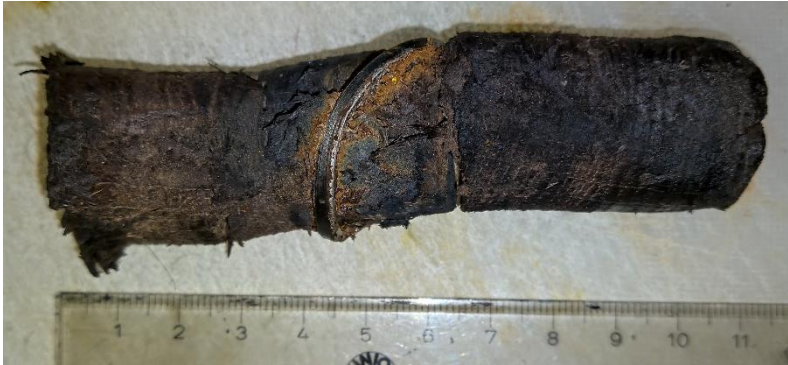
Figure 12 – The Sample #5-B2-#3C with metal ring still attached

- 4) Sample #5-B2-#3C from the 2nd “bay frame” potentially belonging to the “Limisaumahylky”
FIG 11&12, collected 5.7.2019, exclus. C14 dating 1510calAD*, N 59°57,433' | E 24°22,342' (WGS84)

Collecting this sample started out as with previous samples, but about 75% through the frame, the drill got stuck. After marking the underwater position of the frame with four steel marker sticks, the frame was lifted onto DSV Vuoksi's back deck in order to extract the drill and the sample. However, it was soon discovered that the drill cannot be just pulled out as a ring of metal had become loose from the drill's welding and got stuck on the sample (FIG 12).

As a solution, the last 25% of the core were drilled onboard Vuoksi. During the drilling, it was noted that the drill performed worse on surface than it had under water, because on surface it heated up quickly and the residue from drilling tended to clog the sampling point creating too much friction of a drill to function properly. Once the sample consisting of 3 pieces (the sample was broken during the drilling process and had to be removed by force resulting in the scattering of the sample and the right order of the pieces belonging to the core was lost; one of the pieces has the broken off part of the drill still embedded into it) was acquired, the frame it was placed onto seabed in its original position and orientation. A grey plastic tube was inserted into the drilling hole in order to mark the sampling point from other holes in the wood of the wreck. All collected samples were placed in plastic tubes and then in plastic containers filled with local sea water and stored in DSV Vuoksi's refrigerator.

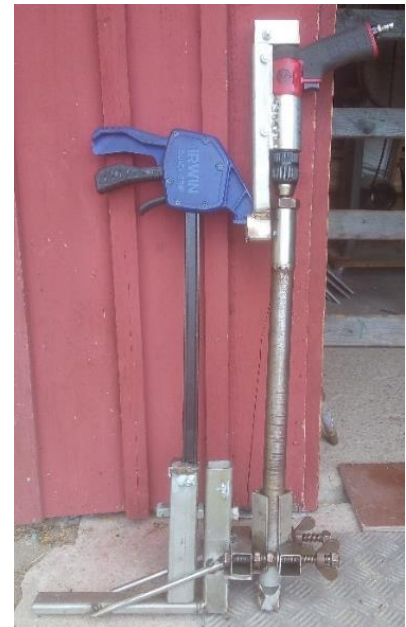
Figure 13 - 3rd version of the drill

As a result of the drillings conducted during the field work camp, especially considering the time needed for the drilling, it was decided that the drilling-device needs further improvements in order to continue its use for underwater sampling. To force more pressure to the bore, which would shorten the time needed for the drilling, a lever device was added (FIG 13). When tested for drilling during the 17th-18th of August expedition to take samples from Limisaumahylky's keel (FIG 14) it was found out, that even though the drill was initially penetrating the wood faster than before, soon after 10cm of drilling it became harder and harder to drill as the drill would get stuck often.

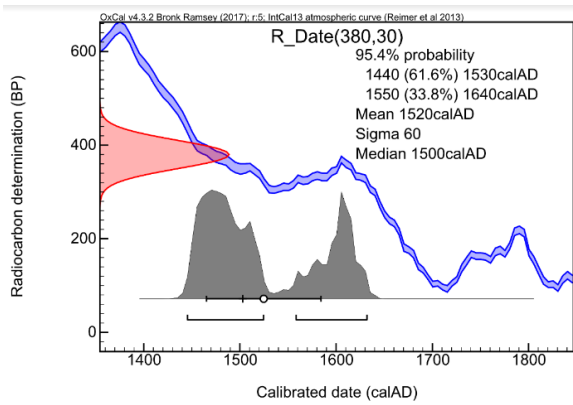
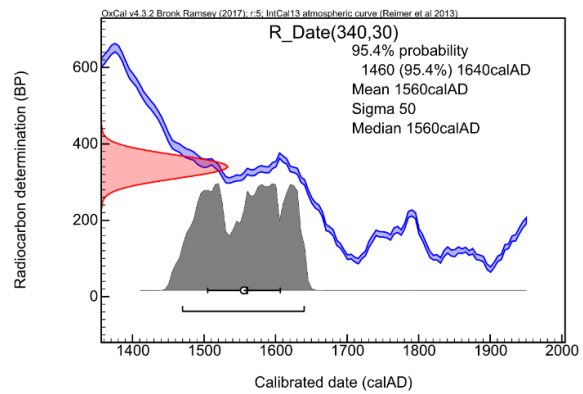
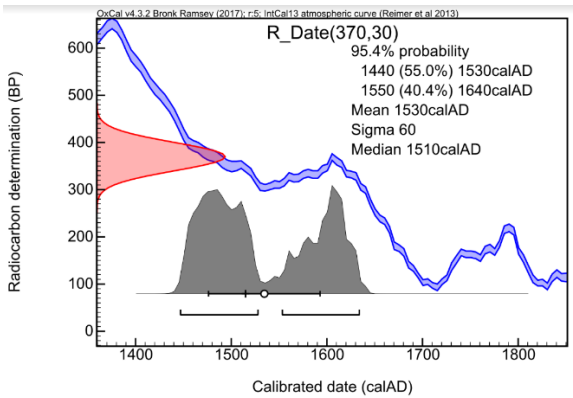
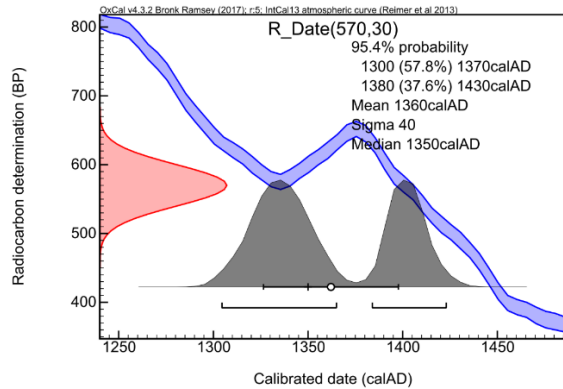
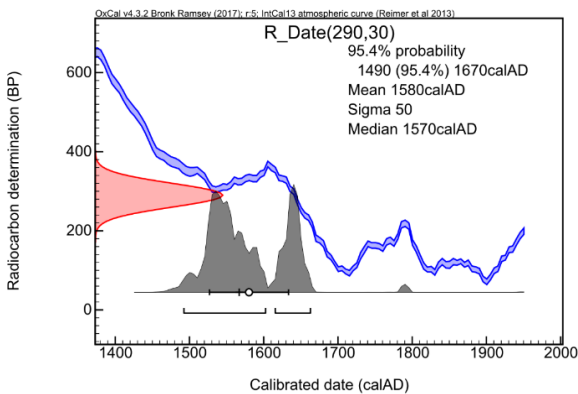
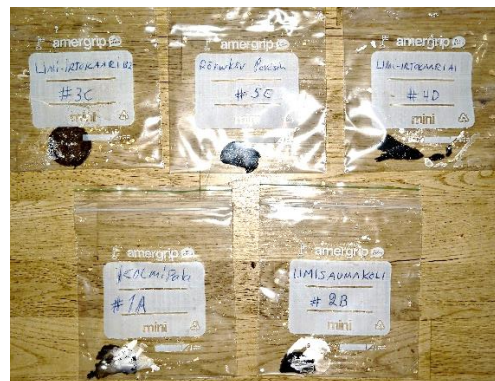
Porkkala Wreck Park project report 2019, Attachment 2. "The C14 datums & datings"

ICA ID	Submitter ID	Material Type	Pretreatment	Conventional Age	Calibrated Age
20W/0128	#1A	Wood	AAA	380 +/- 30 BP	Cal 1440 - 1530 AD (61.6%) Cal 1550 - 1640 AD (33.8%)
20W/0129	#2B	Wood	AAA	340 +/- 30 BP	Cal 1460 - 1640 AD
20W/0130	#3C	Wood	AAA	370 +/- 30 BP	Cal 1440 - 1530 AD (55.0%) Cal 1550 - 1640 AD (40.4%)
20W/0131	#4D	Wood	AAA	570 +/- 30 BP	Cal 1300 - 1370 AD (57.8%) Cal 1380 - 1430 AD (37.6%)
20W/0132	#5E	Wood	AAA	290 +/- 30 BP	Cal 1490 - 1670 AD

The purpose of the C14 datings was to verify the historic status of the wrecksites i.e. not being “recent” timbers. Hence only basic C14 dating by using the “standard” OxCal v4.3.2 Bronk Ramsey (2017); r:5; IntCal13 atmospheric curve (Reimer et al 2013) calibration was performed. Thus, all the datings above were given as calibrated median dates as typical today. However, as the need for calibration and all common calibration methods thereto arise from the atmospheric phenomena of enhanced C14 build up, due to the nuclear tests conducted in the atmosphere, it presents a valid question regarding these finds. As all these samples have been residing at least 9 meters under water throughout the atomic age, are they affected by the nuclear blast based C14 build up at all? By the time of writing this report, no concise answer has yet been received from the physics department. Should it turn out, that no calibration is needed for these finds, then their original datings may be 70-90 years earlier than stated above. This would place all the Limisaumahlky datings on the first part of 15th century, except the #5-A1-#4D, which would remain on the early 14th century. Even the Rönnskär wreck would go to the late 15th or early 16th century.
