ALVAR AALTO FOUNDATION

PAIMIO SANATORIUM COLOR RESEARCH 2015

PART I/2 Main Building

Elina Riksmán

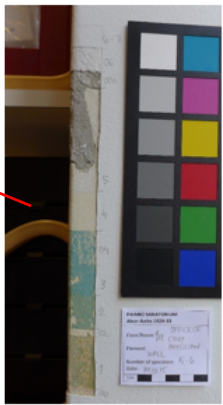
Former Chief Physician's office]

Number of Sample 5-6	Subject Paimio Sanatorium	Building / Space / Surface Main building Ground Floor Chief Physician's office Jamb of window	
Architect, building year Alvar Aalto, 1929-33	Researcher, date Elina Riksmann, June-Dec. 2015, Alvar Aalto-foundation		
Most significant repairs and changes of the space, dates The office has been divided in two separate office spaces with a light structured wall in the 1980's. Also divided a cupboard with its own door to the hallway. Ventilation system built in 1970's, with dropped ceiling structure. New door openings. Sink in opposite corner as in the original office plan.			
Photograph, drawing

Layers of Sample 00 Chelcium based Plaster 01 Oil filler, yellowish 1 Green paint, oil, 3020-G40Y 02 Filler 2 Green 53020-G20Y 3 Blue 3030-B30G 04 Base coat , Beige 1510-Y10R 4 Beige, glossy and hard finish, 1010-Y10R 5 White 003-G80Y 006 Coarse Filler, Grey 06 Light weight filler , White 6-7 White latex, two layers

Observations, remarks, e.g. pigment, adhesive, type of paint, material analysis: 1 layer oil paint. Most of the surfaces have been scraped clean, apparently during the 1970's renovations.			
Technique used to make and take Samples, Circumstance in site, Lighting: Carved color steps on surface, crater technique, daylight + fluorescent lamps	Color chart in use: NCS DeLuge 2004 Color codes are written without the NCS prefix.	Type of Sample, Place of Storage: Cross-section sample 2 and 6, Alvar Aalto Foundation Helsinki. Scale 300µm.	Floor plan, Location of Sample

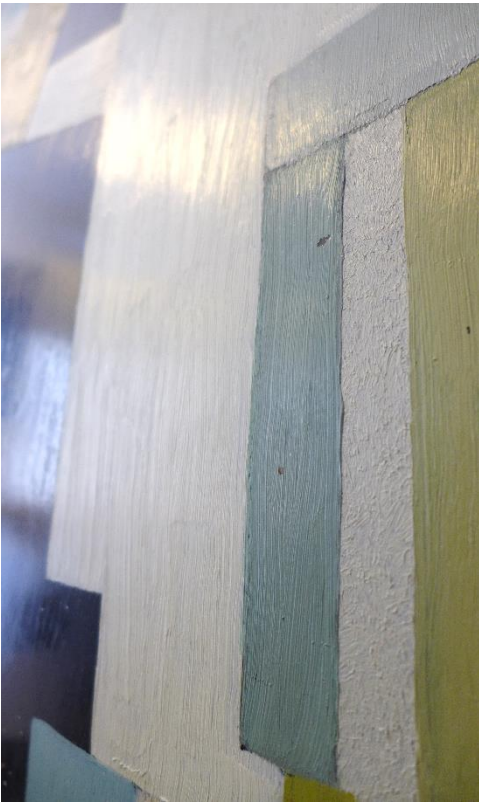
The different textures on the color board created by the brush strokes and technique. This picture presents the textures of the board located in Paimio hospital.

NCS color codes of the color board of Paimio hospital are presented above. This board is at the moment located in Paimio hospital's main building.

The second board's NCS codes are shown left. This board is presumably the original board painted by Kauria himself. It is in the collections of Alvar Aalto museum, Jyväskylä, Finland.

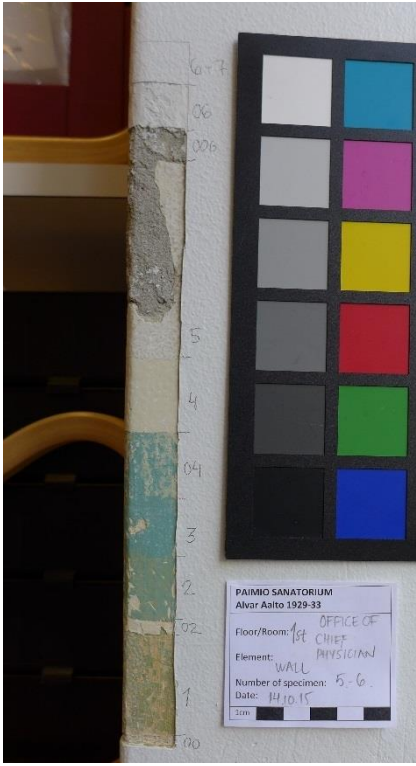
Layers of Sample 00 Chalsium based Plaster 01 Oil filler, yellowish 1 Green paint, oil, 3020-G40Y

Technique used to make and take Samples, Circumstance in site, Lighting: Carved color steps on surface, crater technique, daylight + fluorescent lamps	Color chart in use: NCS Teknos 2004 Color codes are written without the NCS prefix.	Type of Sample, Place of Storage: Cross-section sample 5 and 6, Alvar Aalto Foundation Helsinki. Scale 500µm.	Floor plan, Location of Sample

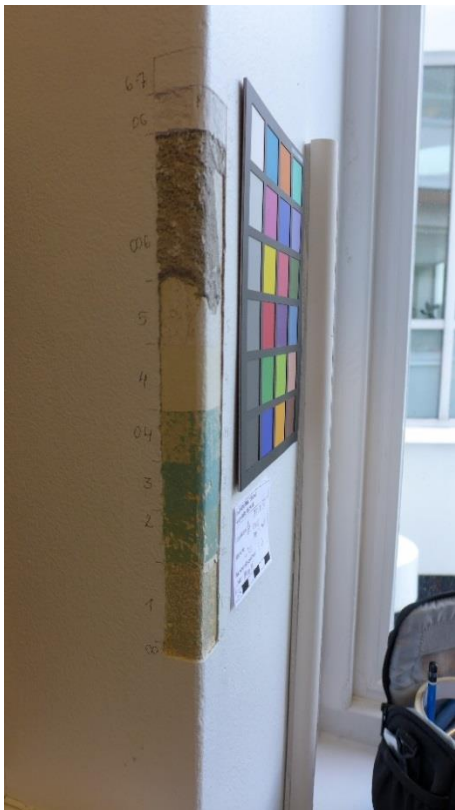
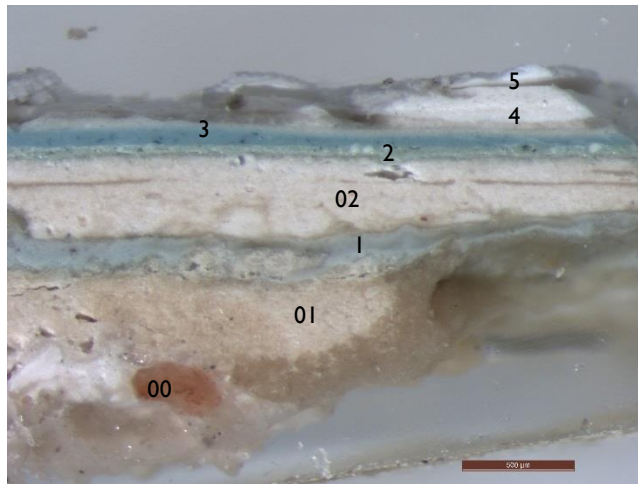
Sample no. 5 showed layers of blues and greens that are also presented in surface excavations. Scale 550μm.

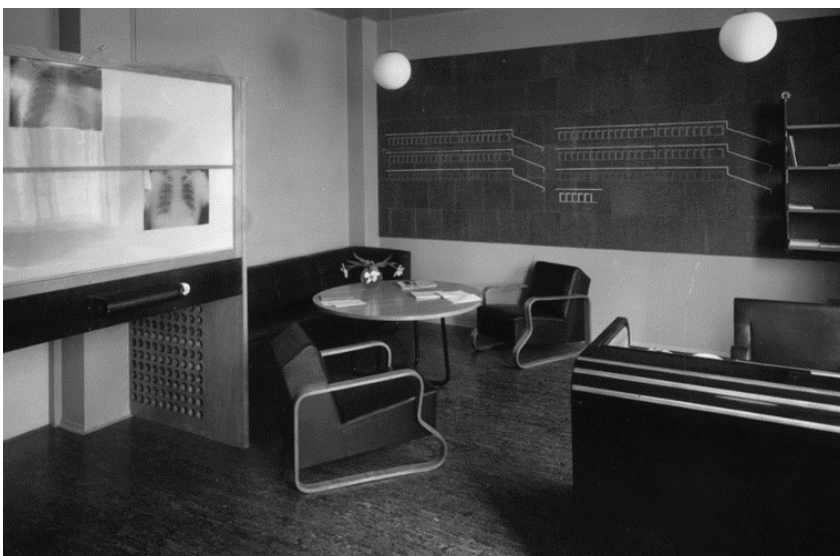
Chief Physician's office. AAM Sign. 50-003-337.

One interesting interior element also shown in the photograph below is the large panel hanging on the wall. It was made of cork according to some receipts found in the archives of the Hospital District of Southwest Finland. The painting resembling the six wards and the seventh isolation ward is painted by Eino Kauria. This was uncovered also in the archives from a receipt showing that Kauria was separately paid to do the paint job for the cork board. This board has not been found in the premises of Paimio Hospital or Hospital District of Southwest Finland.

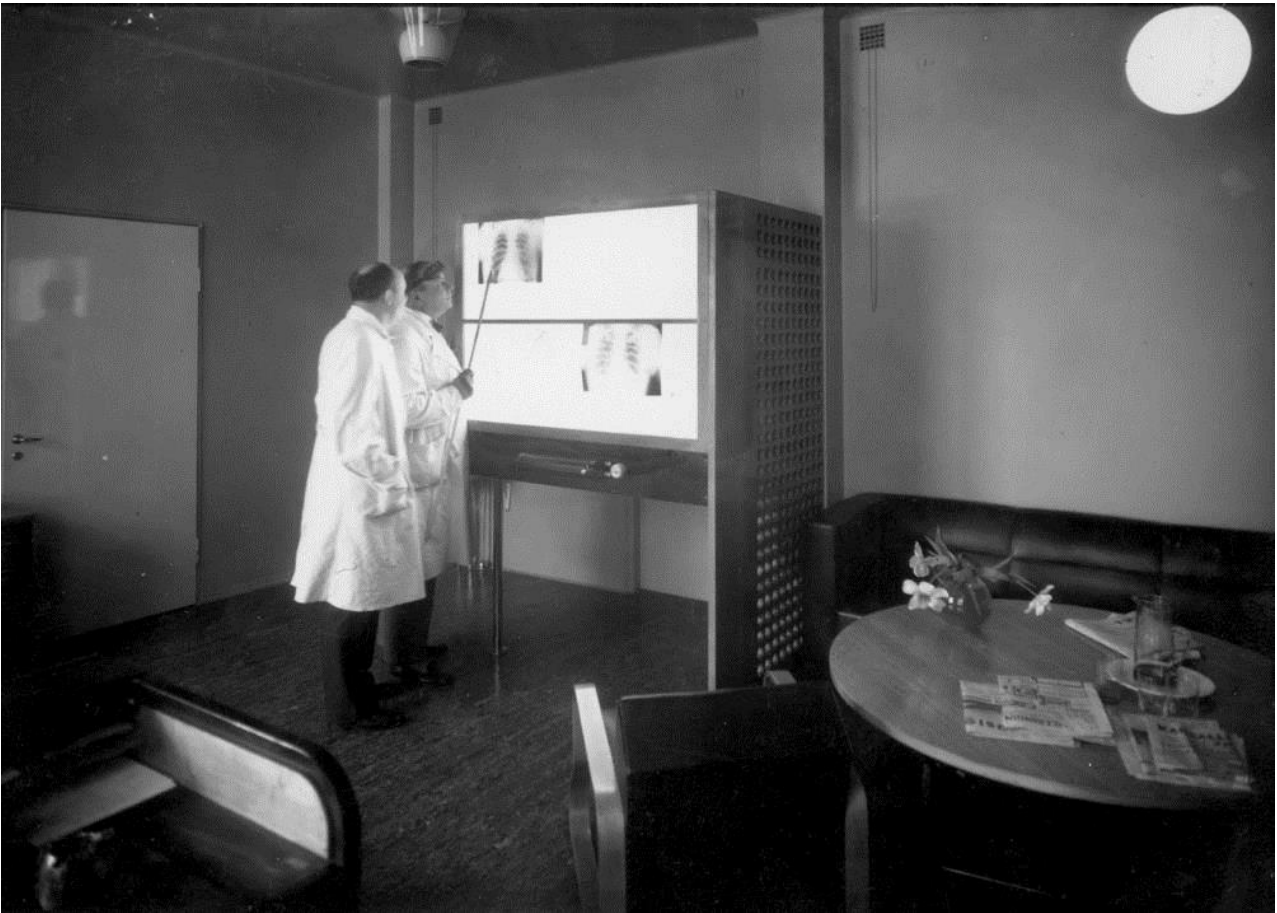
The pilaster where sample 22 (see next page) was taken is behind the gentlemen in the picture. Notice the heavily patterned linoleum flooring. AAM Sign. 50-003-369.

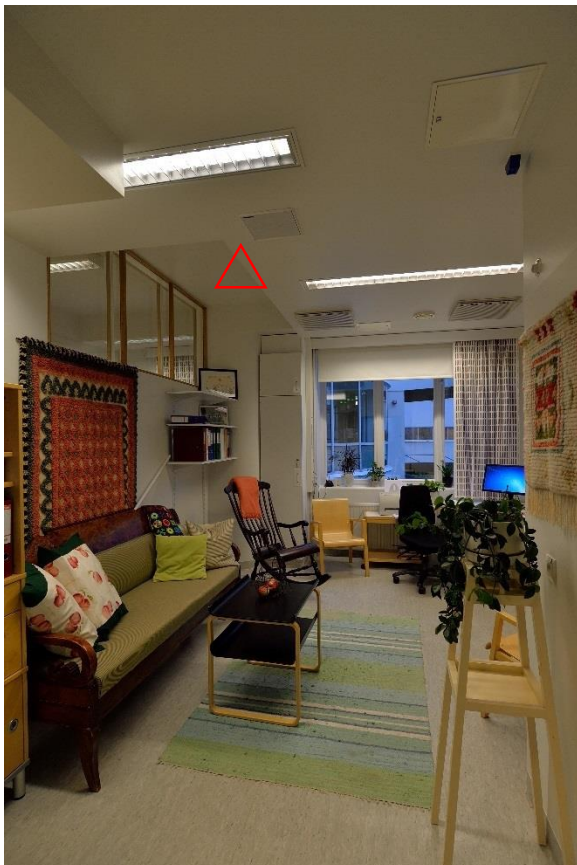
Pink area resembles the size of the original office. At left: A view from the door of the other half of the divided space today. The triangle marks the spot where the ceiling excavation was made.

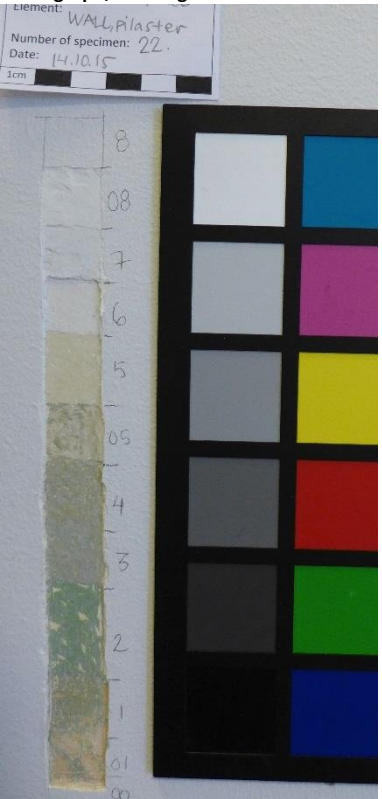
Layers of Sample 00 Chalsium based Plaster 0 Oil based filler 1 Grey paint, oil 2005-B80G 2 Green paint, oil 3030-G10Y 3 Grey paint, between 2005-B20G and 3005-B20G 4 Grayish green 3010-G70Y 5 Glossy, hard paint, Beige 1010-Y10R 6 White paint 0603-G80Y 7 White latex paint

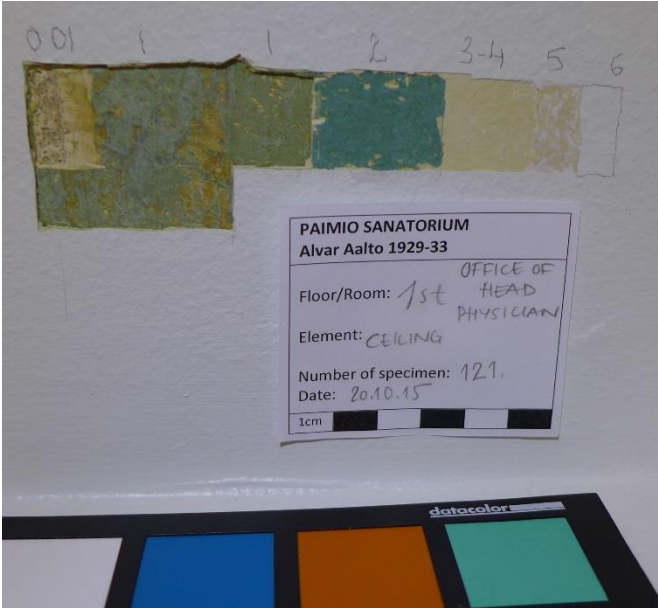
Number of Sample 121	Subject Paimio Sanatorium	Building / Space / Surface Main building Ground	
Architect, building year Alvar Aalto, 1929-33	Researcher, date Elina Riksmán, June-Dec. 2015, Alvar Aalto-foundation	Chief Physician's office (now offices) Ceiling	
Most significant repairs and changes of the space, dates The office has been divided in two separate office spaces with a light structured wall with windows in 1980's. Also divided a cupboard with its own door. Ventilation system built in 1970's, with dropped ceiling structure, but not covering the whole ceiling, leaving parts of it bare. New door openings.			
Photograph, drawing

<p>001 1 1 2 3-4 5 6</p> <p>PAIMIO SANATORIUM Alvar Aalto 1929-33</p> <p>Floor/Room: 1st OFFICE OF HEAD PHYSICIAN</p> <p>Element: CEILING</p> <p>Number of specimen: 121.</p> <p>Date: 20.10.15</p> <p>1cm</p> <p>datacolor</p>		Layers of Sample 00 Chalsium based Plaster 0 Oil based filler 1 Light turquoise/blue paint, surface scratched with scalpel: 2010-B90G, untouched paint surface 4020-G10Y 02 Filler 2 Turquoise-green paint, 4020-B90G 3-4 Light Beige paint layers 1010-Y10R 5 Beige paint 1005-Y20R 6 White

Observations, remarks, e.g. pigment, adhesive, type of paint, material analysis: 1			
Technique used to make and take Samples, Circumstance in site, Lighting: Carved color steps on surface, crater technique, daylight + fluorescent lamps	Color chart in use: NCS Teknos 2004 Color codes are written without the NCS prefix.	Type of Sample, Place of Storage: Cross-section sample 121, Alvar Aalto Foundation Helsinki	Floor plan, Location of Sample

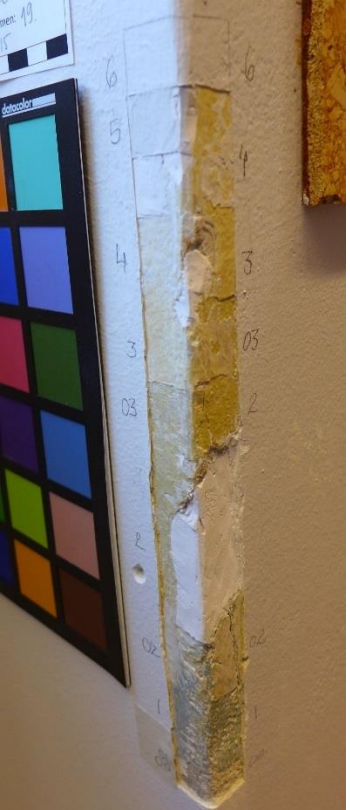
Artificial Sun Treatment Room

Number of Sample 19	Subject Paimio Sanatorium	Building / Space / Surface Main building Ground Floor	
Architect, building year Alvar Aalto, 1929-33	Researcher, date Elina Riksmann, June-Dec. 2015, Alvar Aalto-foundation	Artificial sun treatment room (now: kitchen of staff) Jamb of window, wall	
Most significant repairs and changes of the space, dates Former light treatment room has been divided in three office spaces. Kitchen, used by the staff from 1970's. Ventilation system built in 1970's, with dropped ceiling structure. New door opening.			
Photograph, drawing

Layers of Sample 00 Plaster 0 Filler 1 Greyish blue oil paint, 3020-B50G 02 Beige filler 2 Dark Beige 2030-Y10R 03 Light filler / base coat 2010-Y10R 4 Beige 0510-Y10R 05 Filler, light weight, white 5 Grey Latex 2000-N	
Observations, remarks, e.g. pigment, adhesive, type of paint, material analysis: 1st Layer Oilpaint Small crater type excavations were made in the room.		6 White Latex

Technique used to make and take Samples, Circumstance in site, Lighting: Carved color steps on surface, crater technique, daylight + fluorescent lamps	Color chart in use: NCS Teknos 2004 Color codes are written without a prefix.	Type of Sample, Place of Storage: Cross-section sample 19, Alvar Aalto Foundation Helsinki. Scale 500µm.	Floor plan, Location of Sample

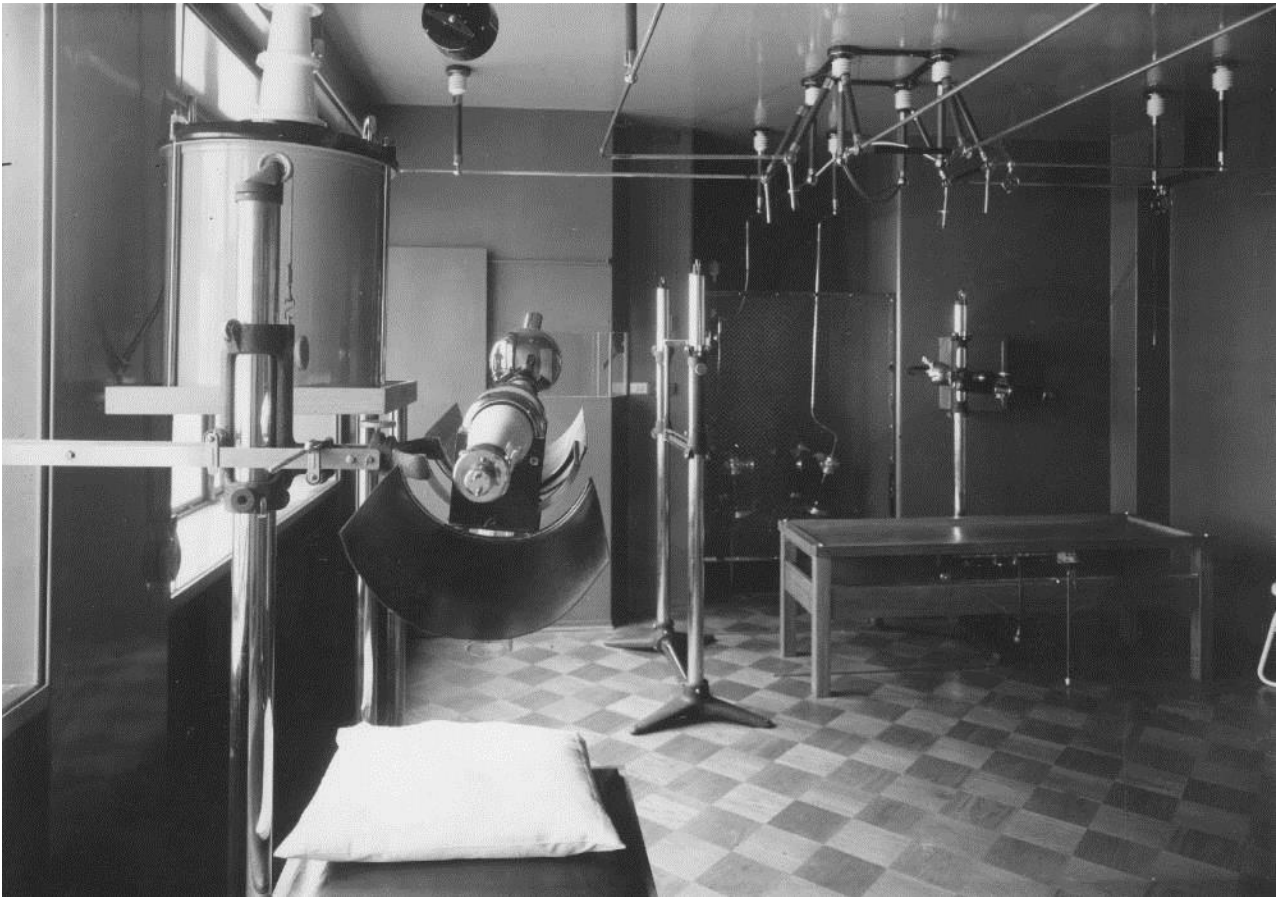
The X-ray room's original look. The orange color was found under the window (at the left in the picture). AAM Sign.50-003-371.

X-ray room's wall coloring was bright orange, just as the Kauria color board insinuates. It is possible that more than one color was used, as the photo above shows differences of gloss and darkness of surfaces. Ceiling has apparently been treated with glossy, enamel-type oil paint. If there was a certain function for this unusual color of orange due to X-ray technique i.e. is not known.

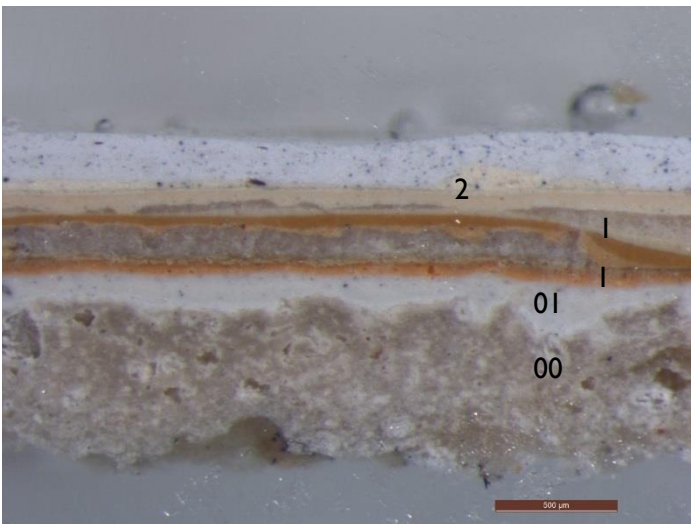
The cross section sample no.22 taken from the wall shows the orange layers.

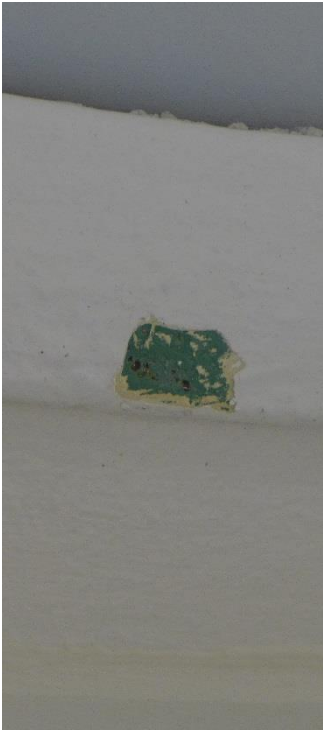
Operation Theatre

Number of Sample	Subject Paimio Sanatorium	Building / Space / Surface Main building Ground Floor Operation theatre Ceiling window	
Architect, building year Alvar Aalto, 1929-33	Researcher, date Elina Riksmán, June-Dec. 2015, Alvar Aalto-foundation		
Most significant repairs and changes of the space, dates Former operation theatre is being used as an archive by the present tenant.			
Photograph, drawing

First sample. Layers of Sample of Wall behind radiator 00 Metal 01 base coat 1 Green 3040-B90G

2 Green 3 Light yellow 4 White 5	
Observations, remarks, e.g. pigment, adhesive, type of paint, material analysis:			
Technique used to make and take Samples, Circumstance in site, Lighting: Carved color step on surface, crater technique, daylight + fluorescent lamps	Color chart in use: NCS Teknos 2004 Color codes are written without the NCS prefix.	Type of Sample, Place of Storage: No sample	Floor plan, Location of Sample

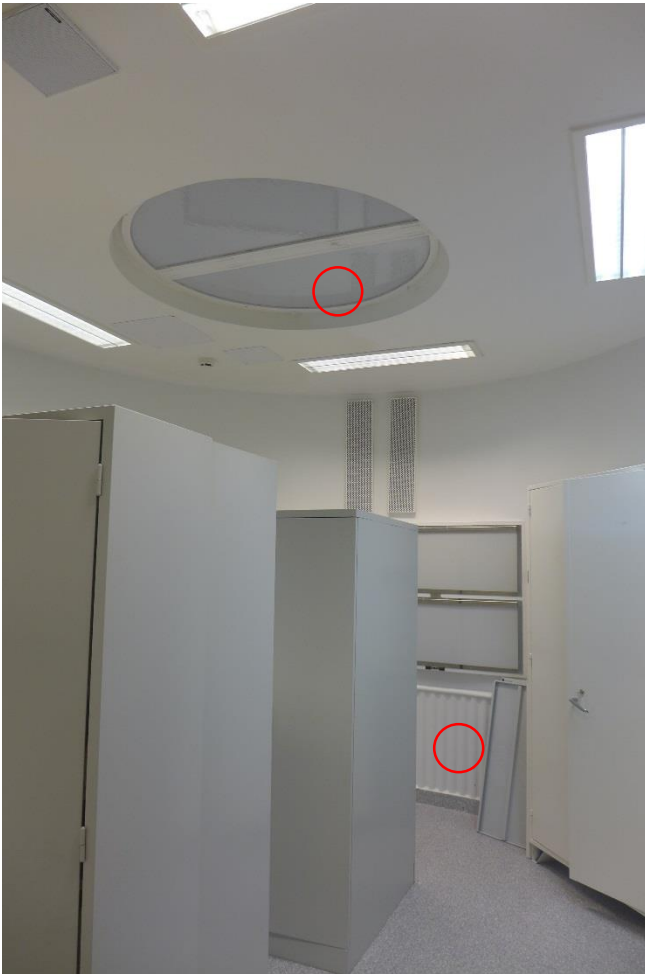
The operation theatre has had the classic “surgical” green paint as its three first layers. This green is shown in the original ceiling window, the walls, and the original round radiator in the back part of the theatre. The window wall on the left side of the room (not showing) had white and cream white layers.

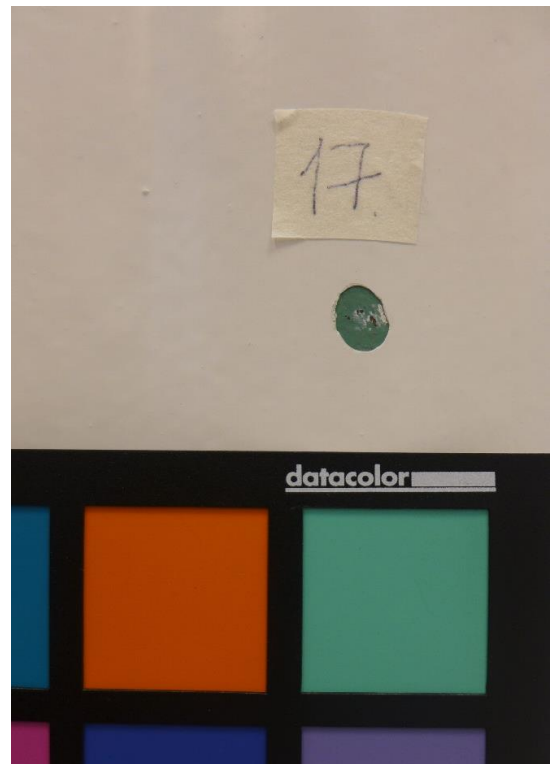
Sample 17 shows the undermost layers of green. The first layer seems to be a blueis, teal kind green.

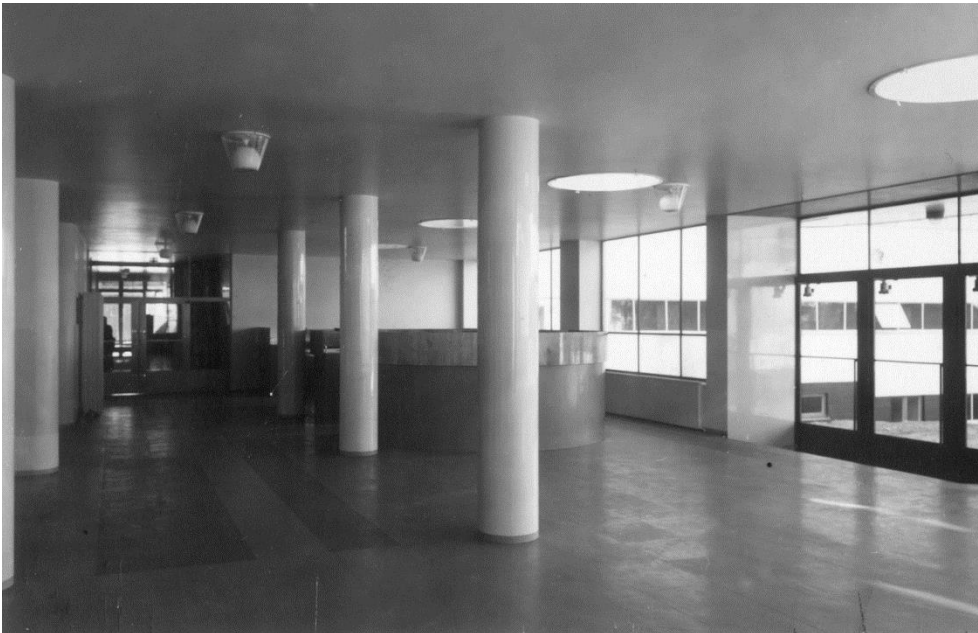
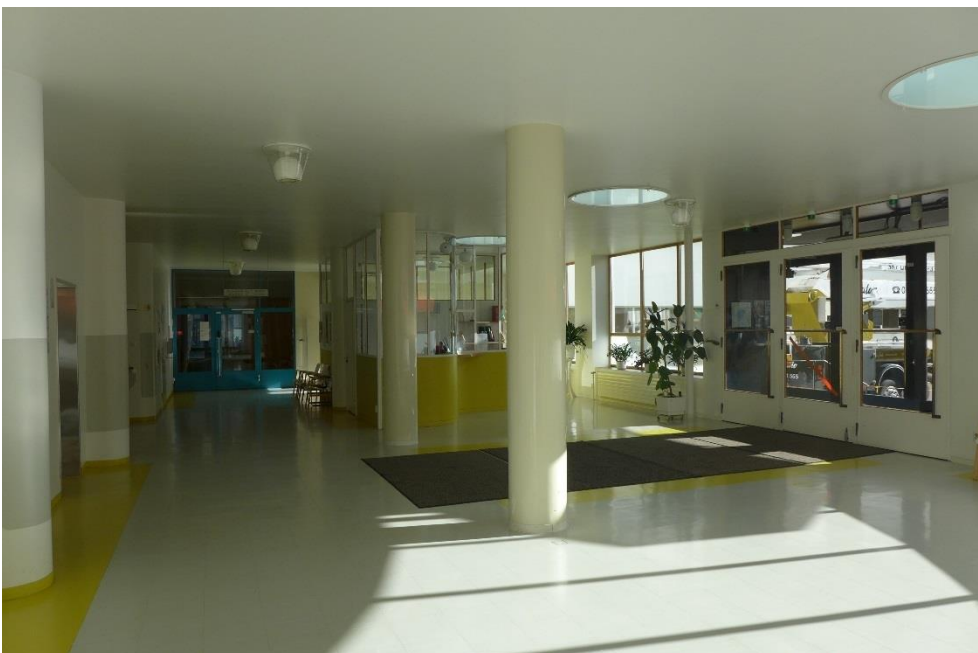
The main lobby of Paimio Sanatorium has gone through several changes. One of the major changes is the change from original front desk to a curved glass cubicle 1958. The change was designed by Alvar Aalto's office. The two elevators have been renewed. The original elevators stood side by side, the structure was a see-through glass-walled shaft. It has been said in a patient statement that one of the elevators was colored red. This was maybe to mark the line of passage for different types of users. All the traces of these color coded elevator cars have been lost during the renovations. The elevator's original technical space at the roof in 6th floor does neither give any hints of color. The Kauria color board marks the elevators bright red and bright blue. The samples and small excavations made in the main hall gave little new information to the facts one can see in the coeval photographs taken after the completing of main building. The ceiling is relatively lightly colored, as the pilasters stand out white and glossy. The main doors seem dark and the cheeks of the doors are light and glossy, as nowadays these cheeks are painted black.

Main hall with the original flooring and front desk. No draught lobby was built at this stage. Below is the current status of the Main lobby. Notice how the light does not pass through the Ground floor ward through the ward doors due to some change, leaving the back part of the lobby dark. AAM Sign. 50-005-308.

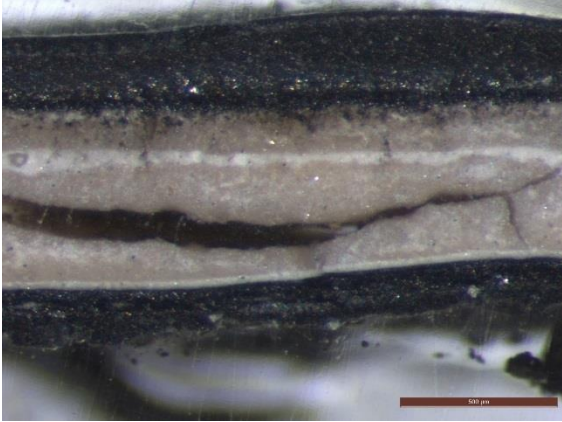
Draught Lobby

Number of Sample 25	Subject Paimio Sanatorium	Building / Space / Surface Main building Ground Floor Entrance hall Draught lobby (between outer and inner main doors)	
Architect, building year Alvar Aalto, 1929-33	Researcher, date Elina Riksmann, June-Dec. 2015, Alvar Aalto-foundation		
Most significant repairs and changes of the space, dates Draught lobby was built 1958 as the inner doors were added. At the same time the front desk was replaced.			
Photograph, drawing

Layers of Sample 00 Plaster 0 Filler 1 Black paint 2 Light beige or white 3 Thick filler 4 Black paint 5 Black paint	
Observations, remarks, e.g. pigment, adhesive, type of paint, material analysis			
Technique used to make and take Samples, Circumstance in site, Lighting: Carved color steps on surface, crater technique, daylight + fluorescent lamps	Color chart in use: NCS Teknos 2004 Color codes are written without the NCS prefix.	Type of Sample, Place of Storage: Cross-section sample 25. Alvar Aalto Foundation Helsinki. Scale 500µm.	Floor plan, Location of Sample

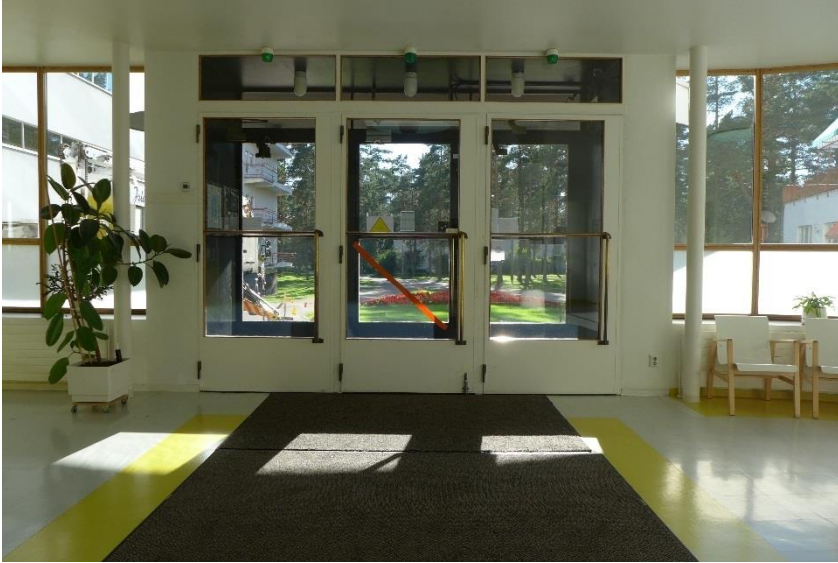
The entrance hall and drought lobby today.

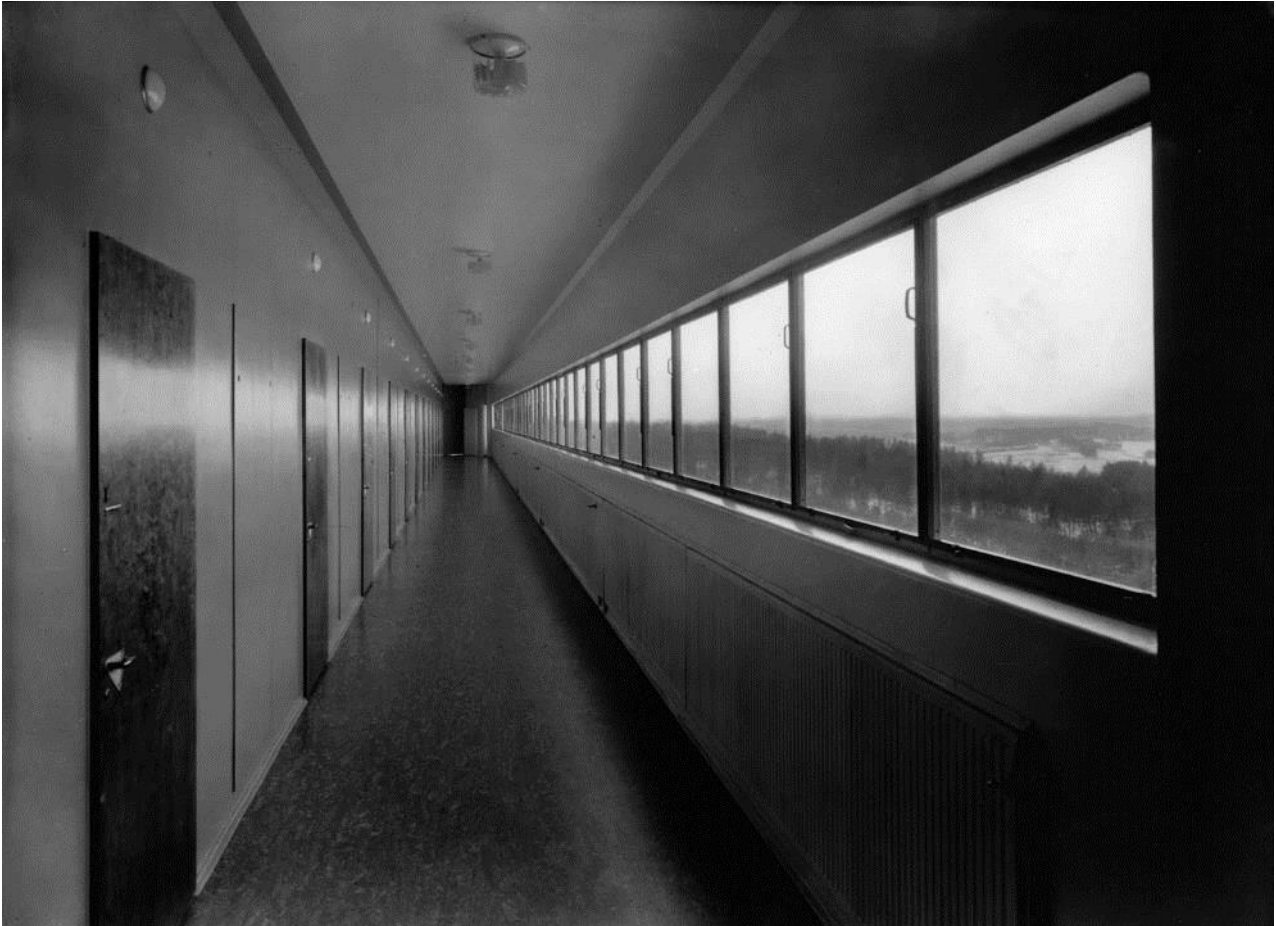
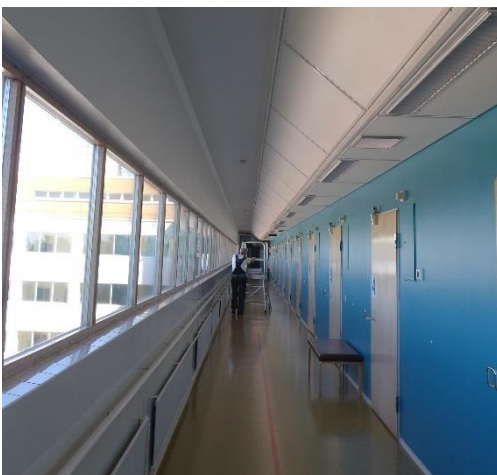
One of the wards (probably sixth according to the view from window). The wall with doors was painted in rich a tone and the outer wall in neutral color of off white. Below is a view today from the sixth floor ward to the opposite direction. Notice the built in structure in the ceiling for the purpose of hiding ventilation systems and electricity cords, dating to the 1970's. AAM. Sign. 50-003-328

The ceiling of the corridor has originally been white but as seen in the picture above, there is was a diagonal molding in the corner of the colored wall and ceiling. This molding was painted with the same color as the wall. In Eino Kauria's color board the wards are marked with three colors, ochre, blue and green.

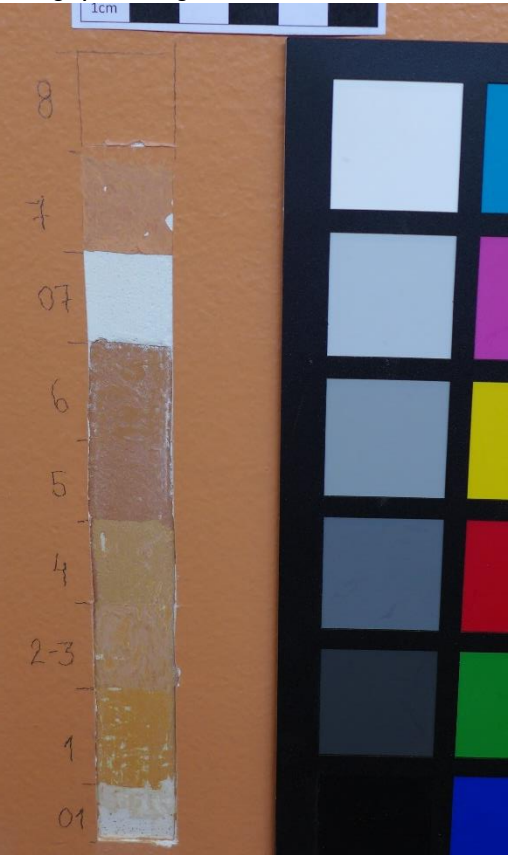
Layers of Sample 00 Plaster 01 Beige filler 1 Ochre S2050-Y30R 2 -3 Reddish browns 3020 – Y40R 4 Brown 3030-Y20R 5 Reddish dark brown 4020-Y60R 6 Brown 4030-Y30R 07 White light weight filler 7 Red 3020-Y60R	
Observations, remarks, e.g. pigment, adhesive, type of paint, material analysis: 1st layer is oil based paint.		8 Orangey red 2040-Y60R (nearest possible shade)

Technique used to make and take Samples, Circumstance in site, Lighting: Carved color steps on surface, crater technique, daylight + fluorescent lamps	Color chart in use: NCS Teknos 2004 Color codes are written without the NCS prefix.	Type of Sample, Place of Storage: Cross-section sample 11, Alvar Aalto Foundation Helsinki. Scale 1mm.	Floor plan, Location of Sample

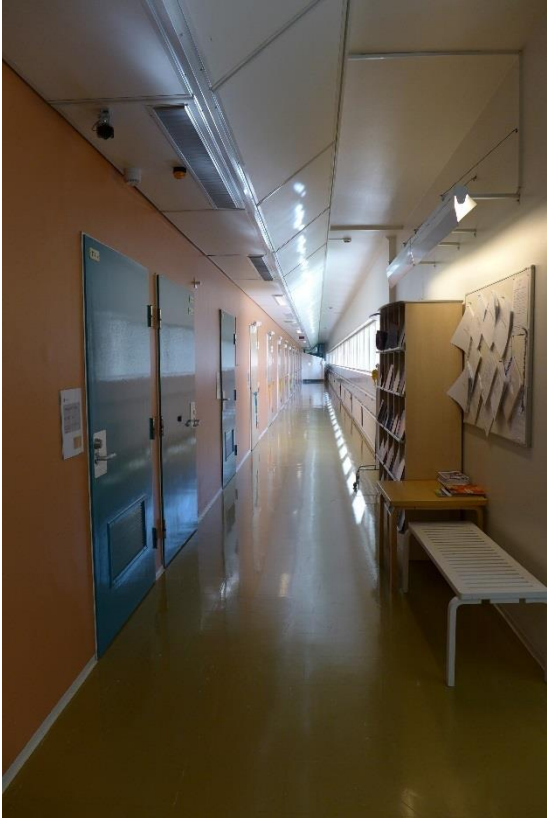
The main hall way of ground floor ward is today painted with somewhat the same tone as it originally was according to the findings. The ceilings have been white and the flooring dark linoleum with light colored heavy pattern. The doors were originally veneered and lacquered.

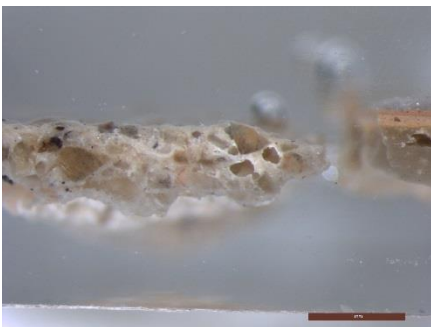
The cross section sample no. 11 taken from this ochre wall, broke into three parts. The bottom picture of this sample shows the undermost plaster, the middle one shows the original base filler as a brown layer, the white base coat and the first two orange paint layers. The surface is presented in the top picture where a light weight white filler layer is visible.

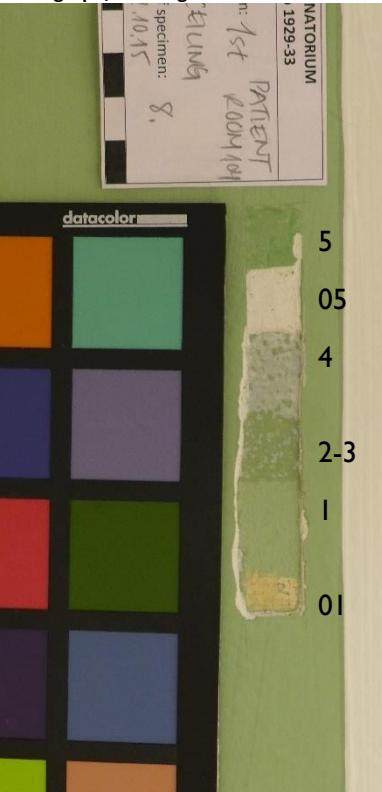
Layers of Sample 00 01 Yellowish filler 1 Green 2020G10Y 2-3 Green 4010-G10Y 4 Light blue 2020-B60G 05 White light weight filler 5 Green 4040-G10Y 6 Green 2020-G10Y	
Observations, remarks, e.g. pigment, adhesive, type of paint, material analysis:

Technique used to make and take Samples, Circumstance in site, Lighting: Carved color steps on surface, crater technique, daylight + fluorescent lamps	Color chart in use: NCS Teknos 2004 Color codes are written without the NCS prefix.	Type of Sample, Place of Storage: Cross-section sample 8, Alvar Aalto Foundation Helsinki. Scale 1mm.	Floor plan, Location of Sample

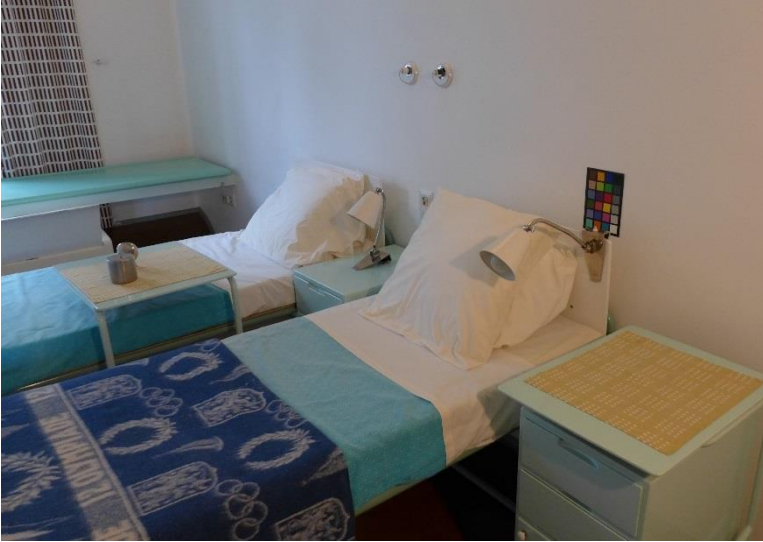
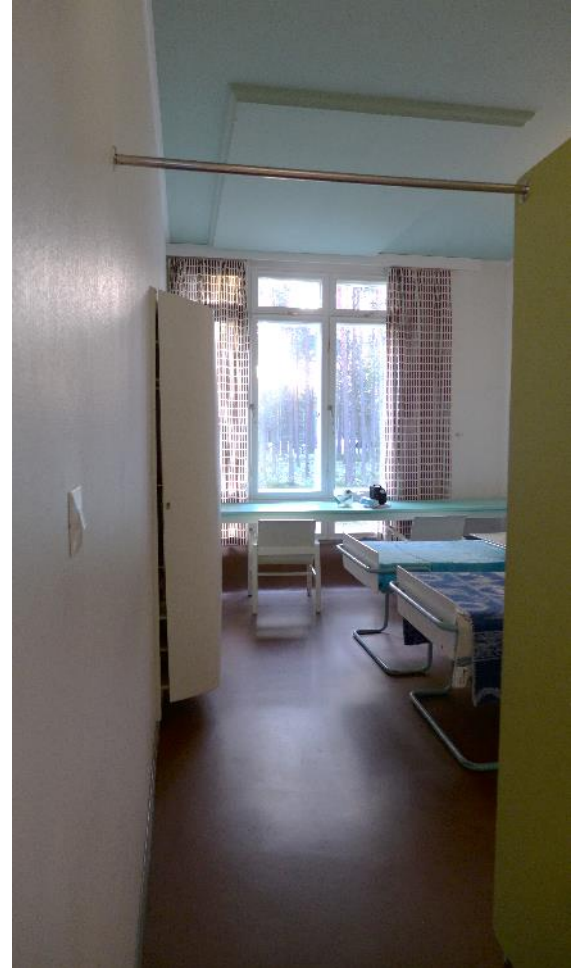
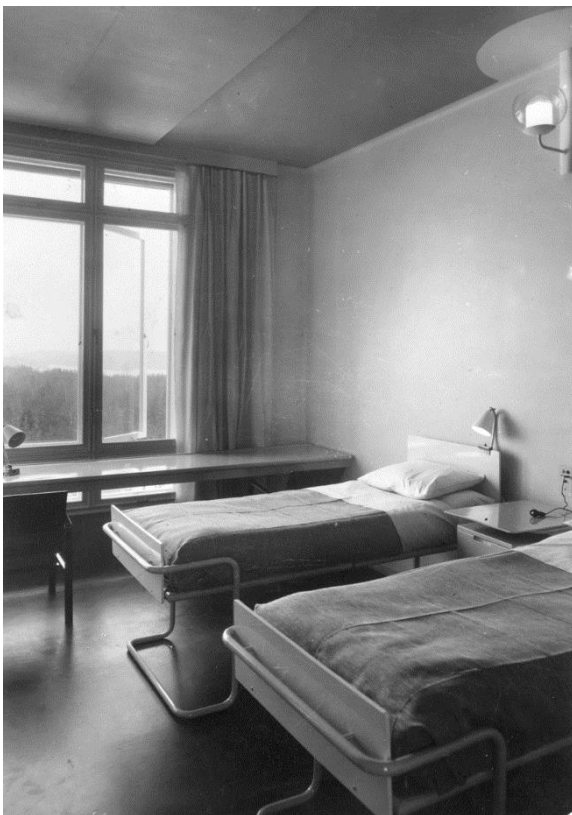
One of the patients' rooms of the upper floors. AAM.Sign. 50-003-360.

The museum room has been built in one of the ground floor ward's patients' room. The room is a 1970's interpretation of an original patients' room interior with its furniture and the original heating system in the ceiling. The coloring of the room seems not to be factual original coloration when compared to the excavations of surfaces made in the year 2000 color research by Katja Aaltonen.

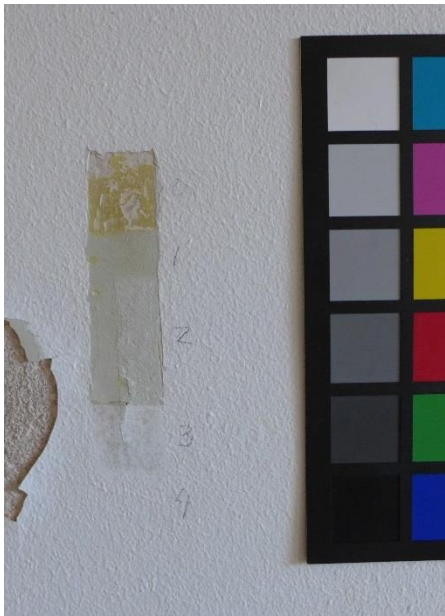
Jamb / Cheek of Door

Number of Sample 52	Subject Paimio Sanatorium	Building / Space / Surface Main building Ground Floor A wing	
Architect, building year Alvar Aalto, 1929-33	Researcher, date Elina Riksmán, June-Dec. 2015, Alvar Aalto-foundation	Museum room (former patient room left untouched in the 1970's renovation) Jamb of door (cheek of door)	
Most significant repairs and changes of the space, dates Patients' rooms have been fully renovated during 1970's but this Museum room was left to resemble the original 1930's look of a patient room. No hospital technique (i.e. different types of gases) or surfaces, HVAC-technique or furniture were redone. Original ceiling radiator was left (still functioning) and ceiling painted. Wallcoverings and flooring were left as they were, a Enso-cardboard covering on one wall and linoleum flooring. Original furniture and light fixtures were put to place.			
Photograph, drawing THIS EXCAVATION WAS MADE DURING ANOTHER RESEARCH YEAR 2000 (Katja Aaltonen).

Layers of Sample 00 Plaster 0 Filler 01 Yellow paint, base coat? 1 Grey paint S1005-G75Y 2 White paint S0505-G60Y 3 White S0601-Y21R 4 S0500-N

Observations, remarks, e.g. pigment, adhesive, type of paint, material analysis: 1 Öljymaali			
Technique used to make and take Samples, Circumstance in site, Lighting: Carved color steps on surface, crater technique, daylight + fluorescent lamps	Color chart in use: NCS Teknos 2004 Color codes are written without the NCS prefix.	Type of Sample, Place of Storage: Cross-section sample 52, Alvar Aalto Foundation Helsinki. Scale 500µm.	Floor plan, Location of Sample

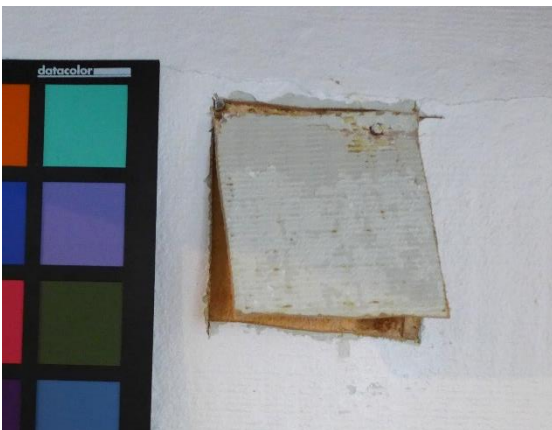
Enso card board was a Finnish wall treatment that was easy to apply and which gave instantly smooth paintable surfaces. It had its own distinctive texture that can be seen in the pictures below. The museum room wall's card board is the last fragment of Enso board in Paimio. Katja Aaltonen made an excavation on the wall board of museum room during the year 2000 research to define the original colors of the wall.

The undermost color was S1005-G30Y, a greenish grey.

Enso card board fragment excavated in Museum room in the year 2000 research.

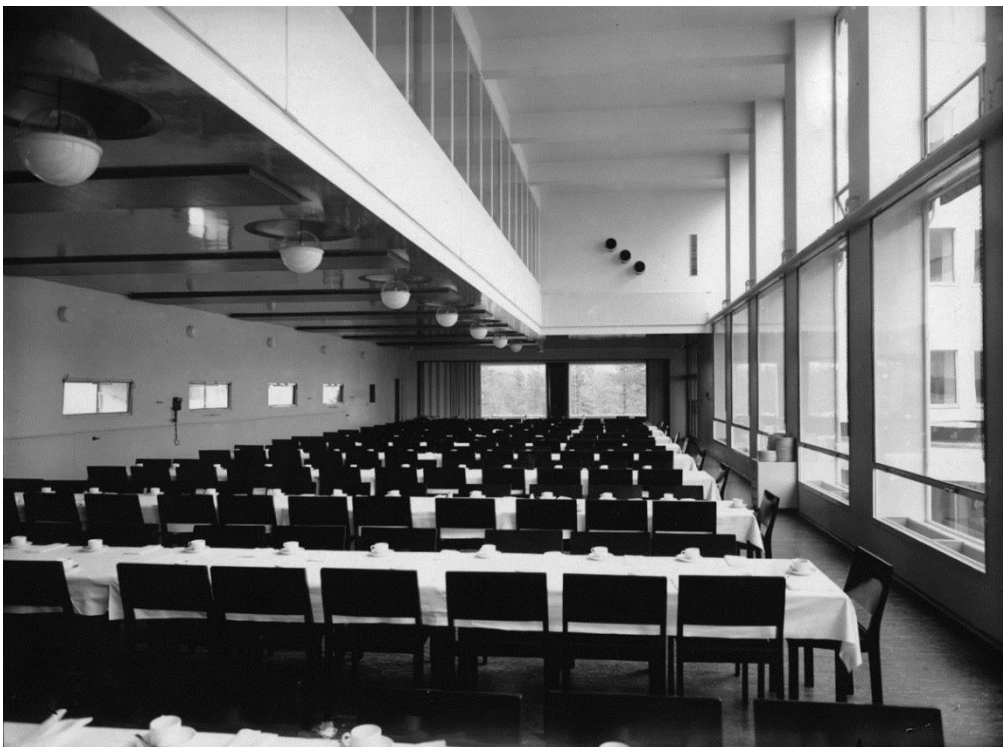
The low wall under the radiators has originally been white or light beige in color. That is also the color of the vertical beams, columns that divide the large windows on the opposite wall. Windows have original steel case frames that have probably been sandblasted in past renovations as they bore just three layers of paint, base included. The original furniture, the dining tables and chairs are still in everyday use, thanks to the rigorous maintenance work of the Paimio Hospital maintenance staff. The chairs have originally been treated black.

The flooring of the hall was rubber with heavy a pattern with a look familiar from marmoleum floors.

At the left the dining hall. AAM. Sign.50-003-339. Below at the left ceiling with ceiling radiators. AAM- Sign. 50-003-397. Below right a Christmas celebration in the dining hall in the 1970's. The original floor color is visible in the picture. AAM.

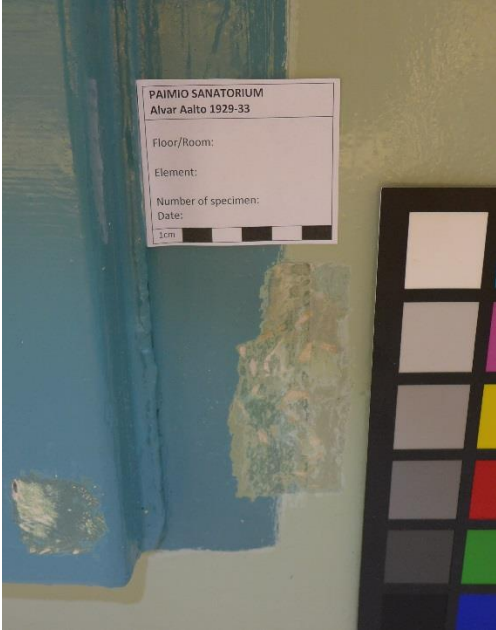
Ceiling Radiator's Lining

Number of Sample 4.1	Subject Paimio Sanatorium	Building / Space / Surface Main building 1 st Floor Dining hall Ceiling radiator, dark color rim lining the radiator	
Architect, building year Alvar Aalto, 1929-33	Researcher, date Elina Riksmann, June-Dec. 2015, Alvar Aalto-foundation		
Most significant repairs and changes of the space, dates The counter desk for distributing food 1970's. Vinyl flooring 1970's. Window frames have been treated (sandblasted?) during 1948 renovation (repair and paint instructions dating 1948).			
Photograph, drawing

Layers of Sample 00 Iron (Radiator) 01 Filler 1 Dark green paint 6020-G10Y or 6020-G

2 3 4 	
Observations, remarks, e.g. pigment, adhesive, type of paint, material analysis: 			
Technique used to make and take Samples, Circumstance in site, Lighting: Carved excavations on surface, daylight + fluorescent lamps	Color chart in use: NCS Teknos 2004 Color codes are written without the NCS prefix.	Type of Sample, Place of Storage: Cross section sample 4.1. Alvar Aalto Foundation, Helsinki. Scale 500µm.	Floor plan, Location of Sample

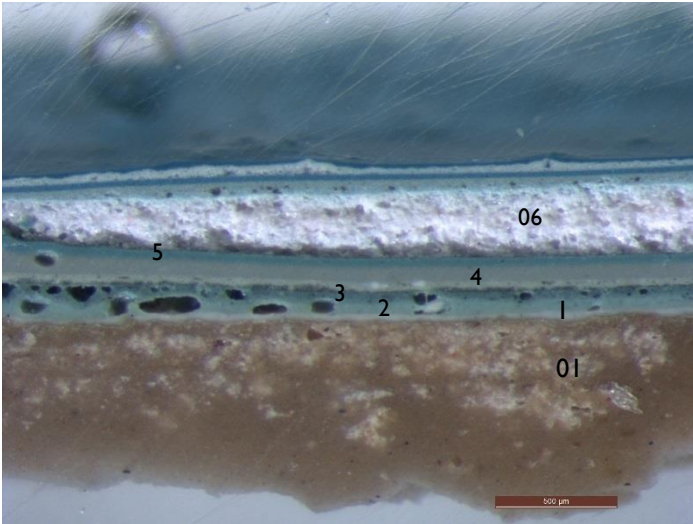
Cross section sample no. 4.1. from the dark color rim surrounding the ceiling radiators.

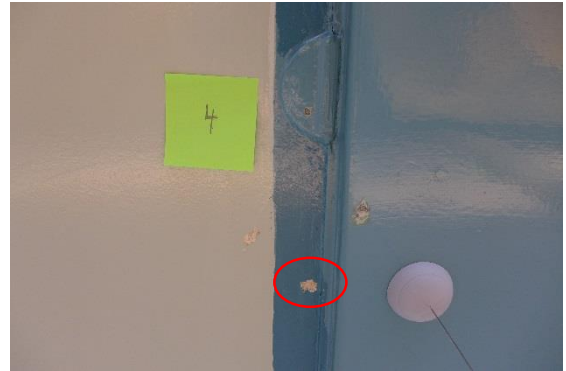
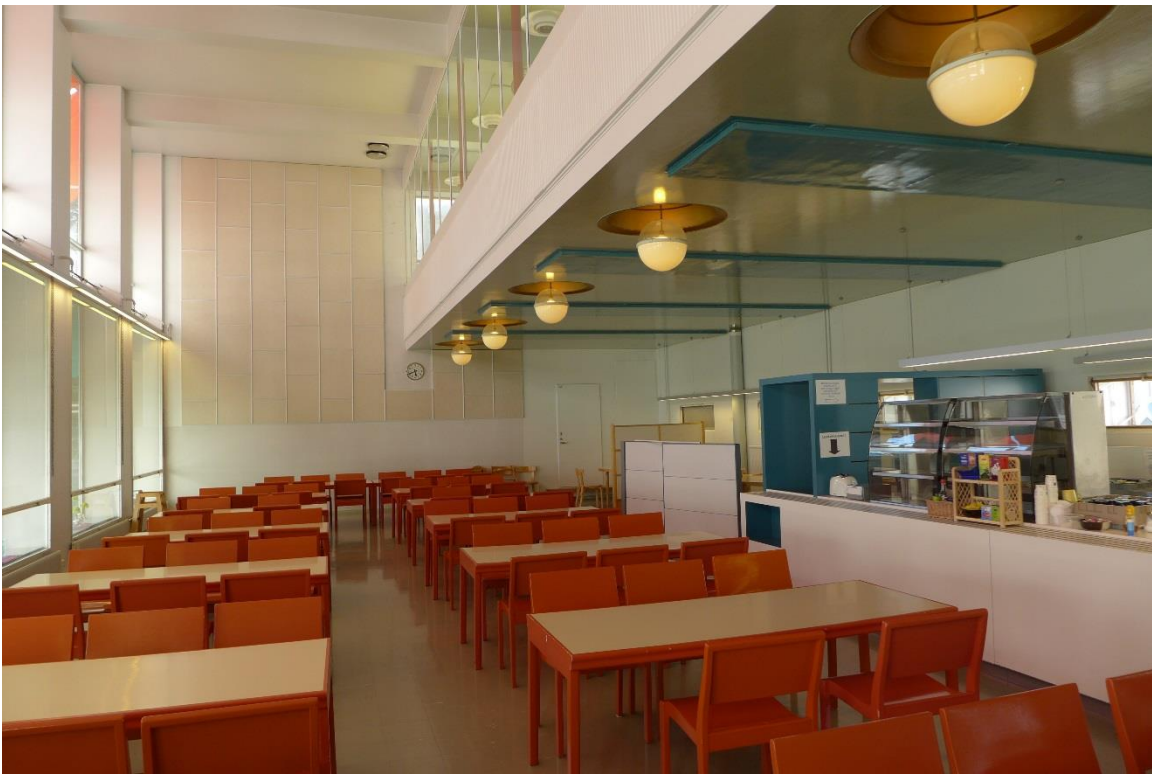
Ceiling Radiator

Number of Sample -	Subject Paimio Sanatorium	Building / Space / Surface Main building 1st Floor Dining hall Ceiling radiator	
Architect, building year Alvar Aalto, 1929-33	Researcher, date Elina Riksmann, June-Dec. 2015, Alvar Aalto-foundation		
Most significant repairs and changes of the space, dates The counter desk for distributing food 1970's. Vinyl flooring 1970's. Window frames have been treated (sandblasted?) during 1948 renovation (repair and paint instructions dating 1948).			
Photograph, drawing

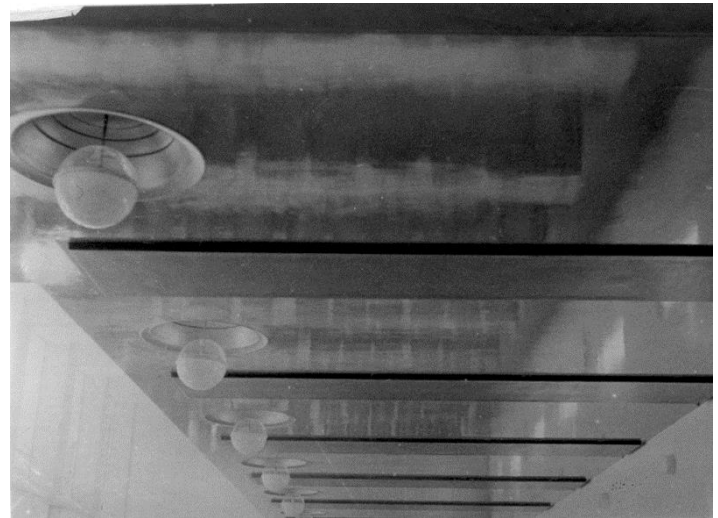
The cross section sample no. 4.1 show few layers as the first paint layer on the sample is light green. The original high gloss finish of the ceiling is shown below.
