ALVAR AALTO FOUNDATION

PAIMIO SANATORIUM COLOR RESEARCH 2015

PART I/2 Main Building

Elina Riksmán

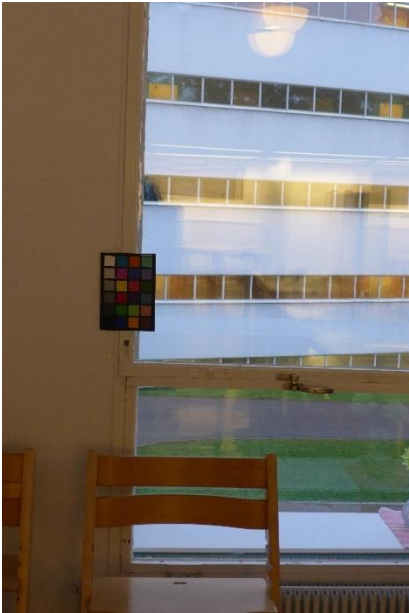
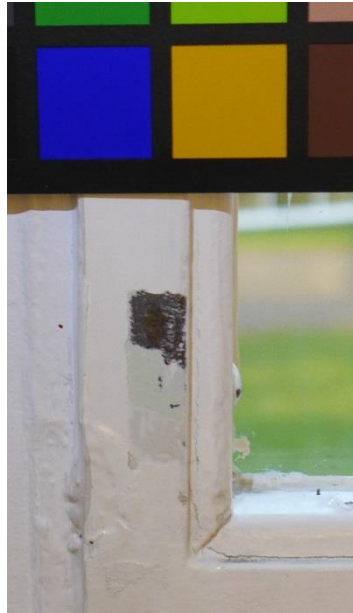
The Window Frames of Dining Hall

The iron window frames have apparently been sanded clean in the 1948 renovation. This is shown in the written order given to the painters at the time. It is highly possible that the window frames have been sand blasted again some times after 1948 renovation, due to their material, iron. The excavation from year 2000 showed only three layers + the newest white paint, the bottom one being base coat for metallic materials.

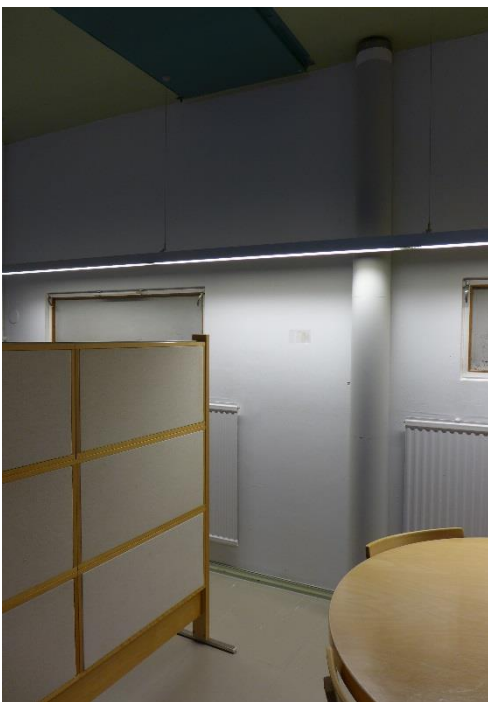
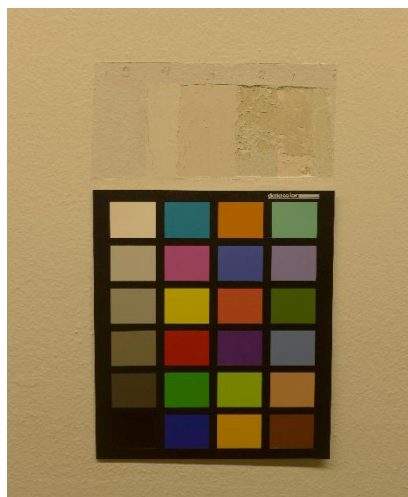
The Walls of Dining Hall

The small craters excavated and the cross section samples showed that the walls have had a neutral coloring through its history. The year 2000 color researcher Katja Aaltonen had made one large excavation on the north wall (the low wall under dropped ceiling). This excavation has deteriorated during 15 years so confirmations were therefore made. The excavation shows neutral tones of white, beige and light green color.

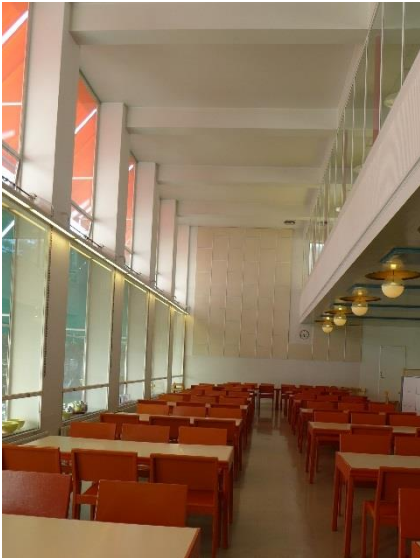
The Dining Hall Ceiling, Samples 102, 104, 105

The high section of the dining hall ceiling rises to almost 6 meters and is divided with supporting concrete beams. The black and white photos stating the original coloring, show that there has not been any other original coloring then white. To see if the beams had had any other coloring in any other point in history, cross section samples were taken from the ceiling and its beams. No such results were found in the three cross section samples

The sample 105 taken from the bottom of a supporting beam shows that the bottom yellow filler layer is covered with modern looking light weight white filler. It tells that the ceiling has probably been stripped from previous paint layers in recent decades.

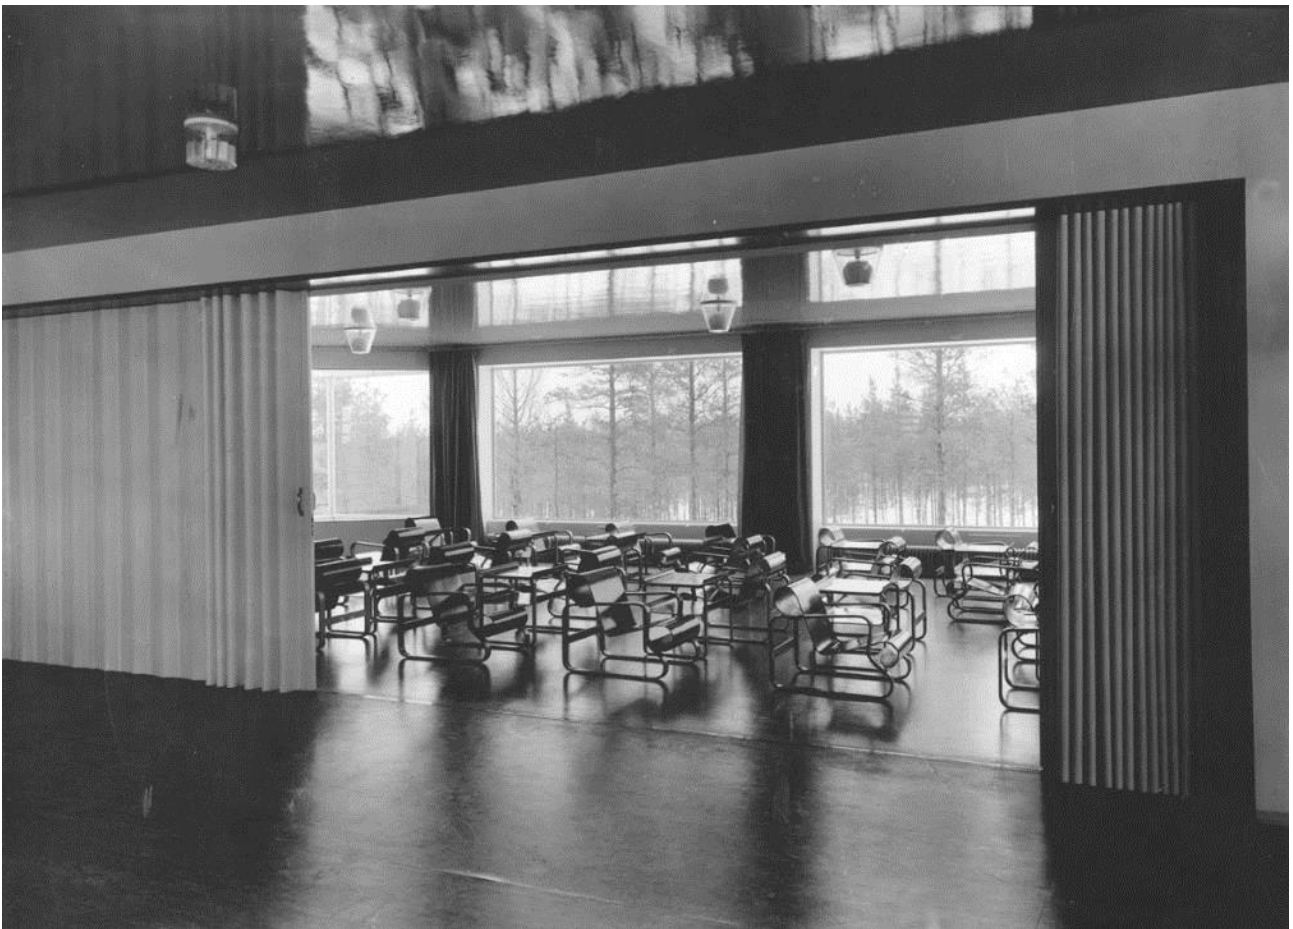
AAM. Sign. 50-003-419

The Lounge was divided from the dining hall by a curtain door that was easy to fold open. The bright lighting of the lounge comes from the big windows that cover most of the west side wall.

The black and white photograph below show the slight difference of color in the flooring between dining hall and lounge. As the dining hall floor is black, is the lounge flooring green. The ceiling of the lounge seems to be treated with the same glossy paint as the dining hall, but with a lighter shade. However the ceiling has been renovated some times, since it has a heavy layer of modern light weight filler. The color of the west side wall with the windows has probably always been rather light as only white and beige colors showed in the cross section sample of that wall. This is also something hinted by photographs.

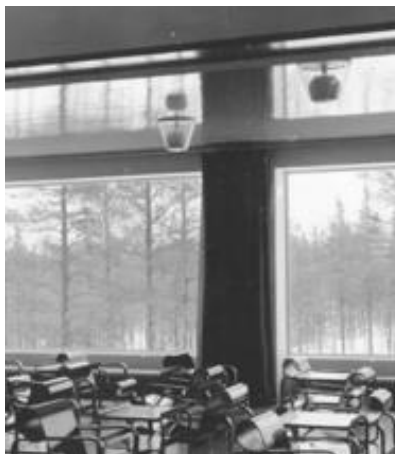
Sample no. 12, ceiling of the reading room.

Number of Sample 12	Subject Paimio Sanatorium	Building / Space / Surface Main building 1 st Floor Lounge Ceiling	
Architect, building year Alvar Aalto, 1929-33	Researcher, date Elina Riksmann, June-Dec. 2015, Alvar Aalto-foundation		
Most significant repairs and changes of the space, dates 1970's ventilation system brought casing of the pipes and electric cords in the ceiling. Doors and their sizing has changed. A new desk and speaker's podium for lecturer has been installed 1980's.			
Photograph, drawing

Layers of Sample 00 plaster 0 1 Filler 1 Green 5010-G30Y or 4010-G30Y	
Observations, remarks, e.g. pigment, adhesive, type of paint, material analysis: 1 Öljymaali			
Technique used to make and take Samples, Circumstance in site, Lighting: Carved color steps on surface, crater technique, daylight + fluorescent lamps	Color chart in use: NCS Teknos 2004 Color codes are written without the NCS prefix.	Type of Sample, Place of Storage: Cross-section sample 12. Alvar Aalto Foundation Helsinki. Scale 500µm.	Floor plan, Location of Sample

The sample 12 from the ceiling of lounge shows only layers that have probably been made since 1970's renovations. It was still possible to find some older layers in some parts of the ceiling, close to the ventilation system installed in the 1970's renovation. The original glossy finish is seen in the black and white picture below.

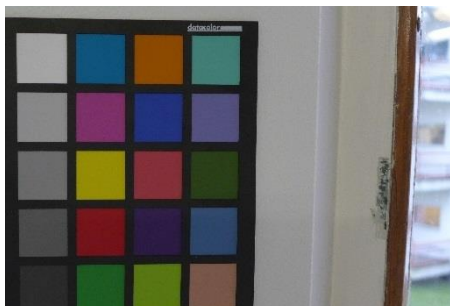
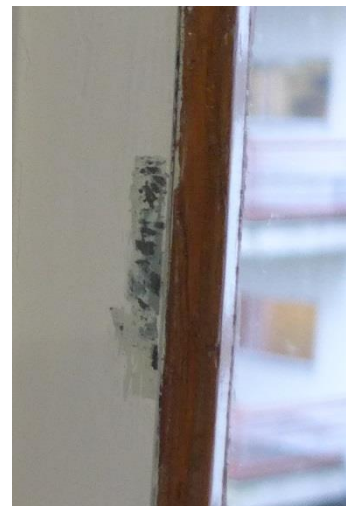
The Lounge's Window Frame

The iron frames showed only few layers, and as the dining hall windows, these windows have also been stripped from paint during and after 1948 renovation. The excavation was made in the year 2000 color research by K.Aaltonen.

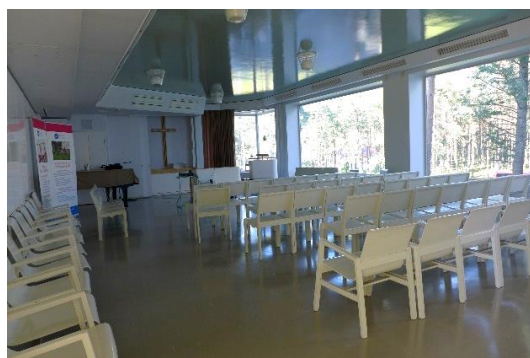
The Lounge's West Wall

The wall with windows showed a bottom layer of yellow oil based filler and beige (yellowed white) paint as the under most paint treatment. See next page.

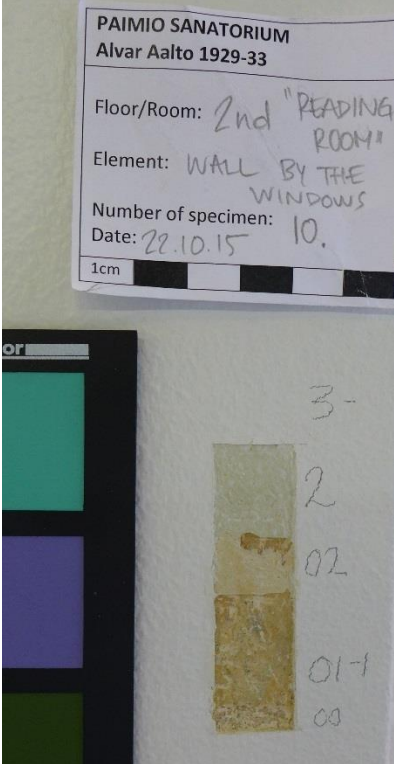
Lounge's Wall by the Windows

Number of Sample 10	Subject Paimio Sanatorium	Building / Space / Surface Main building 1 st Floor Lounge Wall by the windows pointing to west	
Architect, building year Alvar Aalto, 1929-33	Researcher, date Elina Riksmann, June-Dec. 2015, Alvar Aalto-foundation		
Most significant repairs and changes of the space, dates .1970's ventilation system brought casing of the pipes and electric cords in the ceiling. Doors and their sizing has changed. A new desk and speaker's podium for lecturer has been installed 1980's.			
Photograph, drawing

Layers of Sample 00 plaster 01-1 yellow filler, 2040-Y10R 02 filler 2 Oil Paint Light green, made with a hacker technique 1510-G60Y 3 White paint	
Observations, remarks, e.g. pigment, adhesive, type of paint, material analysis:			
Technique used to make and take Samples, Circumstance in site, Lighting: Carved color steps on surface, crater technique, daylight + fluorescent lamps	Color chart in use: NCS Teknos 2004 Color codes are written without the NCS prefix.	Type of Sample, Place of Storage: Cross-section sample 10, Alvar Aalto Foundation Helsinki	Floor plan, Location of Sample

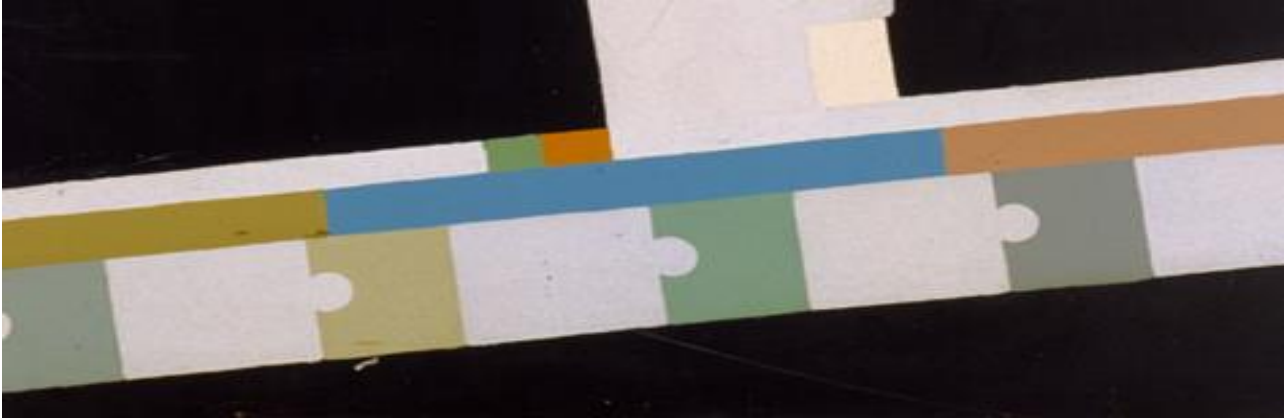
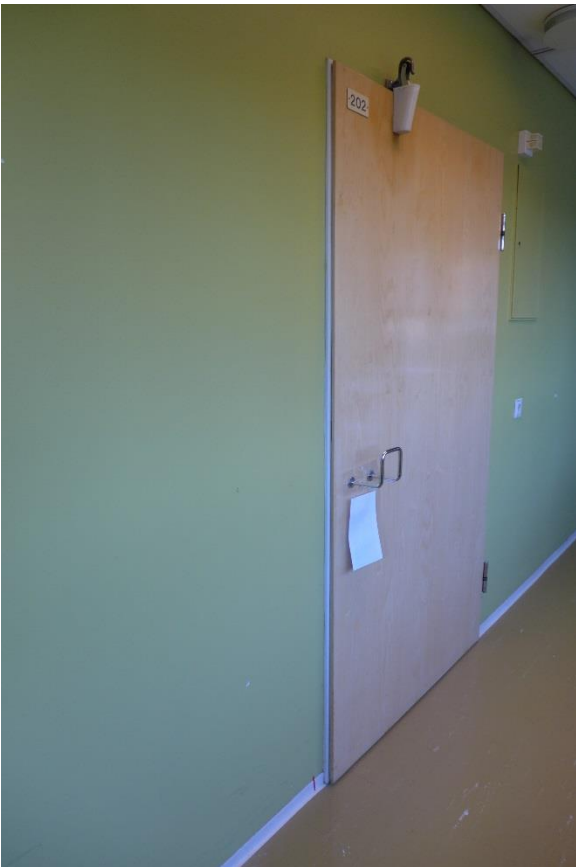
13. 1st Floor Ward

The 1st floor ward in the A-wing is similar to the ground floor by its division and type of spaces and surfaces, but the general look is different compared to ground floor due to the green wall of the ward hall way. The patient room ceiling also have a different original coloring compared to the first floor rooms. This floor has grey ceilings patient rooms.

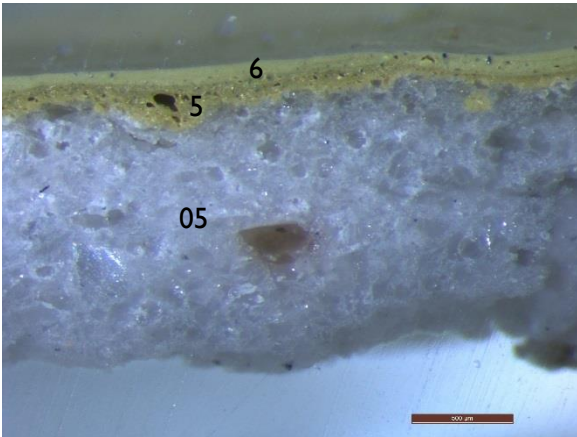
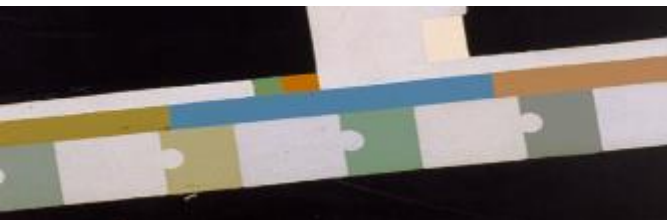
Main Hall Way

Number of Sample 54	Subject Paimio Sanatorium	Building / Space / Surface Main building 1 st Floor	
Architect, building year Alvar Aalto, 1929-33	Researcher, date Elina Riksmann, June-Dec. 2015, Alvar Aalto-foundation	Ward, main corridor Wall (wall with doors leading to patient rooms)	
Most significant repairs and changes of the space, dates 1970's ventilation system brought casing of the pipes and electric cords in the ceiling. Doors and their sizing has changed, broader painted wooden doors have replaced the original wooden doors with lacquered surfaces. The lighting and fixtures have also been replaced.			
Photograph, drawing

Technique used to make and take Samples, Circumstance in site, Lighting: Carved color steps on surface, crater technique, daylight + fluorescent lamps	Color chart in use: NCS Teknos 2004 Color codes are written without the NCS prefix.	Type of Sample, Place of Storage: Cross-section sample 54, Alvar Aalto Foundation Helsinki. Scale 500 µm.	Floor plan, Location of Sample

The sample no. 54 was broken in two parts. The top layers are seen at the picture above and bottom layers below with the original yellow paint. The results are not in line with the Kauria color board that states three different colors that were used one by one in the hall way of each ward. This same yellow undermost layer was also found in other ward hall ways. This indicates that the yellow was first experimented with in the ward hall ways and possibly then painted over with green, blue and ochre colors. As the Kauria interview from the year 1986 tells, Alvar Aalto did not eventually like the look of the yellow flooring he had specially made for the main building's main lobby, hallways and staircases. At that point of Aalto's skepticism it was not possible to cancel the large order of the yellow flooring. This gives one the idea that maybe the same doubt went through Aalto's mind with the main colors of the wards. This is of course only speculation. The found paint layers themselves state that the original first layer of paint truly is this bright sunny yellow.

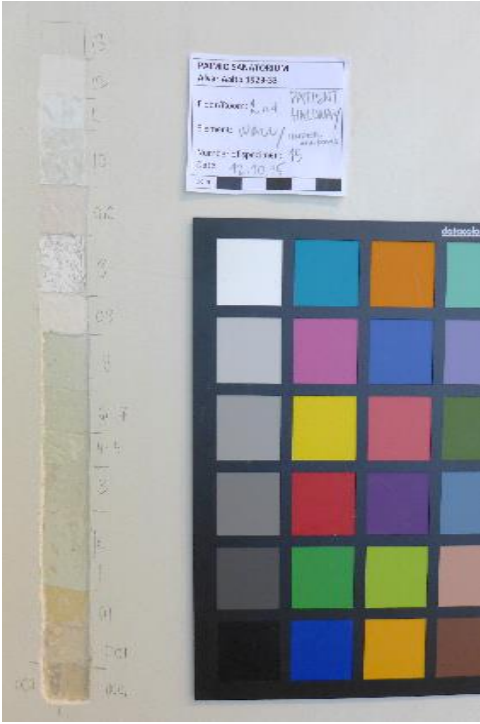
North Wall

Number of Sample -	Subject Paimio Sanatorium	Building / Space / Surface Main building 1 st Floor A wing, main corridor Wall with windows, to north	
Architect, building year Alvar Aalto, 1929-33	Researcher, date Elina Riksmann, June-Dec. 2015, Alvar Aalto-foundation		
Most significant repairs and changes of the space, dates 1970's ventilation system brought casing of the pipes and electric cords in the ceiling. Doors and their sizing has changed, broader painted wooden doors have replaced the original wooden doors with lacquered surfaces. The lighting and fixtures have also been replaced.			
Photograph, drawing

Layers of Sample 000 Plaster 0001 Filler 001 Consolidating cotton canvas with oil filler 01 Yellow filler 1 Greenish grey 1005-G50Y 2 Greenish grey 1010-G70Y 3 Grey 2005-G60Y 4 -5 White 0603-G40Y and green 1510-G60Y? 6-7 Green? 8 Light blue 2010-G50Y 09 Filler 9 White 0300-N 010 Filler 10 Light green 1005-G20Y 11 White 0300-N

Observations, remarks, e.g. pigment, adhesive, type of paint, material analysis: 1st layer oil paint.		12 White 0502-Y 13 White 1002-Y	
Technique used to make and take Samples, Circumstance in site, Lighting: Carved color steps on surface, crater technique, daylight + fluorescent lamps	Color chart in use: NCS Teknos 2004 Color codes are written without the NCS prefix.	Type of Sample, Place of Storage: Cross-section sample, Alvar Aalto Foundation Helsinki	Floor plan, Location of Sample

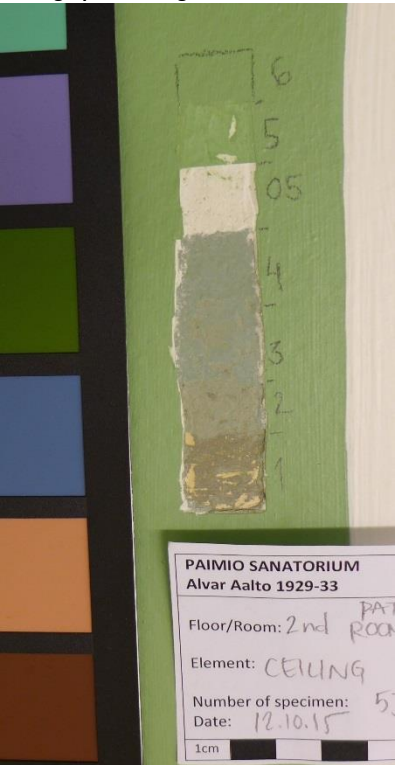
Patient Room Ceiling

Number of Sample 53	Subject Paimio Sanatorium	Building / Space / Surface Main building 1 st Floor Patients' room 203 Ceiling	
Architect, building year Alvar Aalto, 1929-33	Researcher, date Elina Riksmann, June-Dec. 2015, Alvar Aalto-foundation		
Most significant repairs and changes of the space, dates Patient rooms have been fully renovated during 1970's as the hospital technique (i.e. different types of gases, electricity) and all of the surfaces, HVAC-technique and furniture were redone. Original ceiling radiators were removed and ceilings painted (but not hidden under dropped ceiling structures). Wallcoverings and flooring were replaced. Original furniture was removed.			
Photograph, drawing

Layers of Sample 00 01 Filler 1 Grey 6502-G 2 Grey 3005-G50Y 3 Blue? Not possible to define 4 Blue 4010-B70G 05 White filler 5 Green 4010-G10Y or -G30Y 6 Green 4010-G10Y or -G30Y	
Observations, remarks, e.g. pigment, adhesive, type of paint, material analysis:

Technique used to make and take Samples, Circumstance in site, Lighting: Carved color steps on surface, crater technique, daylight + fluorescent lamps	Color chart in use: NCS Teknos 2004 Color codes are written without the NCS prefix.	Type of Sample, Place of Storage: Cross-section sample 53, Alvar Aalto Foundation Helsinki. Scale 500 µm.	Floor plan, Location of Sample

The ceiling of the patient room 203 has an original layer of grey paint that is also found in the Kauria color board. The sample no. 53 was broken in half. It shows more layers that was possible to excavate in situ. The bottom layers are shown in the picture below and the surface with thick white light weight filler in the picture above.

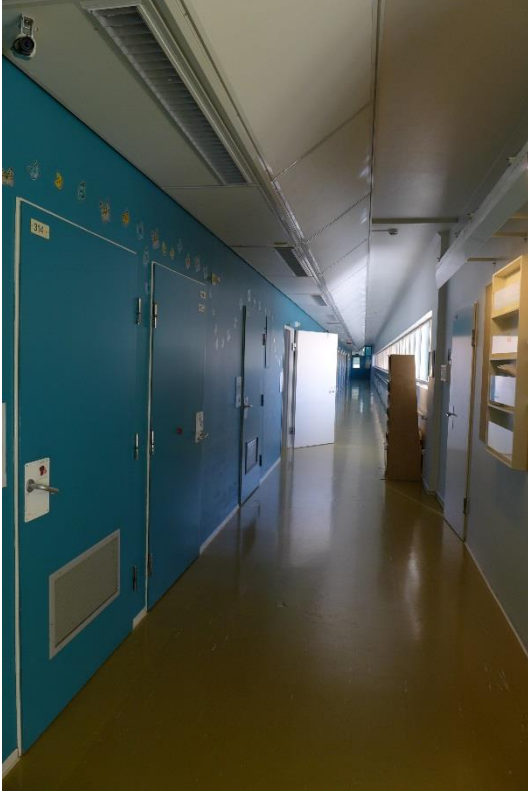
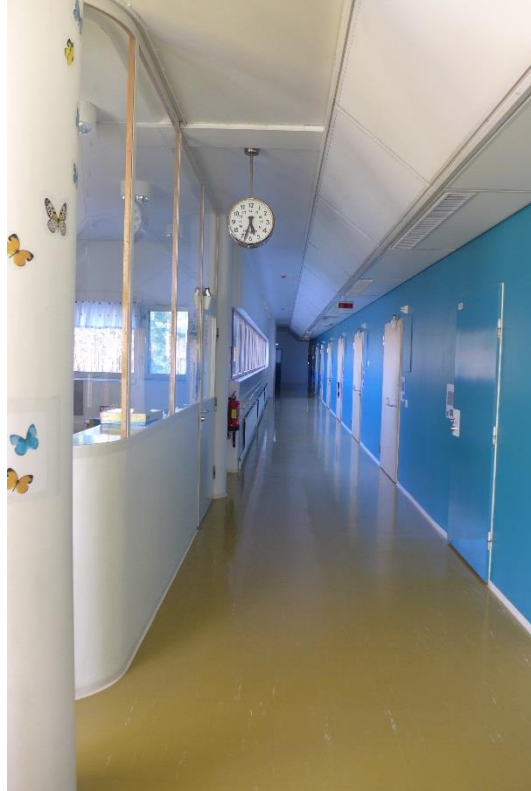
Ward, Main Corridor

The 2nd floor ward's main corridor carries deep blue as a primary color.

Number of Sample 31	Subject Paimio Sanatorium	Building / Space / Surface Main building 2 nd Floor	
Architect, building year Alvar Aalto, 1929-33	Researcher, date Elina Riksmann, June-Dec. 2015, Alvar Aalto-foundation	Patient wing, main hallway Wall (the wall with the doors to patient rooms)	
Most significant repairs and changes of the space, dates 1970's ventilation system brought casing of the pipes and electric cords in the ceiling. Doors and their sizing has changed, broader painted wooden doors have replaced the original wooden doors with lacquered surfaces. The lighting and fixtures have also been replaced.			
Photograph, drawing

The ward's main corridors colored wall shows less layers than other ward corridors have shown. The bottom one found stated a blue color. The sample no. 31 broke in to two parts: the surface is seen in the picture above, and the bottom layers below. The undermost layer is white, porous, light weight filler that obviously is not the original 1930's oil filler used, but a layer from later renovation.

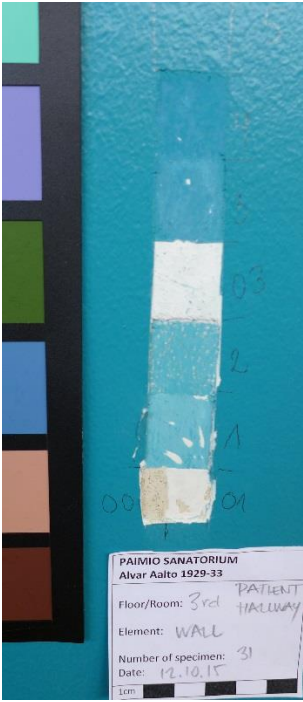
Layers of Sample 00 Plaster 01 white light weight filler 1 Blue 2040-B20G 2 Two shades: 3040-B30G, 3040-B20G 03 White filler 3 Blue 4040-B10G 4 Two shades: 4040-B10G, 4050-B 5 Blue 4040-B30G	
Observations, remarks, e.g. pigment, adhesive, type of paint, material analysis:

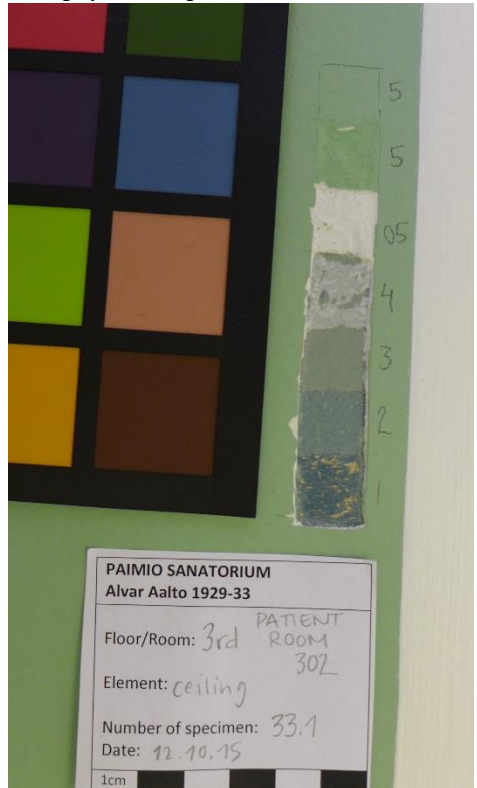
Patient Room Ceiling

Number of Sample 33.1	Subject Paimio Sanatorium	Building / Space / Surface Main building t Floor 2 nd Floor Patient room Ceiling	
Architect, building year Alvar Aalto, 1929-33	Researcher, date Elina Riksmann, June-Dec. 2015, Alvar Aalto-foundation		
Most significant repairs and changes of the space, dates Patient rooms have been fully renovated during 1970's as the hospital technique (i.e. different types of gases, electricity) and all of the surfaces, HVAC-technique and furniture were redone. Original ceiling radiators were removed and ceilings painted (but not hidden under dropped ceiling structures). Wallcoverings and flooring were replaced. Original furniture was removed.			
Photograph, drawing

<p>PAIMIO SANATORIUM Alvar Aalto 1929-33</p> <p>Floor/Room: 3rd PATIENT ROOM 302</p> <p>Element: ceiling</p> <p>Number of specimen: 33.1</p> <p>Date: 12.10.15</p> <p>1cm</p>		Layers of Sample 00 Plaster 01 Filler, yellow oil based 1 Blue 5020-B10G 2 Blueish grey 4010-B30G 3 Grey 3010-G10Y 4 Light grey 2005-G 05 Filler white light weight 5 Green 2020-G10Y

Observations, remarks, e.g. pigment, adhesive, type of paint, material analysis: Oil paint			
Technique used to make and take Samples, Circumstance in site, Lighting: Carved color steps on surface, crater technique, daylight + fluorescent lamps	Color chart in use: NCS Teknos 2004 Color codes are written without the NCS prefix.	Type of Sample, Place of Storage: Cross-section sample, 33.1. Alvar Aalto Foundation Helsinki. Scale 500µm.	Floor plan, Location of Sample

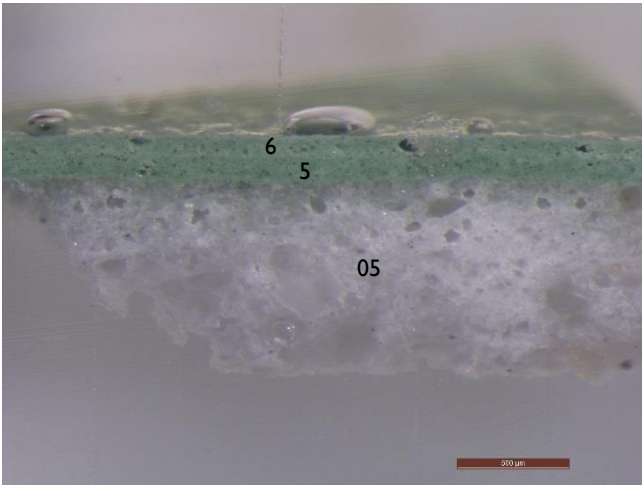
The patients' room ceilings of 2nd floor ward have blue undermost layers that can be seen in the sample no. 33.1 bottom layers, in the picture below.

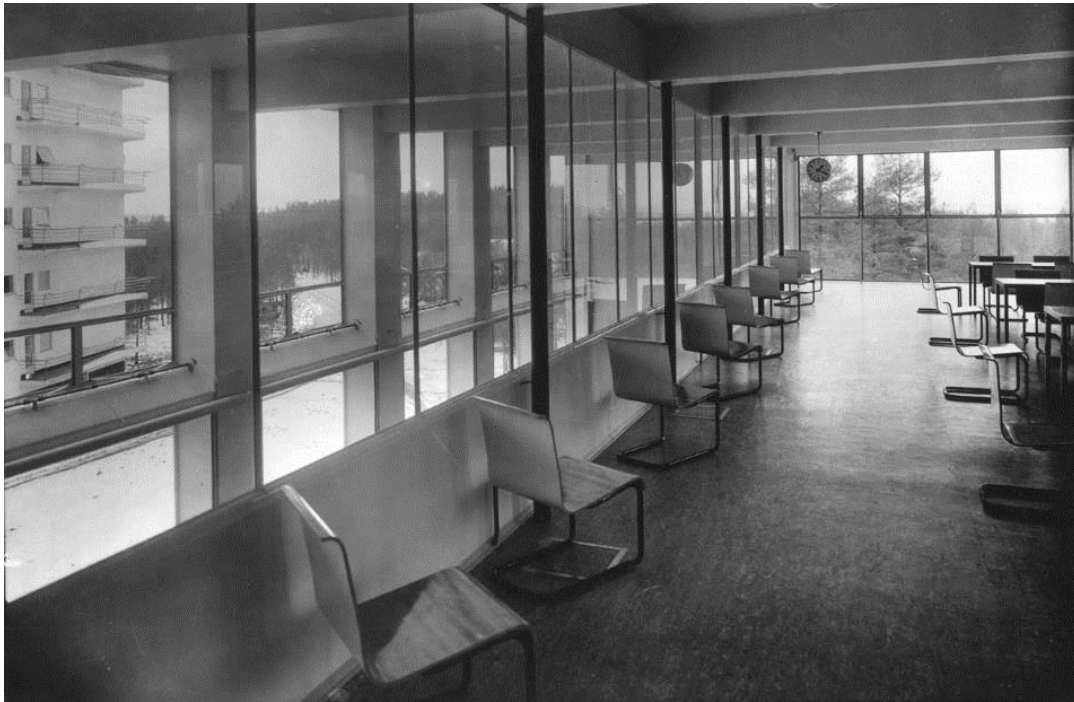
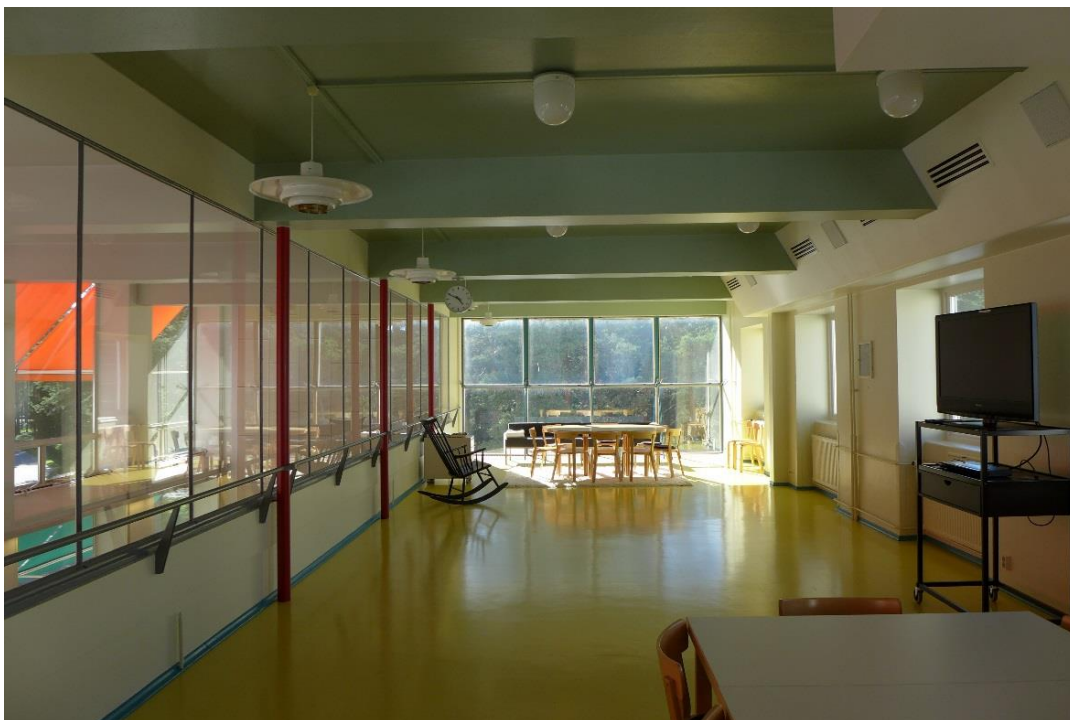
16.2nd Floor Reading room

Today the reading room has rich colors that originate to the year 2000 color research and renovations done after. The ceiling has supporting beams. The south wall is glass framed with iron. The big windows facing east are also iron framed and they bare a vibrant petrol blue. The north wall is neutrally colored with smaller windows. The thin iron columns line the glass wall giving to the dining hall. They are now, as they were before, painted-bright red. The 1970's renovation brought dropped ceiling structures on the north

side of the room, to cover the

ventilation system installed.

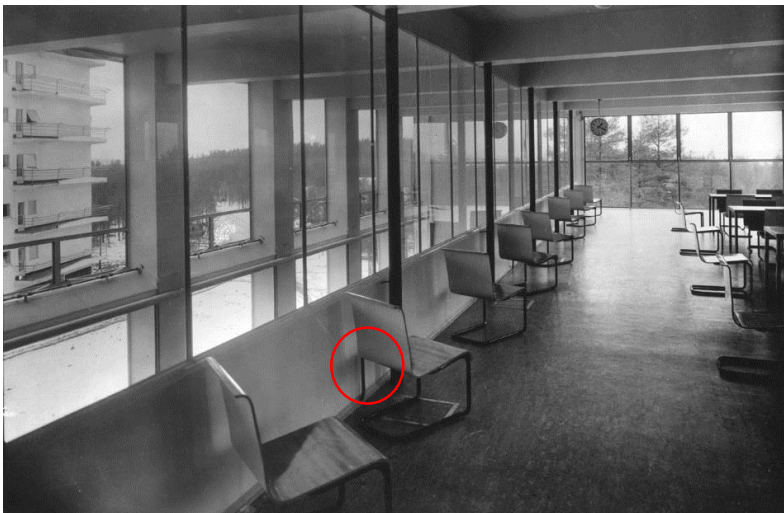
The Coloring of HVAC Pipes

The warm water pipe sticking from the wall is a pipe for bleeding the air in the original radiator system below, in the ceiling of the Dining hall. This pipe is the only piece of evidence found that shows in reality the fact that originally at least some of the HVAC system's pipes in Paimio main building were color coded. This small air bleeding pipe shows bright red paint underneath the other layers.

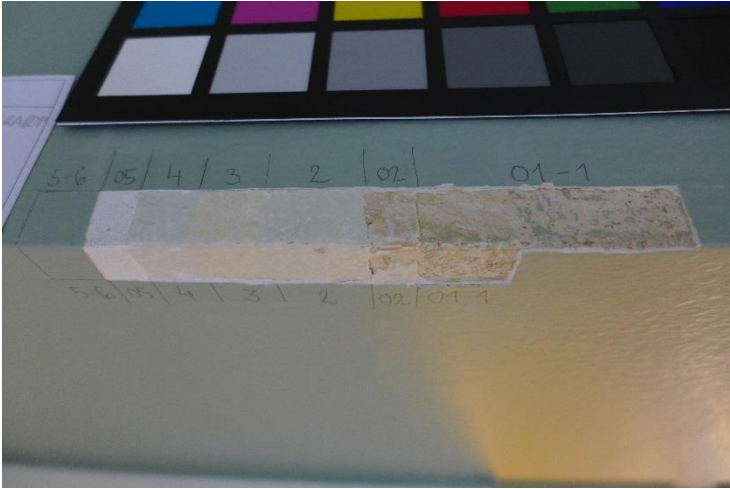
Ceiling Beams

Number of Sample 28	Subject Paimio Sanatorium	Building / Space / Surface Main building t Floor 2 nd Floor Reading room Ceiling beams, cheek and bottom surface	
Architect, building year Alvar Aalto, 1929-33	Researcher, date Elina Riksmán, June-Dec. 2015, Alvar Aalto-foundation		
Most significant repairs and changes of the space, dates HVAC-remodeling in the 1970's renovation brought the dropped ceiling structures that hide ventilation pipes and electric cords. Original rubber flooring has been changed to a vinyl floor.			
Photograph, drawing

Layers of Sample 00 Plaster 01 Filler 1 Green 2020-G10Y 02 Filler 2 Light grey 1005-B80Y 3 Yellow 0510-Y10R 4 Grey 1502-Y 05 White light weight filler 5-6 Green 3010-G20Y	
Observations, remarks, e.g. pigment, adhesive, type of paint, material analysis: It was not possible to specify the type of paint of 1st layer.			
Technique used to make and take Samples, Circumstance in site, Lighting: Carved color steps on surface, crater technique, daylight + fluorescent lamps	Color chart in use: NCS Teknos 2004 Color codes are written without the NCS prefix.	Type of Sample, Place of Storage: Cross-section sample 28, Alvar Aalto Foundation Helsinki. Scale 500µm.	Floor plan, Location of Sample

The cross section sample no. 28 from the ceiling beams of reading room show no trace of green original color layer. The excavation how ever showed the green original color. The sample was broken in two parts, the undermost half is presented in the picture below.

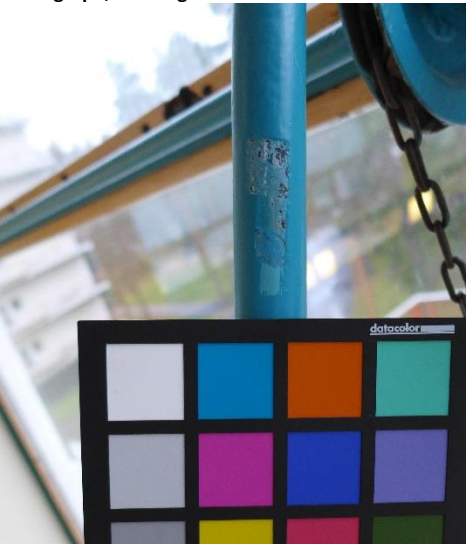
Iron Frame Windows Giving to West

Number of Sample	Subject Paimio Sanatorium	Building / Space / Surface Main building t Floor 2 nd Floor Reading room Iron windows (to west)	
Architect, building year Alvar Aalto, 1929-33	Researcher, date Elina Riksmann, June-Dec. 2015, Alvar Aalto-foundation		
Most significant repairs and changes of the space, dates HVAC-remodeling in the 1970's renovation brought the dropped ceiling structures that hide ventilation pipes and electric cords. Original rubber flooring has been changed to a vinyl floor.			
Photograph, drawing

Layers of Sample 00 Iron 01 base coat, light beige 1 Blue 3030-B30G

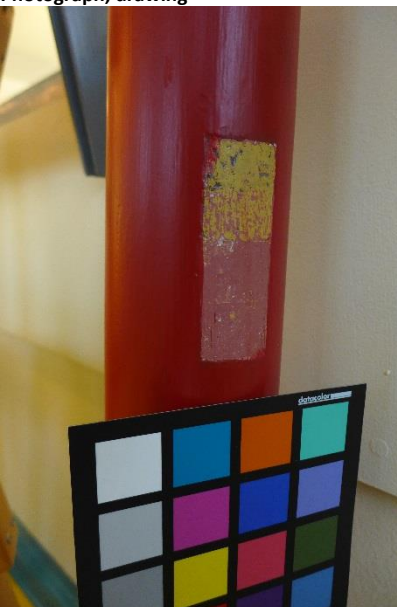
Number of Sample	Subject Paimio Sanatorium	Building / Space / Surface Main building t Floor 3 rd Floor reading room Columns lining the windows giving to south and dining hall	
Architect, building year Alvar Aalto, 1929-33	Researcher, date Elina Riksmán, June-Dec. 2015, Alvar Aalto-foundation		
Most significant repairs and changes of the space, dates HVAC-remodeling in the 1970's renovation brought the dropped ceiling structures that hide ventilation pipes and electric cords. Original rubber flooring has been changed to a vinyl floor.			
Photograph, drawing

Layers of Sample 00 Iron 1 Red 1580-Y80R

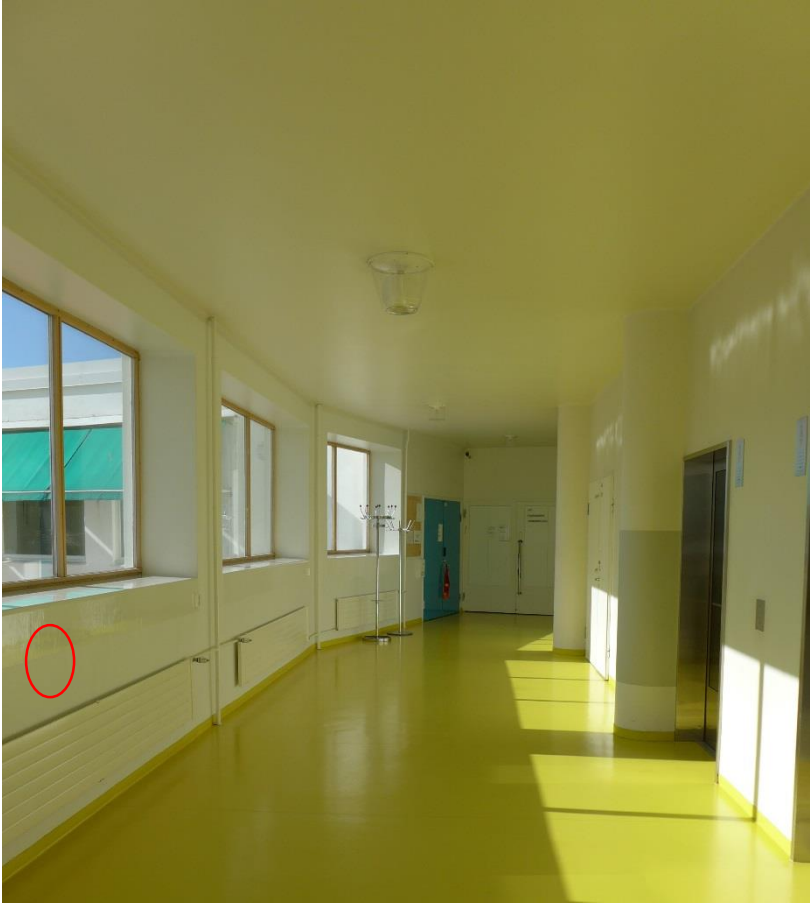
The main corridors through out the main building had the same coloring. The sample no. 84 shows the general situation of the walls surrounding corridors, a palette of neutral tones through decades, as the undermost layers are white.

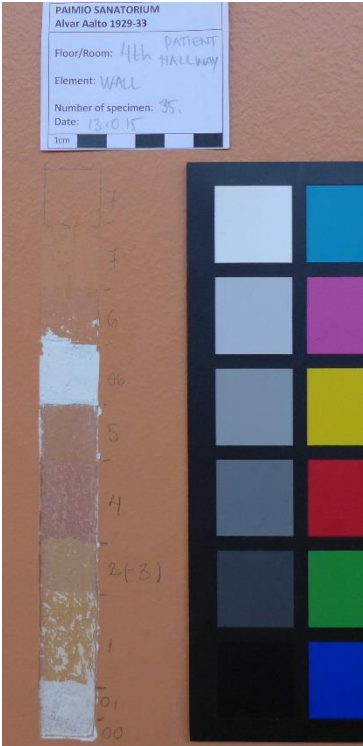
Patient Ward, Main Hallway

Number of Sample 35	Subject Paimio Sanatorium	Building / Space / Surface Main building 4 th Floor	
Architect, building year Alvar Aalto, 1929-33	Researcher, date Elina Riksmann, June-Dec. 2015, Alvar Aalto-foundation	Patient wing, main hallway Wall (the wall with doors leading to patient rooms)	
Most significant repairs and changes of the space, dates 1970's ventilation system brought casing of the pipes and electric cords in the ceiling. Doors and their sizing has changed, broader painted wooden doors have replaced the original wooden doors with lacquered surfaces. The lighting and fixtures have also been replaced.			
Photograph, drawing

Layers of Sample 00 Plaster 01 Filler 1 Orange, ochre 2040-Y30R 2-3 Brown 3020-Y30R 4 Red 3030-Y50R 5 Ochre 3030-Y50R 06 White light weight filler 6 Red 3040-Y60R 7 Red 2030-Y40r or 2030-Y50R	
Observations, remarks, e.g. pigment, adhesive, type of paint, material analysis: 1st layer: Oil paint

Technique used to make and take Samples, Circumstance in site, Lighting: Carved color steps on surface, crater technique, daylight + fluorescent lamps	Color chart in use: NCS Teknos 2004 Color codes are written without the NCS prefix.	Type of Sample, Place of Storage: Cross-section sample 35. Alvar Aalto Foundation Helsinki.	Floor plan, Location of Sample

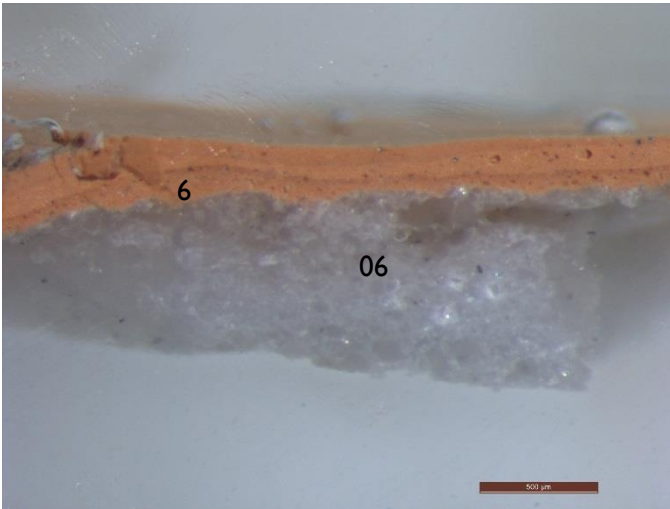
The sample no. 35 broke in two parts: the picture below shows the undermost layers.

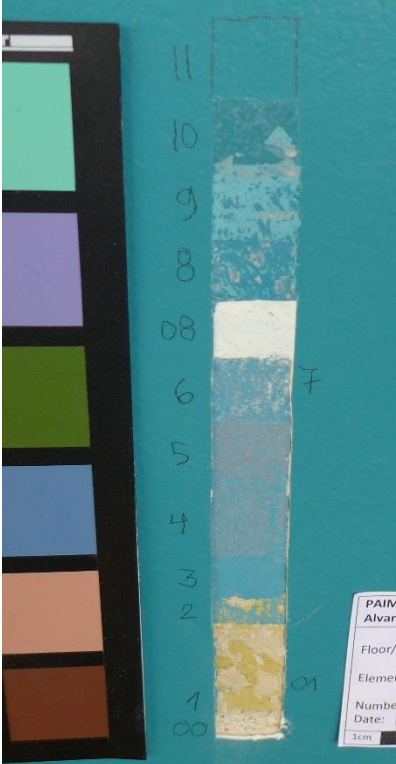
Patient Wing, Main Corridor

Subject Paimio Sanatorium 79	Building / Space / Surface Main building 5 th Floor	
Researcher, date Elina Riksmán, June-Dec. 2015, Alvar Aalto- foundation	Patient wing, main corridor Wall (wall with doors leading to patient rooms)	
Most significant repairs and changes of the space, dates Patient rooms have been fully renovated during 1970's as the hospital technique (i.e. different types of gases, electricity) and all of the surfaces, HVAC-technique and furniture were redone. Original ceiling radiators were removed and ceilings painted (but not hidden under dropped ceiling structures). Wallcoverings and flooring were replaced. Original furniture was removed.		
Photograph, drawing

Layers of Sample 00 01 Filler 1 Yellow, oil paint, 1040-Y10R 2 Blue 3030-B10G 3 Blue 3040-B10G 4 Blue 4020-B10G 5 Violet blue 4020-R80B 6 Blue 2050-B 7 Blue 4030-B10G	
Observations, remarks, e.g. pigment, adhesive, type of paint, material analysis: 1st layer: Oil paint	08 Filler, white light weight 9 Light blue 1040- B20G 10 Petrol Blue 4550-B20G 11 Blue 3050-B30G

Color chart in use: NCS Teknos 2004 Color codes are written without the NCS prefix.	Type of Sample, Place of Storage: Cross-section sample 79, Alvar Aalto Foundation Helsinki. Scale 500 µm.	Floor plan, Location of Sample

The sample no. 79 was broken into two parts, the undermost layers shown here below. The cross section sample clearly shows a rather thick yellow paint layer that has been painted on white filler. This same undermost yellow layer is also found in the ward walls in 2nd and 5th floors. See second floor ward wall for further details addressing the yellow paint.

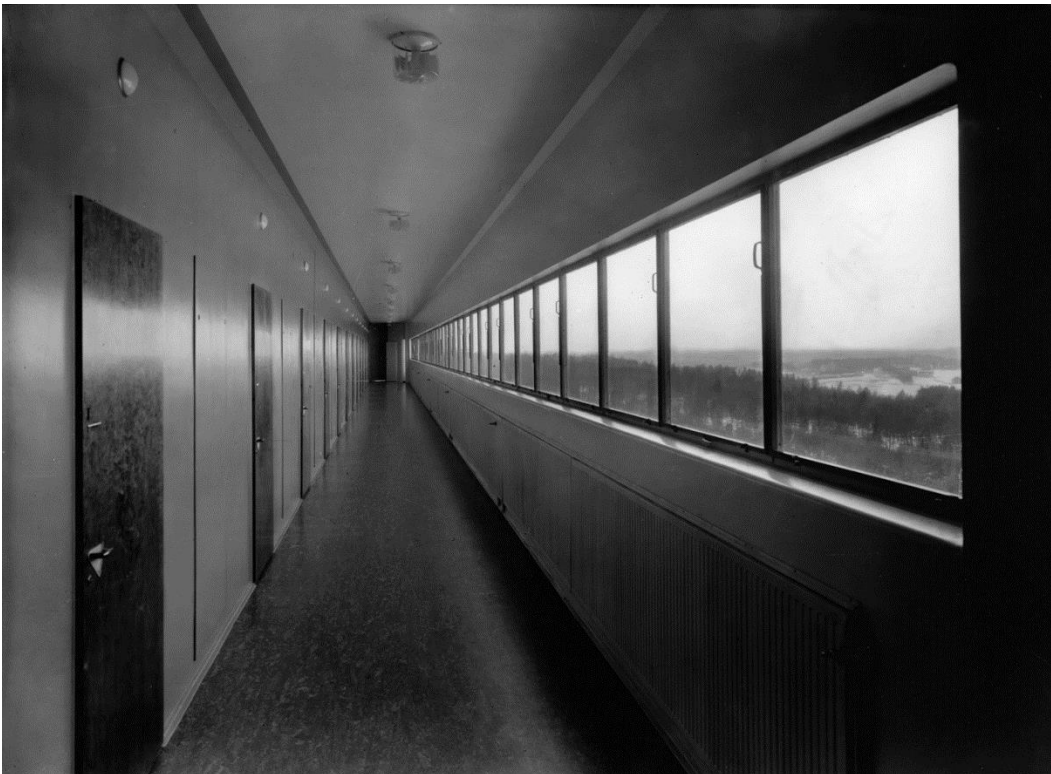
The black and white photograph below states the interior of sixth floor ward after the completion of main building in 1933. The flooring is heavy patterned rubber.

Ward corridor of 5th floor presents the original look and confining of color. Notice the corners of walls and ceiling, the original radiators, laquered doors and linoleum flooring. AAM. Sign. 50-003-328.

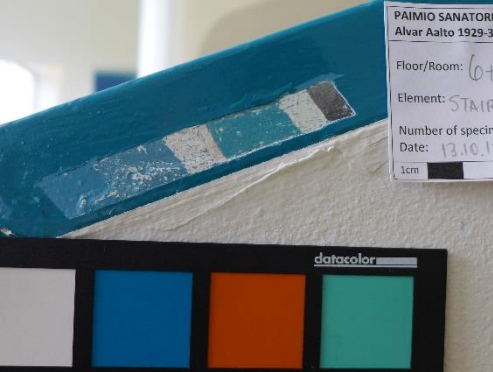
5th floor, Main Staircase, Handle

Number of Sample 80	Subject Paimio Sanatorium	Building / Space / Surface Main building 5th Floor Main staircase, handrail Ceiling	
Architect, building year Alvar Aalto, 1929-33	Researcher, date Elina Riksmann, June-Dec. 2015, Alvar Aalto-foundation		
Most significant repairs and changes of the space, dates Patient rooms have been fully renovated during 1970's as the hospital technique (i.e. different types of gases, electricity) and all of the surfaces, HVAC-technique and furniture were redone. Original ceiling radiators were removed and ceilings painted (but not hidden under dropped ceiling structures). Wallcoverings and flooring were replaced. Original furniture was removed.			
Photograph, drawing

Layers of Sample 00 Iron 1 White 0502-Y 2 Blue 3040-B20G 3 White 4 White 5 Blue 4030-B10G 6 Blue 3040-B10G 7 Blue 4040-B30G	
Observations, remarks, e.g. pigment, adhesive, type of paint, material analysis: 1st layer not determined.

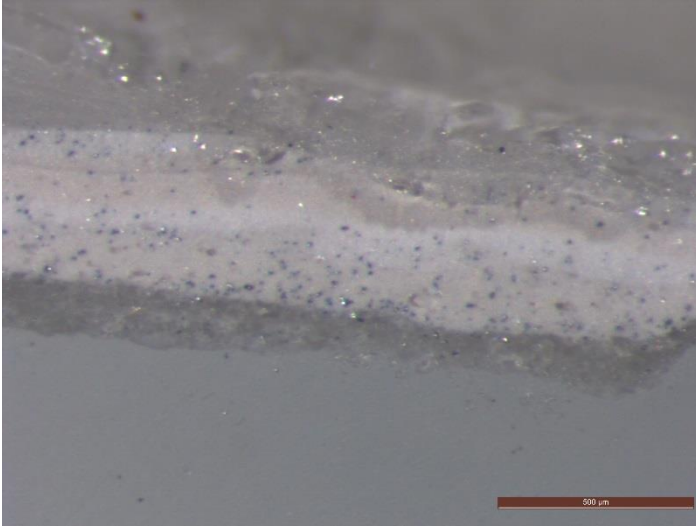
The cross section samples no. 82 and 83 gave a poor result. Neither gave the information needed. Excavation work gave better results. All things considered the grey area and its' original size researched on the pilaster was not thoroughly determined.

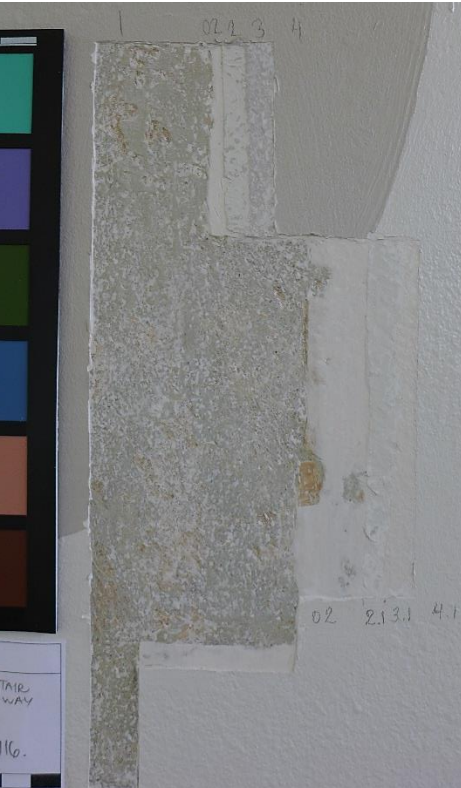
Main Staircase, Wall Behind Stair Handrail

Number of Sample 117	Subject Paimio Sanatorium	Building / Space / Surface Main building 6th Floor	
Architect, building year Alvar Aalto, 1929-33	Researcher, date Elina Riksmann, June-Dec. 2015, Alvar Aalto-foundation	Main staircase Wall, an area of grey paint on white painted wall.	
Most significant repairs and changes of the space, dates Main stair has had a few changes. The flooring has been changed from the original yellow rubber flooring to new material. The last change of flooring was made only in the 1990's. Walls have been painted. The main stair's middle handrail has had a recent change as clear screens were attached between railings to protect visiting children. Hand railings are original on both sides of stairs. No dropped ceiling structures have been installed, ceilings of main stairway have only been painted during many renovations.			
Photograph, drawing

Layers of Sample, WHITE AREA 00 Plaster 02 Filler 2.1 White 1002-G50Y 3.1 White 1002-Y50R 4.1 White 0300N Layers of sample. GREY AREA 00 plaster 1 Grey 2005-G80Y or 3005-G80Y

Observations, remarks, e.g. pigment, adhesive, type of paint, material analysis: Grey undermost paint: oil paint.		02 Filler 2 White 0500-N 3 Grey 1502-Y50R 4 Grey 1502-Y	
Technique used to make and take Samples, Circumstance in site, Lighting: Carved color steps on surface, crater technique, daylight + fluorescent lamps	Color chart in use: NCS Teknos 2004 Color codes are written without the NCS prefix.	Type of Sample, Place of Storage: No sample.	Floor plan, Location of Sample

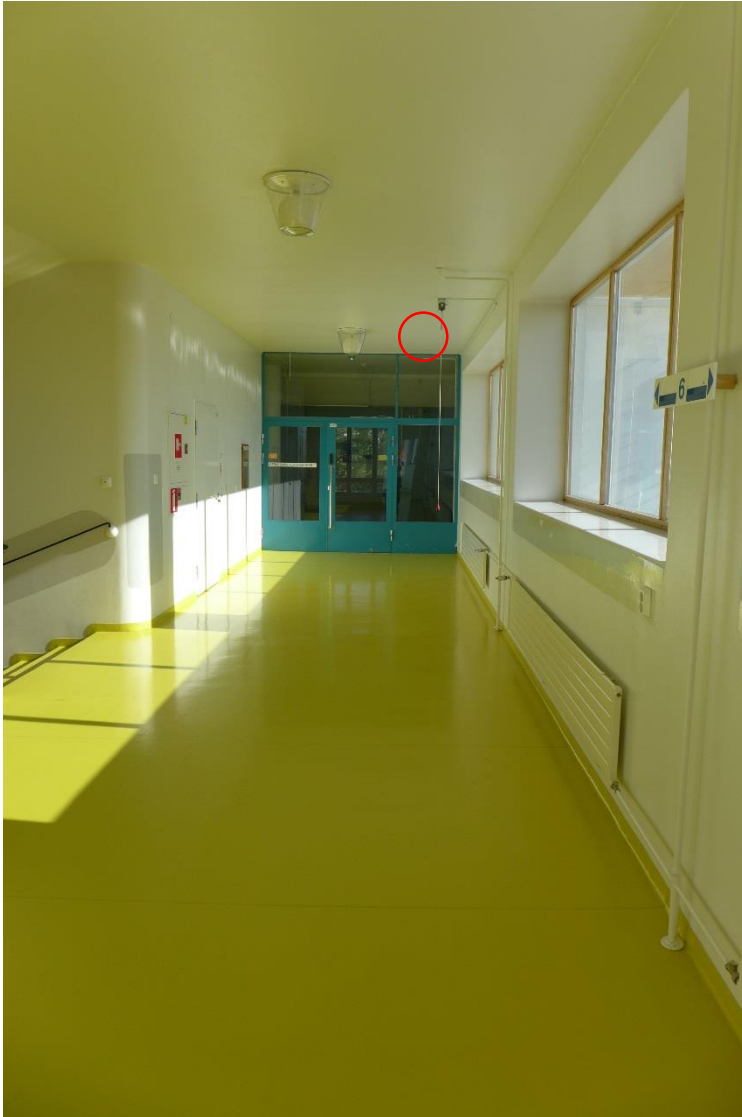
The ceilings of main staircase corridors were researched throughout the floors from ground floor to 5th by taking cross section samples. All samples showed white and beige neutral colors. Below are three examples from the cross section samples taken from the ceilings of main halls in each floor.

The fifth floor main staircase. The spot where cross section sample was taken.

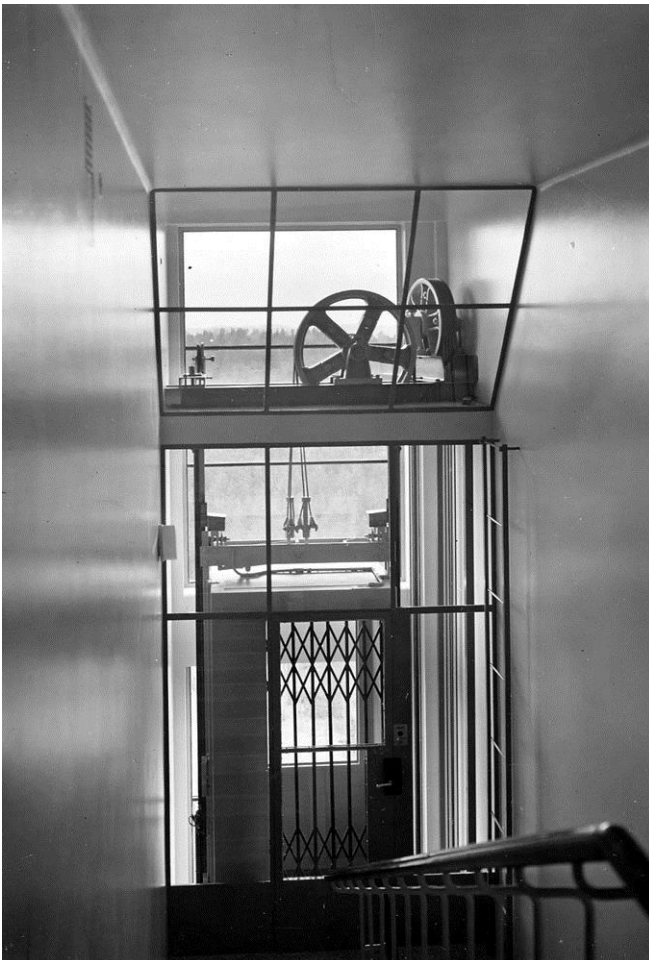
The original elevator in the west end of the ward wing is still in its place. The Elevator car and technique are well preserved and fully functioning. The elevator is still in use, if not daily, but by the tourist groups that visit the main building. They ride it down from the scenery balconies down to the first floor ward. The elevator shafts west wall is mainly glass, hence the nickname Scenic elevator.

Original look of the elevator. AAM. Sign. 50-003-

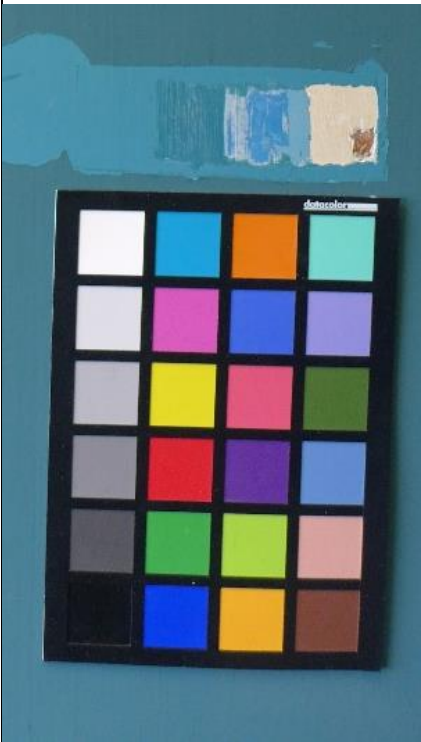
Elevator Car

Number of Sample	Subject Paimio Sanatorium	Building / Space / Surface Main building The west elevator of wards	
Architect, building year Alvar Aalto, 1929-33	Researcher, date June-Dec. 2015, Alvar Aalto- foundation	The elevator car walls RESEARCH POINT MADE IN YEAR 2000 COLOR RESEARCH	
Most significant repairs and changes of the space, dates The elevator car is original. The ceiling light fixture of the elevator has been changed at some point. The front wall surrounding of every floor elevator door was originally made of glass. It was been changed to metal board. The button board inside the car has also been changed.			
Photograph, drawing

Layers of Sample 00 0 1 White 1010-Y10R, base coat 2 Blue 2030-B10G
