ALVAR AALTO FOUNDATION

PAIMIO SANATORIUM COLOR RESEARCH 2015

PART I/2 Main Building

Elina Riksmán

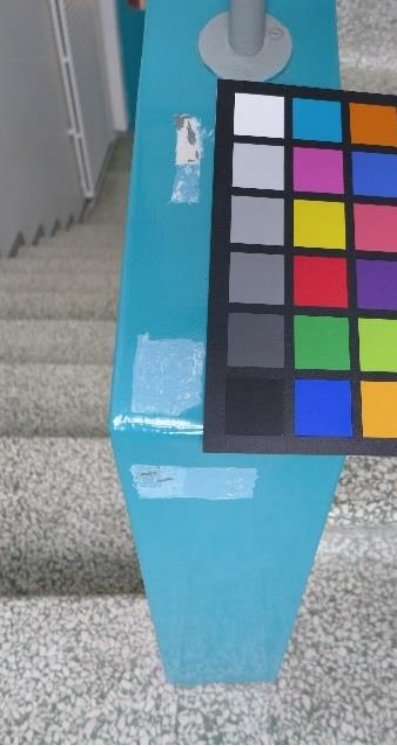
Number of Sample	Subject Paimio Sanatorium	Building / Space / Surface Main building 3rd Floor Ward The West Staircase	
Architect, building year Alvar Aalto, 1929-33	Researcher, date June-Dec. 2015, Alvar Aalto- foundation	The handrail, metallic base RESEARCH POINT MADE IN YEAR 2000 COLOR RESEARCH	
<p>Most significant repairs and changes of the space, dates</p> <p>The elevator car is original. The ceiling light fixture of the elevator has been changed at some point. The front wall surrounding of every floor elevator door was originally made of glass. It was been changed to metal board. The button board inside the car has also been changed.</p>			
<p>Photograph, drawing</p>

<p>Layers of Sample</p> <p>00 Metal</p> <p>0</p> <p>01 White 1010-Y30R, base coat</p> <p>1 Blue 3040-B30G

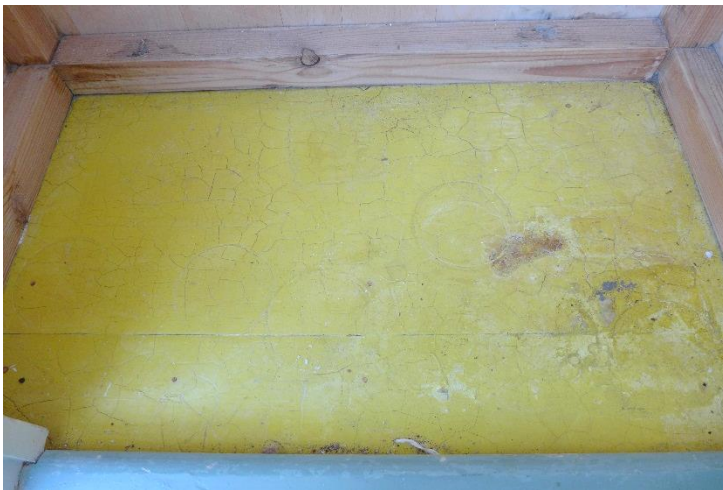
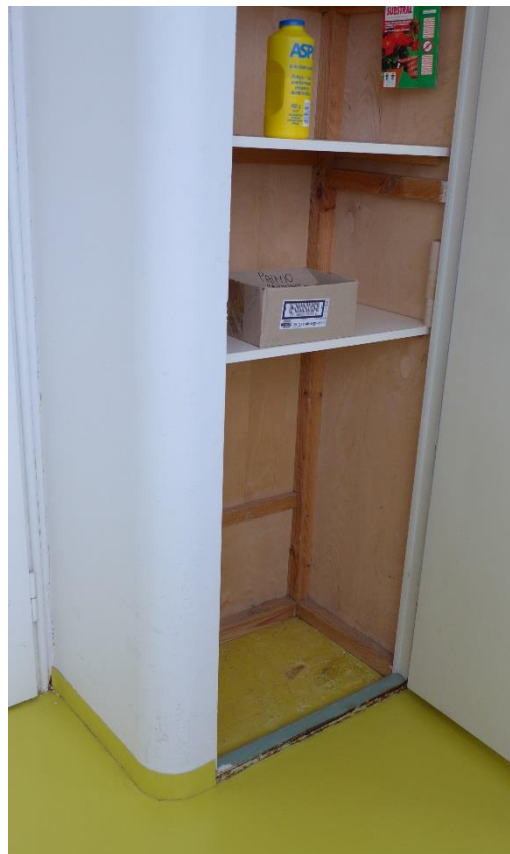
The original fragment of yellow flooring in comparison to the renewed flooring surrounding the cupboard.

The yellow flooring was originally specially made, a hue that was not available in catalogs. In an interview from 1986 Eino Kauria tells that soon after the order for the yellow flooring was made, Aalto had some grave second thoughts about the color yellow. At that point it was impossible to cancel the order. According to Kauria, Aalto himself stated that the chosen yellow color was a mistake.

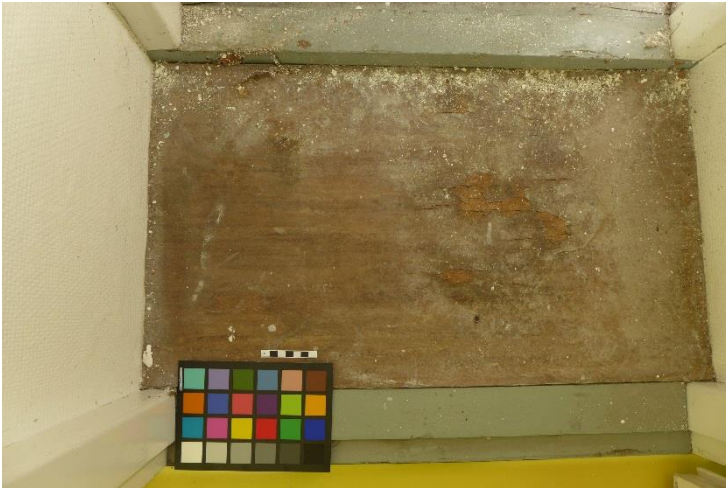
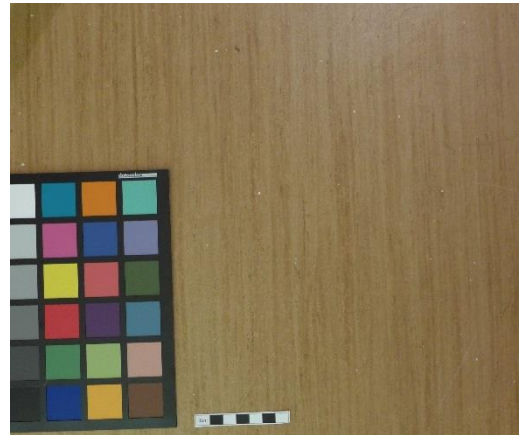
Other flooring fragments beside the original yellow, found in Paimio main building, have no resembles to the marmoleum patterned linoleum floorings seen in the photographs that present the original state of the dining hall, lounge or ward corridors. This brown linoleum at the middle, left, found in a drought lobby of a balcony in second floor main building, has somewhat heavy but straight pattern, and it is presumably a later linoleum from 1940's or 1950's. The same flooring, in a better condition is found in the second floor of former engine room for the cinematography technique.

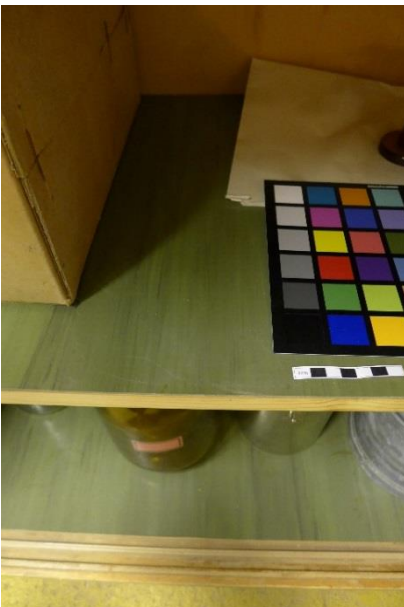
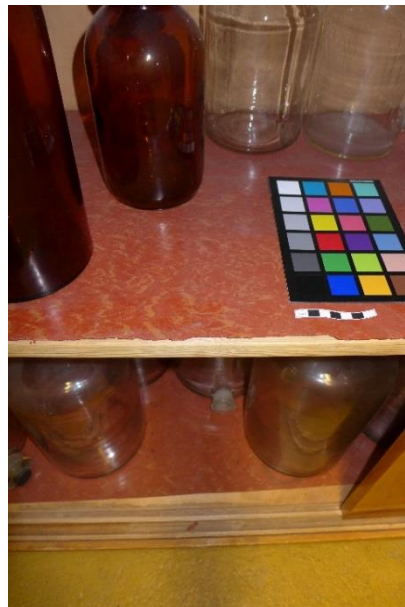
The two floor samples seen below were found inside old cupboards in the hospital's staff building from the 1950's (by architect Lauri Sipilä). The fragments have been used for covering the cupboard shelves. The red sample shows some resembles to the original 1930's type of linoleum with marmoleum pattern. Green flooring sample covering another cupboard shows a slightly more modern pattern and material. The green fragment is probably from the 1950's.

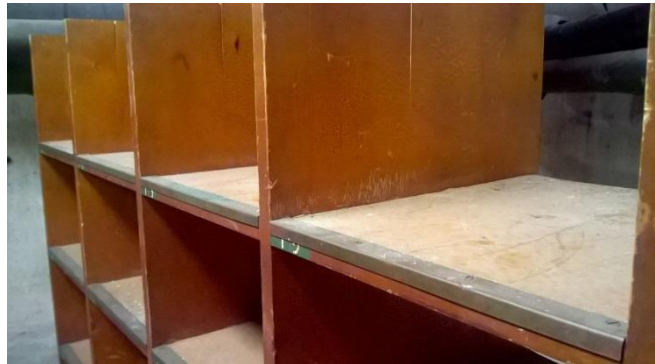
The linoleum type flooring was also used to protect some heavy duty furniture like the original shoe shelves that were originally situated in the entrance hall. The flooring matt seems to have a pattern typical in 1940's so it has likely been installed during the 1948 renovation to cover up some detrition of the shelves. This flooring has not been found in any other location in the main building nor in the other buildings in the hospital area. nor shown in any photographs found.

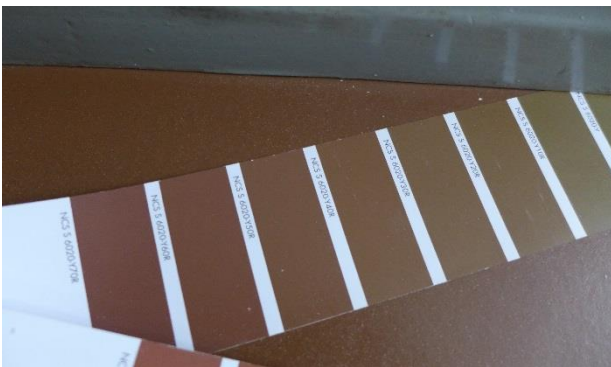
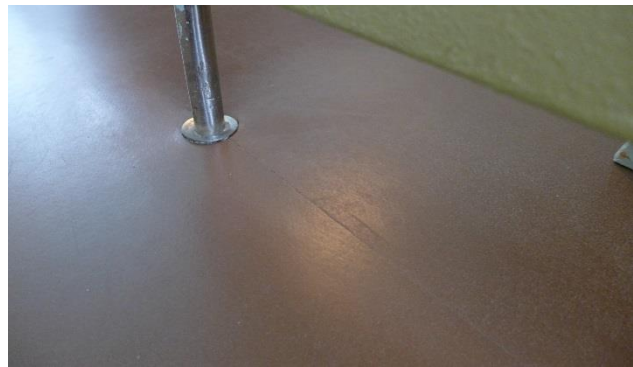
Museum Room Flooring Today

The deep brown linoleum flooring of the ground floor museum room showed at the left, is probably not the original flooring of a patient room as it is in such good, resilient condition and shows vibrant uniform color throughout the room. The color code of this flooring is something between the two NCS color codes

NCS S 6020-Y50R and 6020 Y60R.

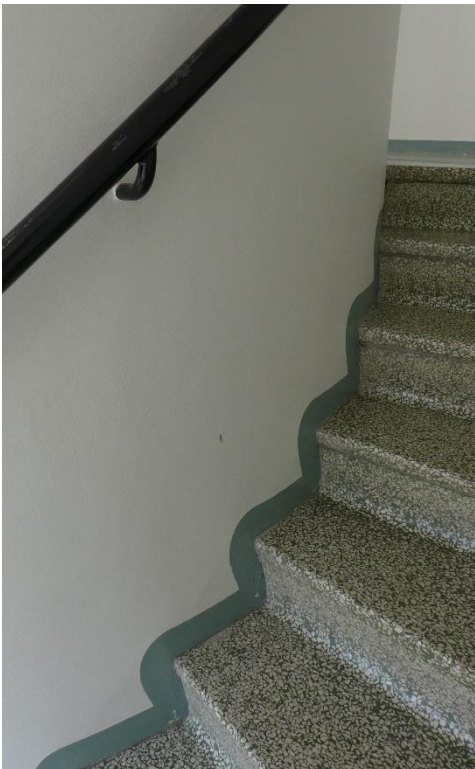
The stairs climbing around the chimney of C-wing.

The mosaic concrete steps of these stairs were pre-produced modules and they were installed on site. The color of all three stairs was the same: the base concrete mixture had a deep color of green with 3mm to 15mm sized white stone grains. The NCS color codes for the green are

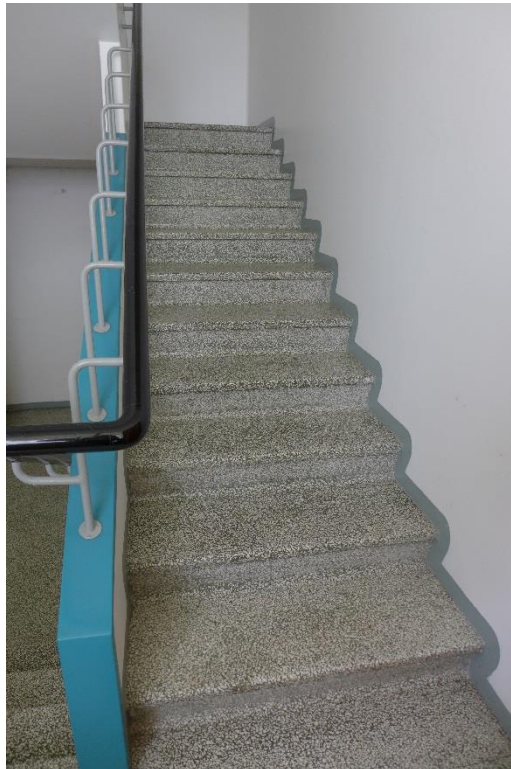
The staircase in the east end of the wards.

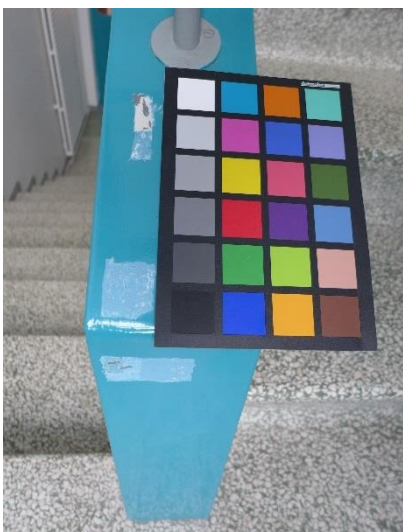
The staircase with panoramic lift, in the west end of the wards.

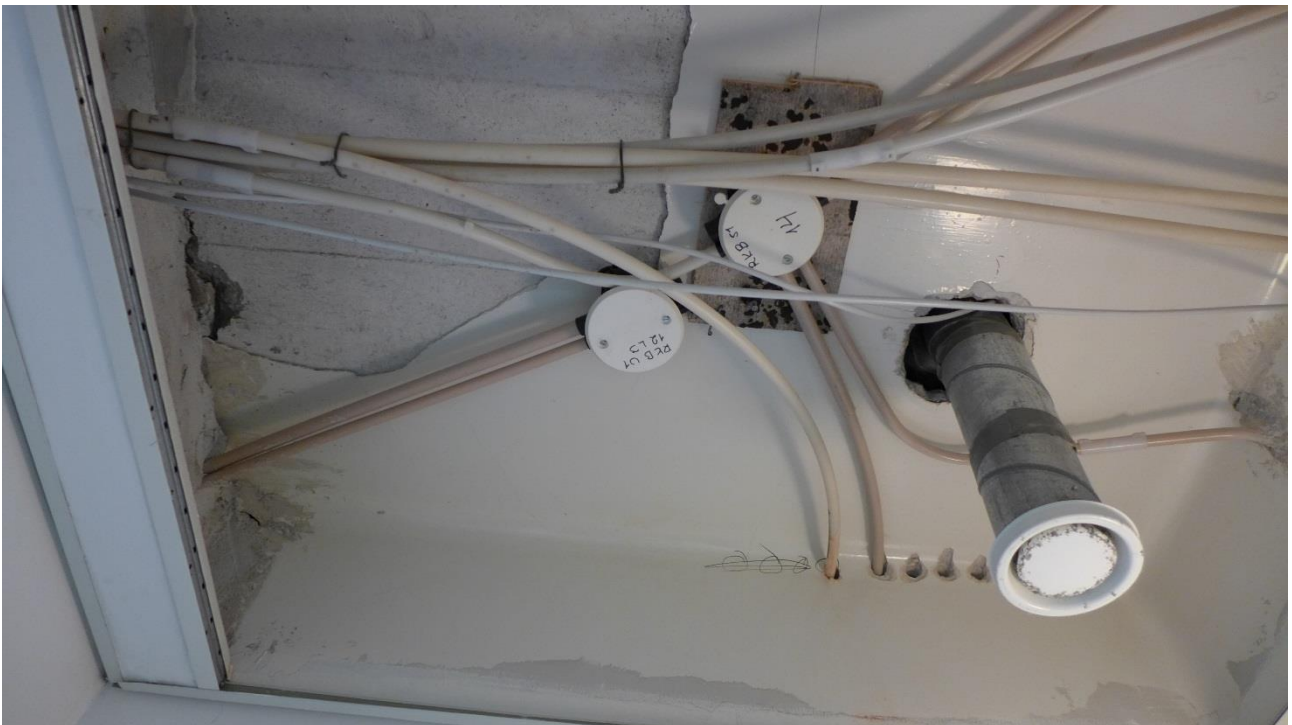
An original ceiling fragment in one of the 4th floor toilets, above the dropped ceiling structure hiding the 1970's and later HVAC-installations. The gloss of this fragment is not as distinctive as it probably has been in more important spaces like entrance hall or lounge in the first floor.

A vast number of the spaces today have a dropped ceiling structure to cover HVAC-systems installed during 1970's renovation (mainly ventilation pipes but also later electrical installations have been fitted inside these structures). These structures cover the whole original ceiling or just parts of it. In some rare cases the original ceiling was still left as a fragment above these structures, but mainly the ceilings had only new, few layers as the original surface had been sand blasted off, or otherwise removed in earlier renovation. The problem of the glossy paint surfaces produced on calcium plastering was that they had the tendency to detach from the ceiling as it is visible in the picture below.

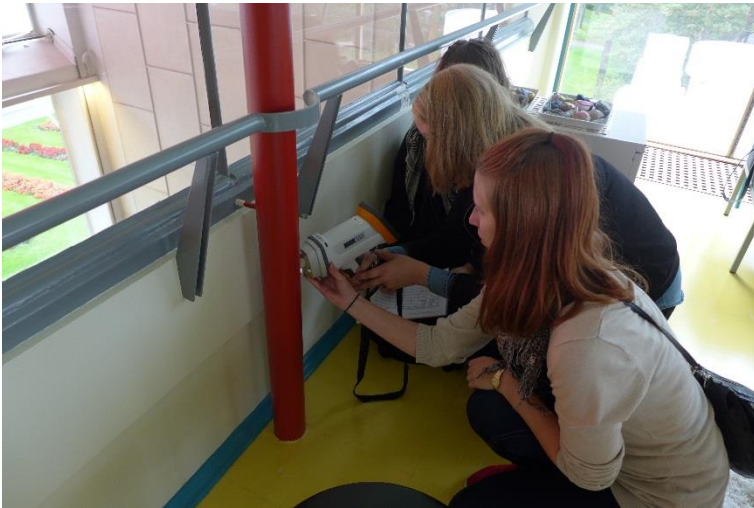
The conservation students from Metropolia University of Applied Sciences measure Reading room columns with the guidance of chemist and lecturer Krista Hackzell (in front).

The X-ray Fluorescence (XRF) measurements were made in selected research points in the reading room of second floor and in the museum room of ground floor. Mainly first layers were measured to achieve data from the assumed first and original layers of paint. The aim was to gather data from paints to find out if these materials contained toxic elements as Lead (Pb) or Arsenic (As).

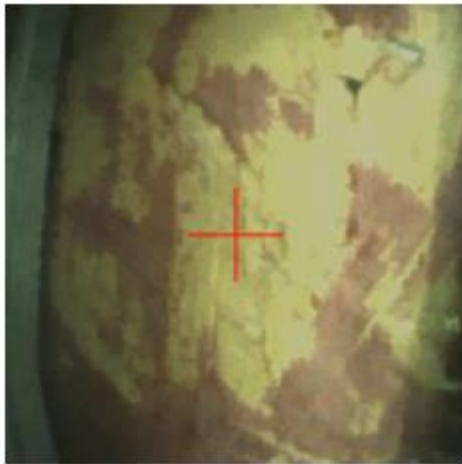
Nimi	Luokka	Päivämäärä	Kellonaika	Kesto			
kirjasto punainen 3 krs keltainen	Soil_LE_FP	7.9.2015	15.01.54	20,5 s			
Alkuaine	Zn ppm	S ppm	Ti ppm	Pb ppm	Si ppm	Ba ppm	Cl ppm
±	367139 717	74520 738	51650 285	50192 490	44216 1735	26752 888	22110 440
Alkuaine	Ca ppm	Fe ppm	V ppm	Cr ppm	Sr ppm	Mn ppm	Ta ppm
±	19428 267	14786 231	13557 1177	4658 1191	4304 70	950 172	636 130
Alkuaine	Co ppm						
±	415 72

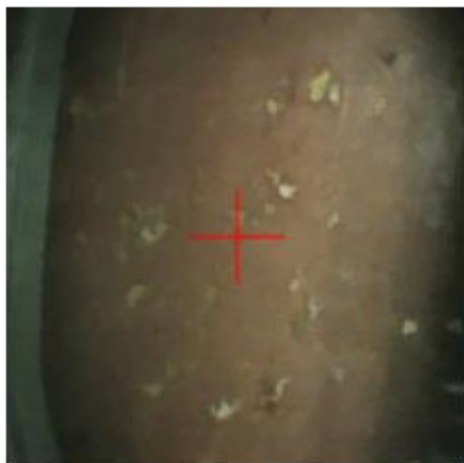
Reading room, red iron columns, third layer, red

Nimi	Luokka	Päivämäärä	Kellonaika	Kesto			
kirjasto punainen 3 krs punainen	Soil_LE_FP	7.9.2015	15.06.03	20,5 s			
Alkuaine	Zn ppm	S ppm	Ti ppm	Pb ppm	Si ppm	Ba ppm	Ca ppm
	343118	90489	57583	50054	34118	31350	29420
±	692	782	304	475	1496	907	323
Alkuaine	Cl ppm	Fe ppm	V ppm	Sr ppm	Mn ppm	Ta ppm	Co ppm
	28197	17650	14593	4985	1332	629	260
±	471	254	1276	72	169	143	70

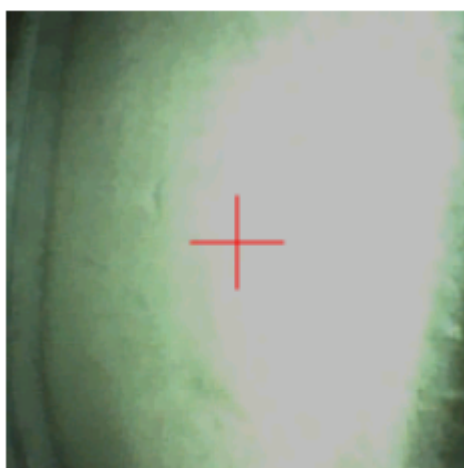
Nimi	Luokka		Päivämäärä	Kellonaika	Kesto		
museuhuone 1. karmi 1	Soil_LE_FP		7.9.2015	16.14.01	20,6 s		
Alkuaine	Zn ppm	Cl ppm	Pb ppm	Fe ppm	S ppm	K ppm	Ca ppm
	543240	58974	52808	27566	10401	8482	8475
±	881	611	574	270	328	265	207
Alkuaine	Ba ppm	Si ppm	Ti ppm	V ppm	Ta ppm	Cd ppm	Co ppm
	6885	6760	5320	2256	1535	1219	722
±	661	1096	104	486	156	147	72
Alkuaine	Mn ppm	Sr ppm					
	412	138					
±	113	42
