# PAIMIO SANATORIUM COLOR RESEARCH 2015

PART 2/2

Chief Physician's Villa, Sub Physicians' Row House Apartment, Staff Apartment  
House and Rose cellar – the Morgue

Elina Riksman

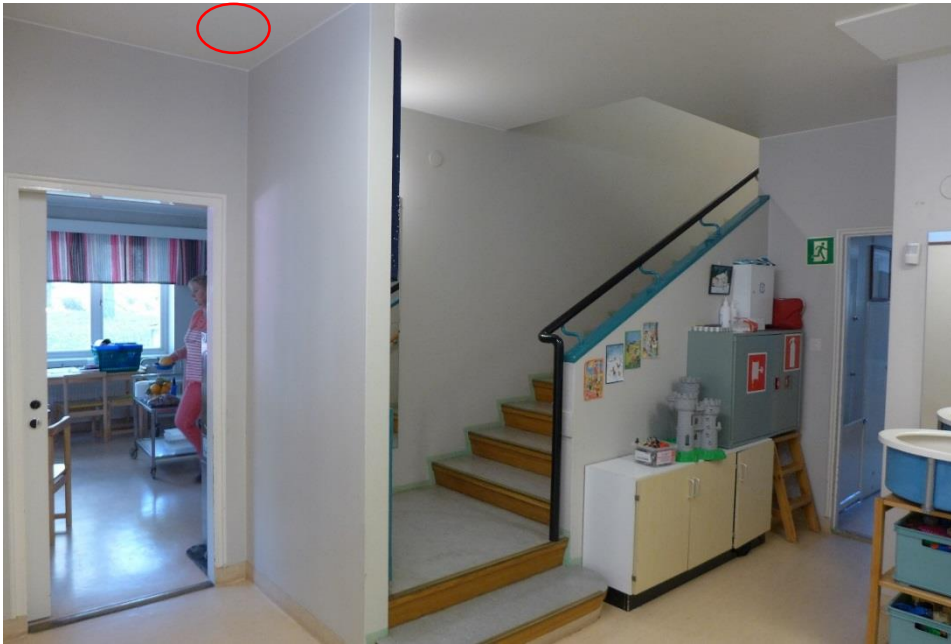
Sample 126 was taken from the lobby ceiling.

7The ceiling of the lobby has always been painted white according to the cross section sample 126.

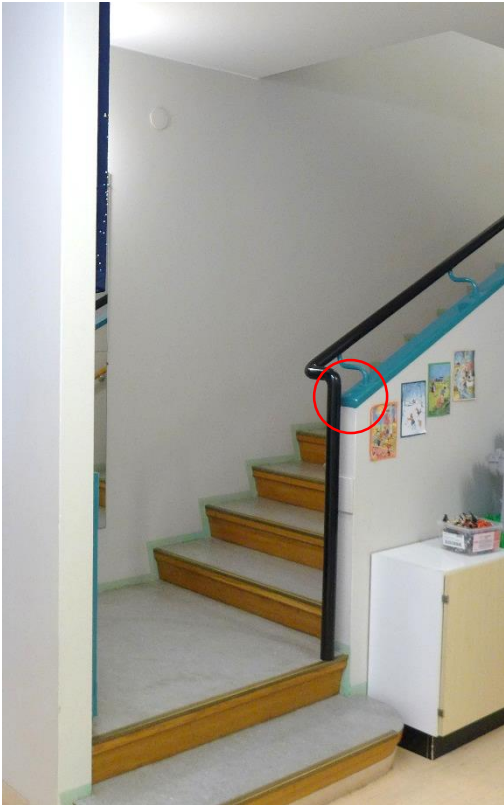
The cross section sample 129 showed the light blue original paint coat of the hand railing. The black wooden hand rail had three black layers of paint, original being also black.

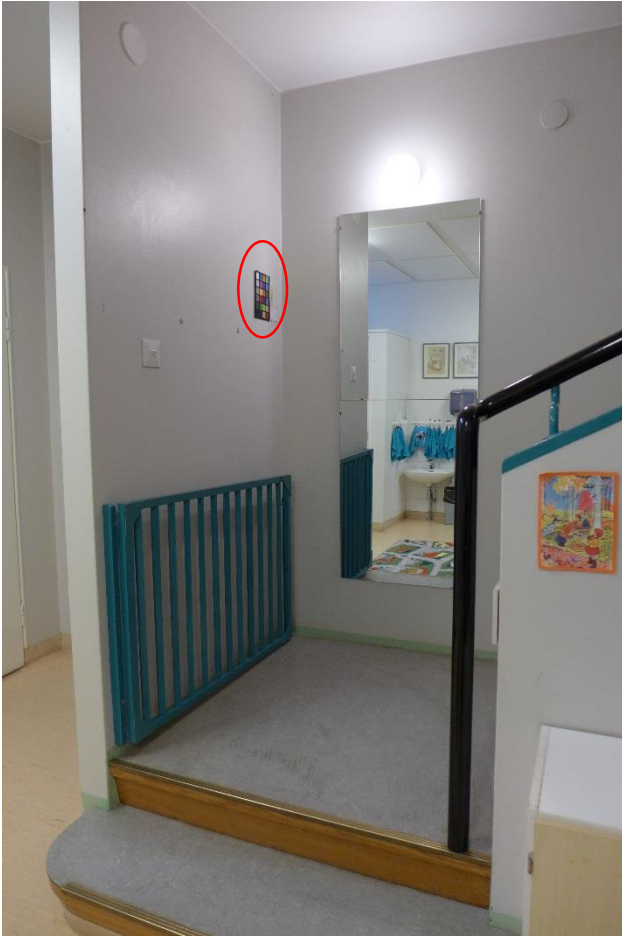
The wall of the stairway and surrounding walls in the lobby have been painted in rich brown – orange oil paint. The undermost layers are white and the perception is that the white layer 01 is only a base coat. It is also possible that the white was used under the orange to give it a slightly brighter look as oil paints were sometimes used in layers to affect the surface color look. With a white layer underneath, the deep surface color adapted a more bright and “luminous” look.<sup>5</sup>

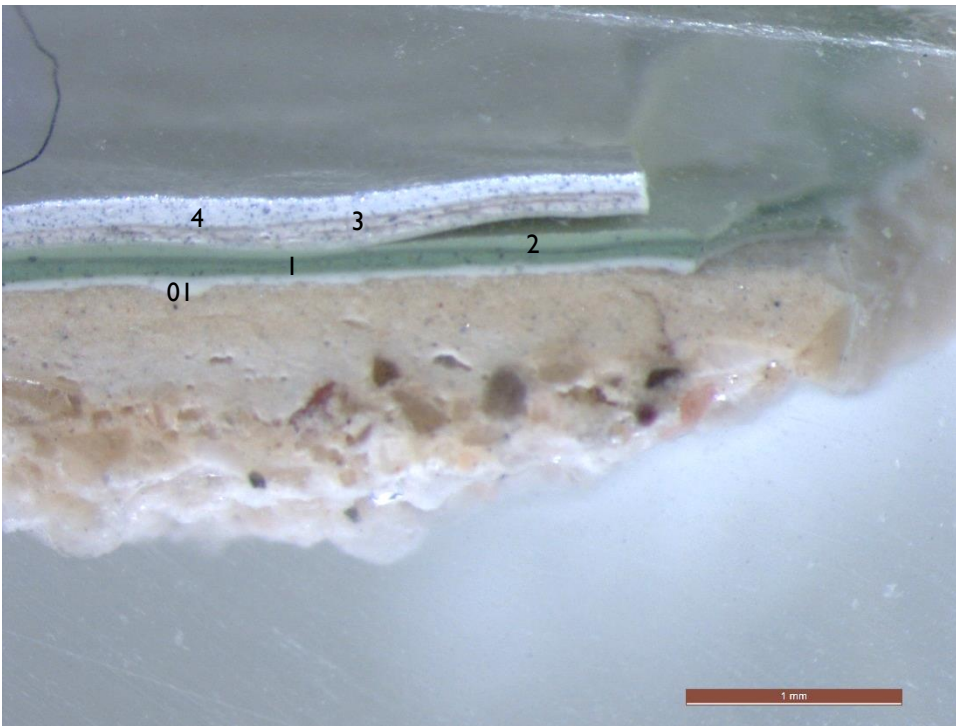
Sample 136. Scale 1mm.

The sample no 136 taken from the lobby wall next to the doorways of dining hall and former kitchens had green undermost layers, that have the same hue as the ceilings in main building lounge. Similar green can also be found in the ceilings of some patient rooms in A-wing wards of the main building.

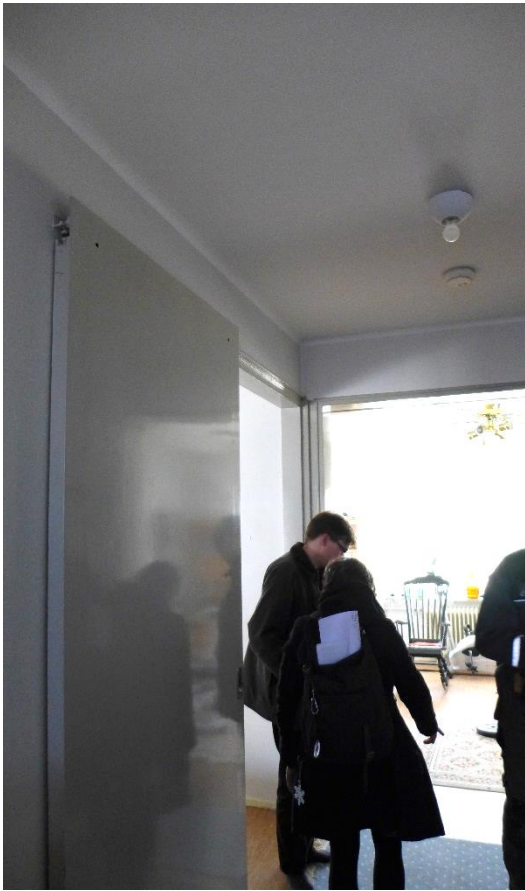
Sample 142. Lobby wall, taken behind the sliding door in the photograph at left. Scale 1mm.

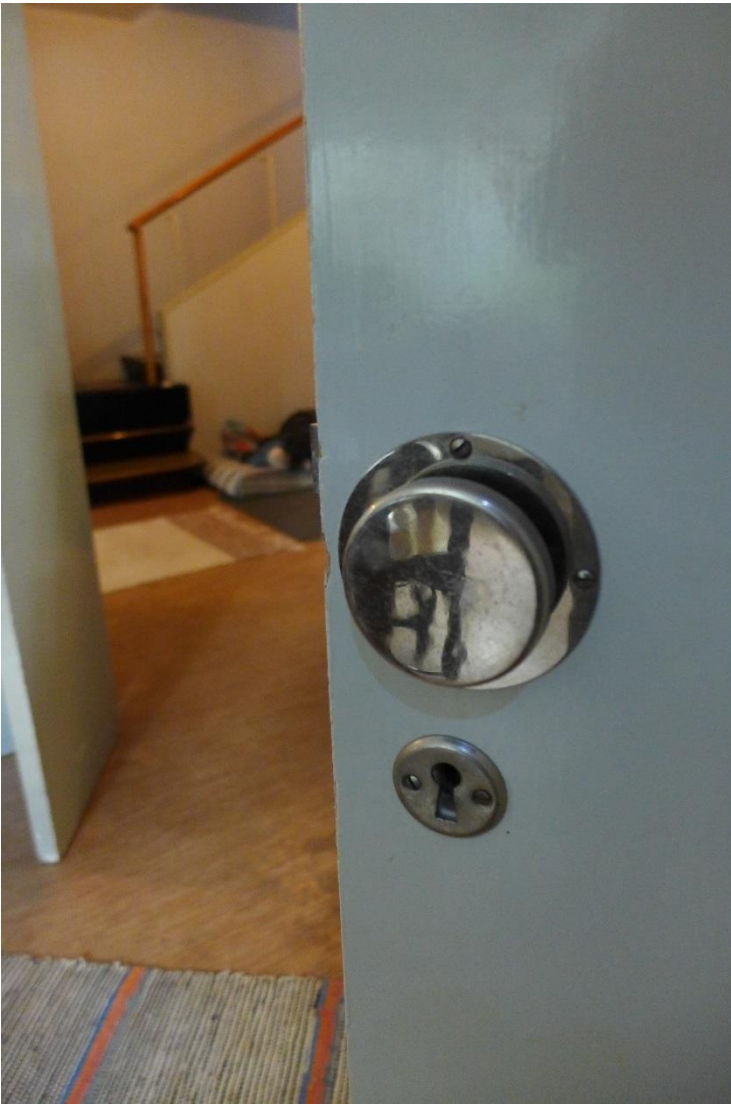
*A detail of the original sliding door between the lobby and living room.*

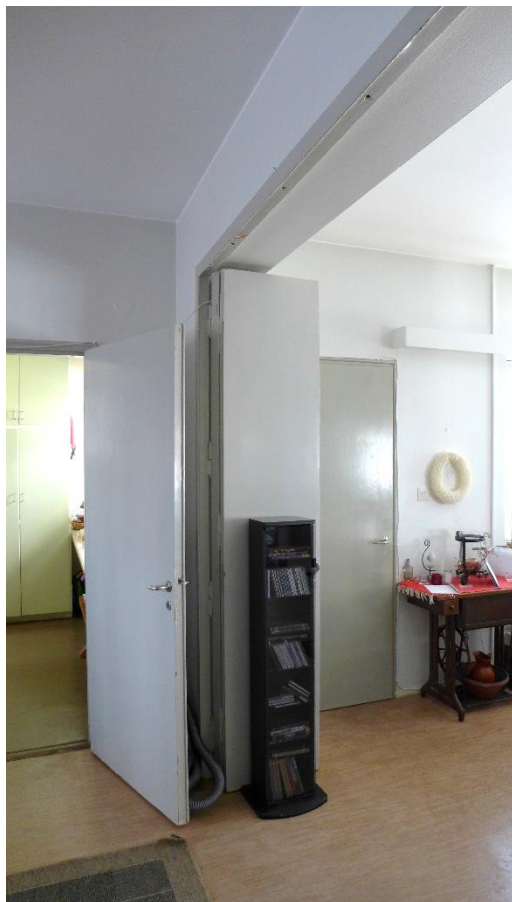
Floors of living and dining room are heavily patterned linoleum. Notice the large original folding doors dividing the rooms.

The flooring of Sub Physician's apartment today is linoleum. It is possible that some of the floorings are original. As no photographs nor maintenance documents of these apartments and their floors have been found, there are no proof of the originality of these floors.

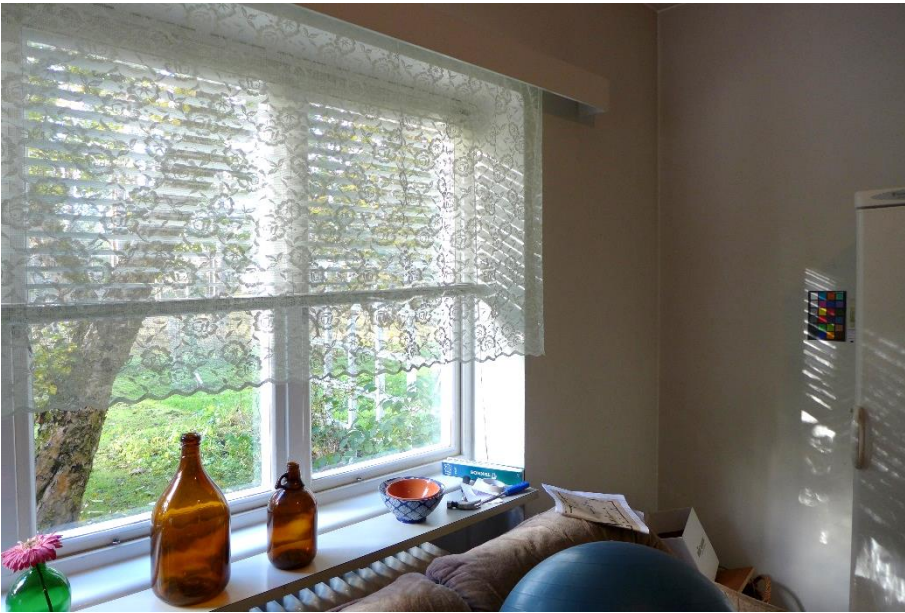
'As the picture below shows, the original living room wall color in one of the apartments has had a rich coloring. The difference between ceiling's white and the wall color is notable. It is possible that the second layer found in excavation (see picture in previous page chart), green, is the original color of the living room walls. The opposite side of the room showed same layers in carved crater excavations.

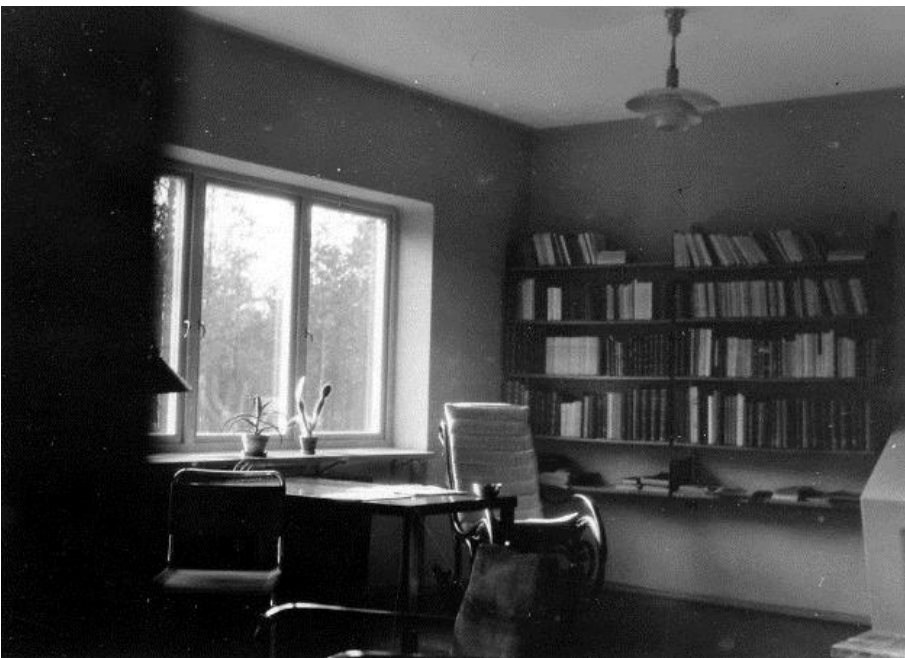
Sample 143 in two parts. Living room wall. Scale 1mm. Uppermost layers at the right.

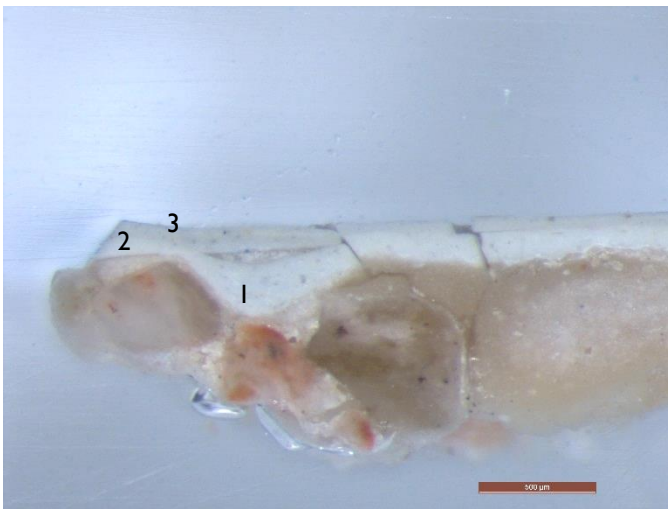
Sample 144. Dining room wall by the window. Scale 500μm. Sample broke in two parts, below are the undermost layers.

Undermost paint layer in the dining room is light green. The sample 144 does not have the same rich colors of green as the living room wall sample 143.

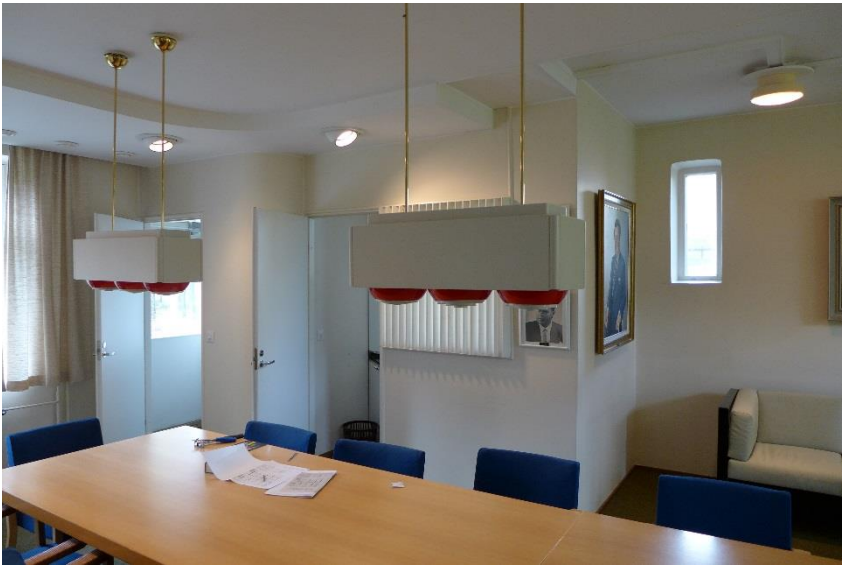
The former kitchenette cubicle seen in the picture at left, has gone through some changes in the 1980's renovation from staff housing to office space. It is the only one left of the kitchen cubicles in the staff house. The samples were taken from another point of the house, but from a similar spot. The results are white paint layers as undermost layers on both ceilings.

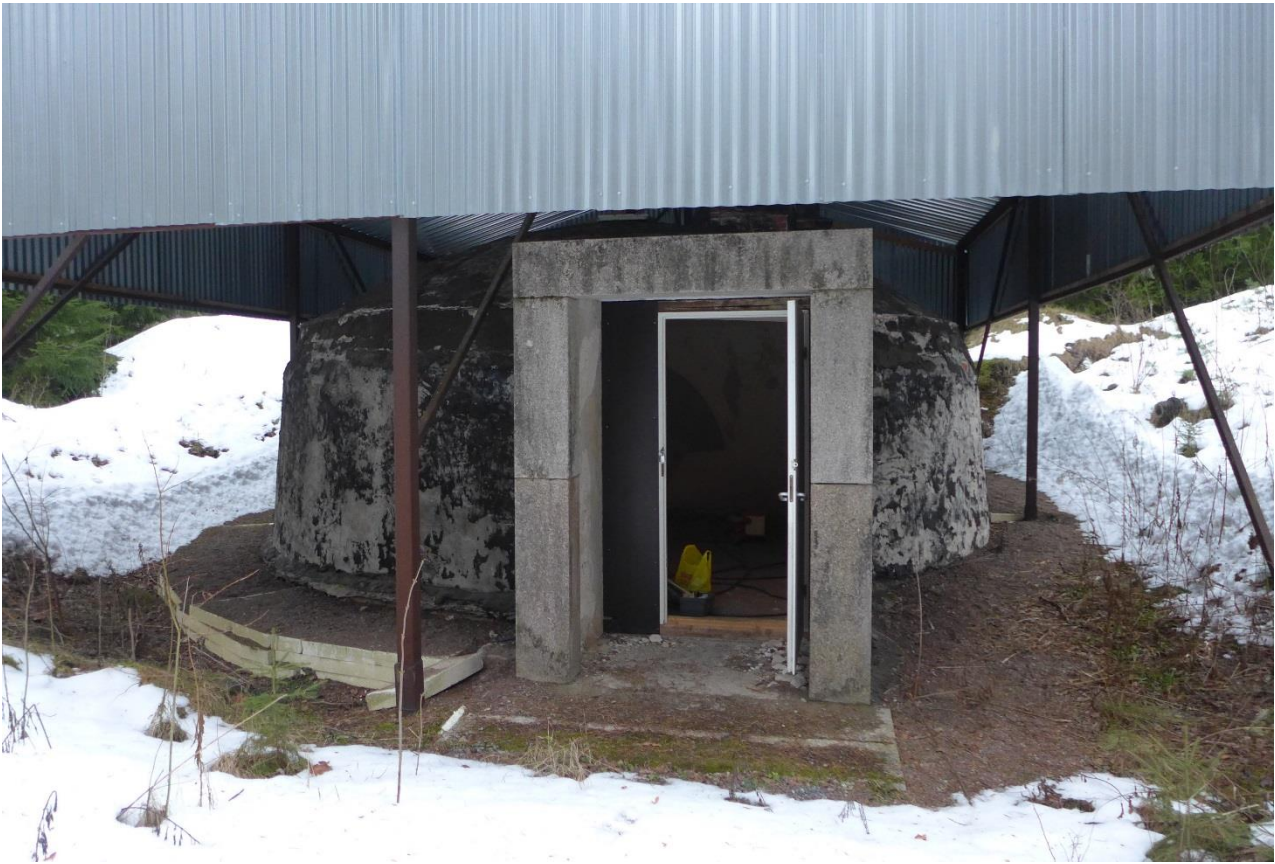
*The state of Rose cellar today. The masses of soil covering the dome have been removed. The original moisture insulation, the black tar-like coating has been scraped down to ensure further drying of the structure. The cellar has been covered with a temporary shelter to protect it from rain and subzero temperatures during 2005. The original door has been removed, stored and replaced by a temporary door. An underground drain has been installed around the dome to gather most of the water from the ground.*

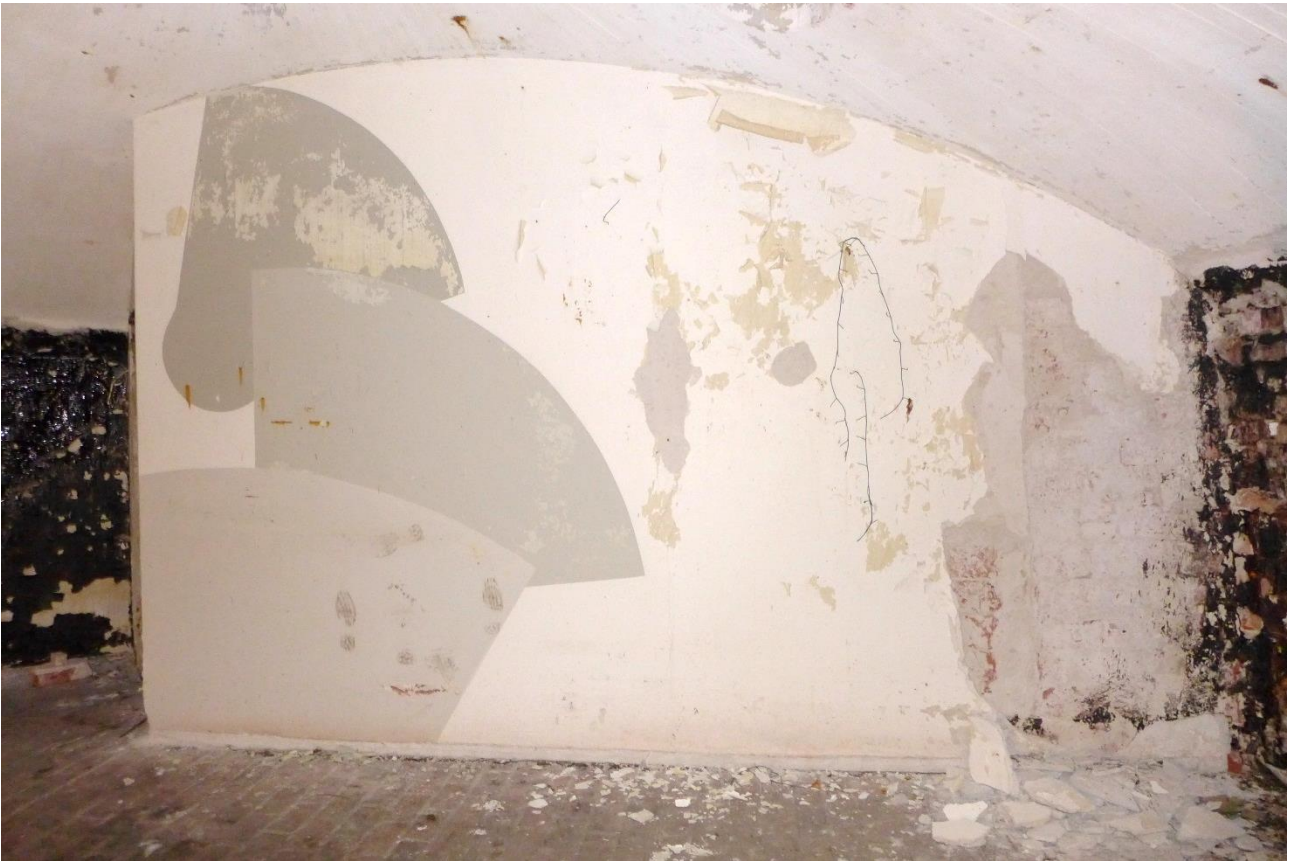
The mural on the wall dividing the round space is badly deteriorated due to humidity and subzero conditions of the cellar. The surface seems to be a traditional three-step calcium based plastering. Mural has an abstract matt, light colored painting that presents three different pastel colored, fan shaped areas overlapping each other. The right corner of the mural has been so badly deteriorated that the surface of the plastering has fallen off. Seems that this lost area did not carry any other color than the background color and not the actual theme of the mural.

The current state of the Rose Cellar mural. August 2015. The presumed original redbrick floor is now revealed after the peeling of concrete flooring. Black tar-like watertight coating has also been stripped partly to enhance the drying process of the water damaged wall structures.

The architectural office Laiho-Pulkkinen-Raunio, which has been involved in Paimio hospital renovation and development of the hospital area during 2000's, has planned and written instructions for the cellar's renovation and restorative work. This plan from year 2005 has been updated 2010. No operative work has yet taken place in the cellar, after the demolition of damaged structures (to start the drying process) in year 2005. At this time a digital hygrometer was installed to monitor the drying process of the cellar. Also a concrete research report has been made 2003. by a concrete, mural and plaster expert Thorborg von Konow as a part of a larger research project "The Analysis and Restoration of Historical Concrete".

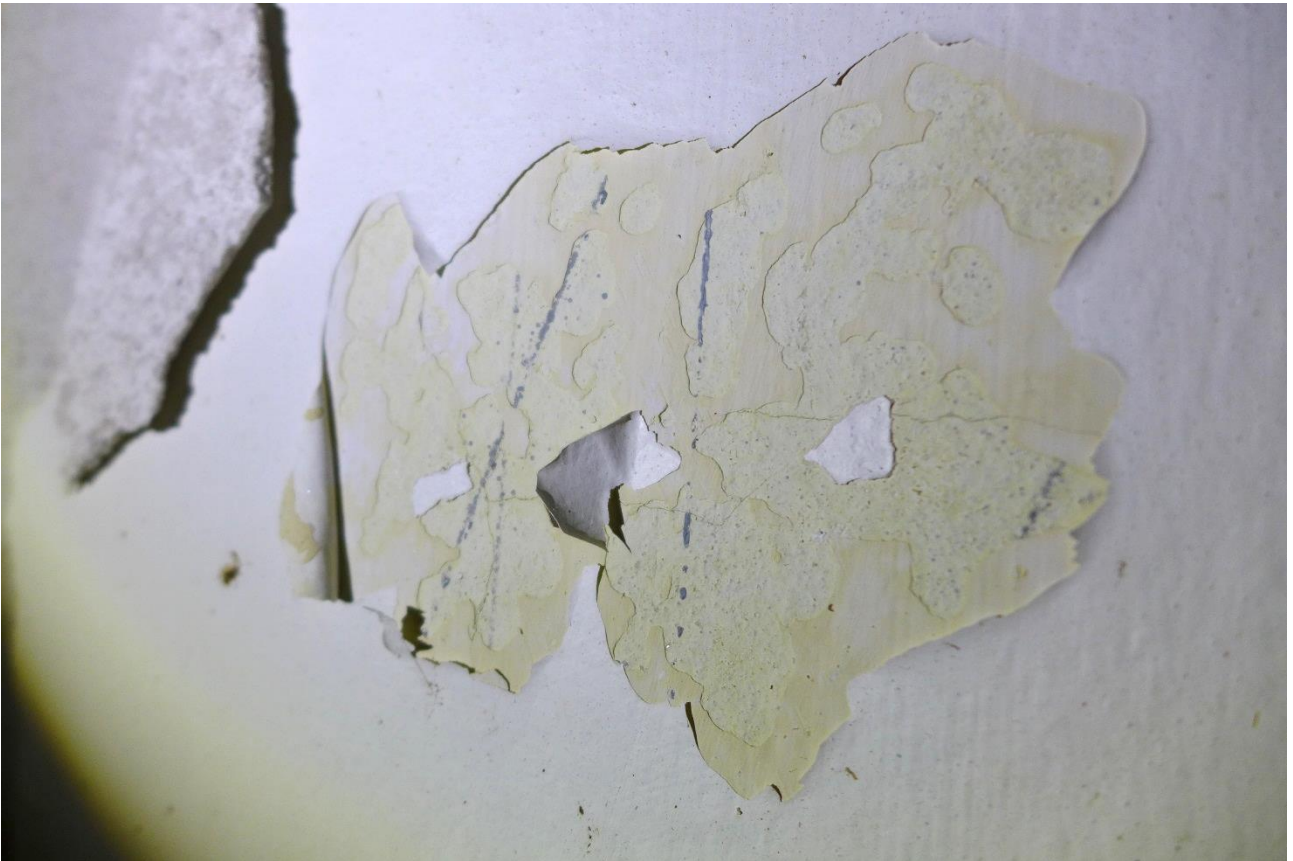
Above is a small lagoon in the surface of the mural. It exposes the paint layers underneath. The dark grey stripes made by Kauria are clearly visible on the undermost layer. In the picture below it is shown how the stripes continue through the different color areas of light pastel blue and yellow.

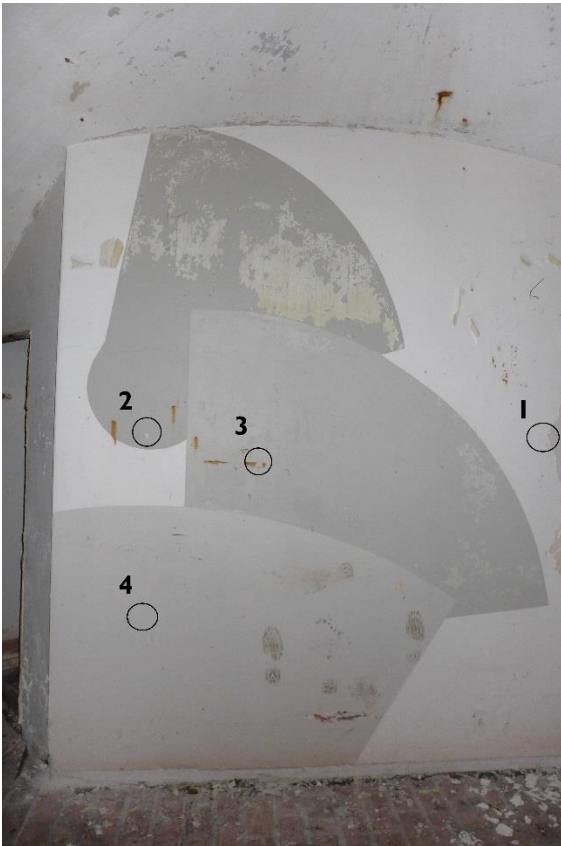
The cross section samples gathered from the Rose cellar mural show three light colored layers. Sample number 1 shows light cream or yellow layers, as the bottom layer there seems almost nonexistent.

The sample number 2 has clear white upmost layer of latex-like paint. The second seems light yellow and the bottom layer again a barely there layer of yellow paint.

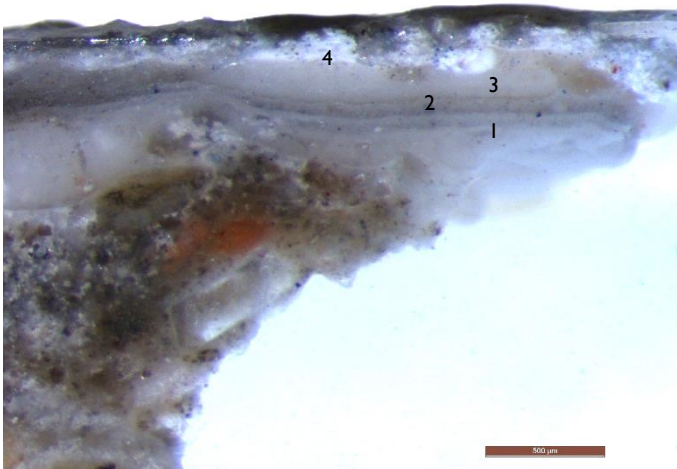
Sample number 00, taken from the wall behind the mural, to present the "general coloring" of the Rose cellar.

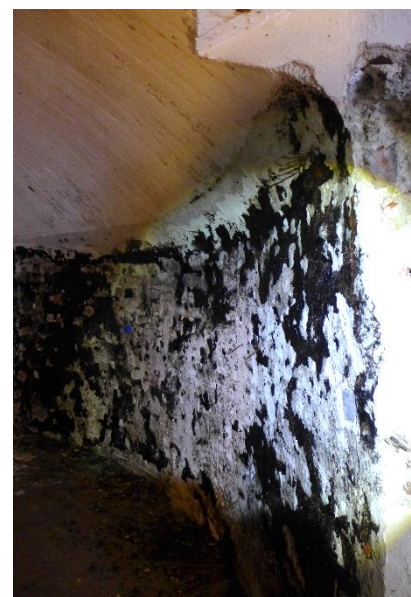
The state of the walls inside the cellar. Tar-like coating has been partly stripped to help the drying process of the structure.

The inner surface of the wall structure of the dome has been removed due to heavy moisture problems inside the wall structure (water coming from outside gathered inside the wall structure). The wall with mural, the wall surfaces by the door way and the ceiling are still relatively good spots for research and gathering samples in the future.

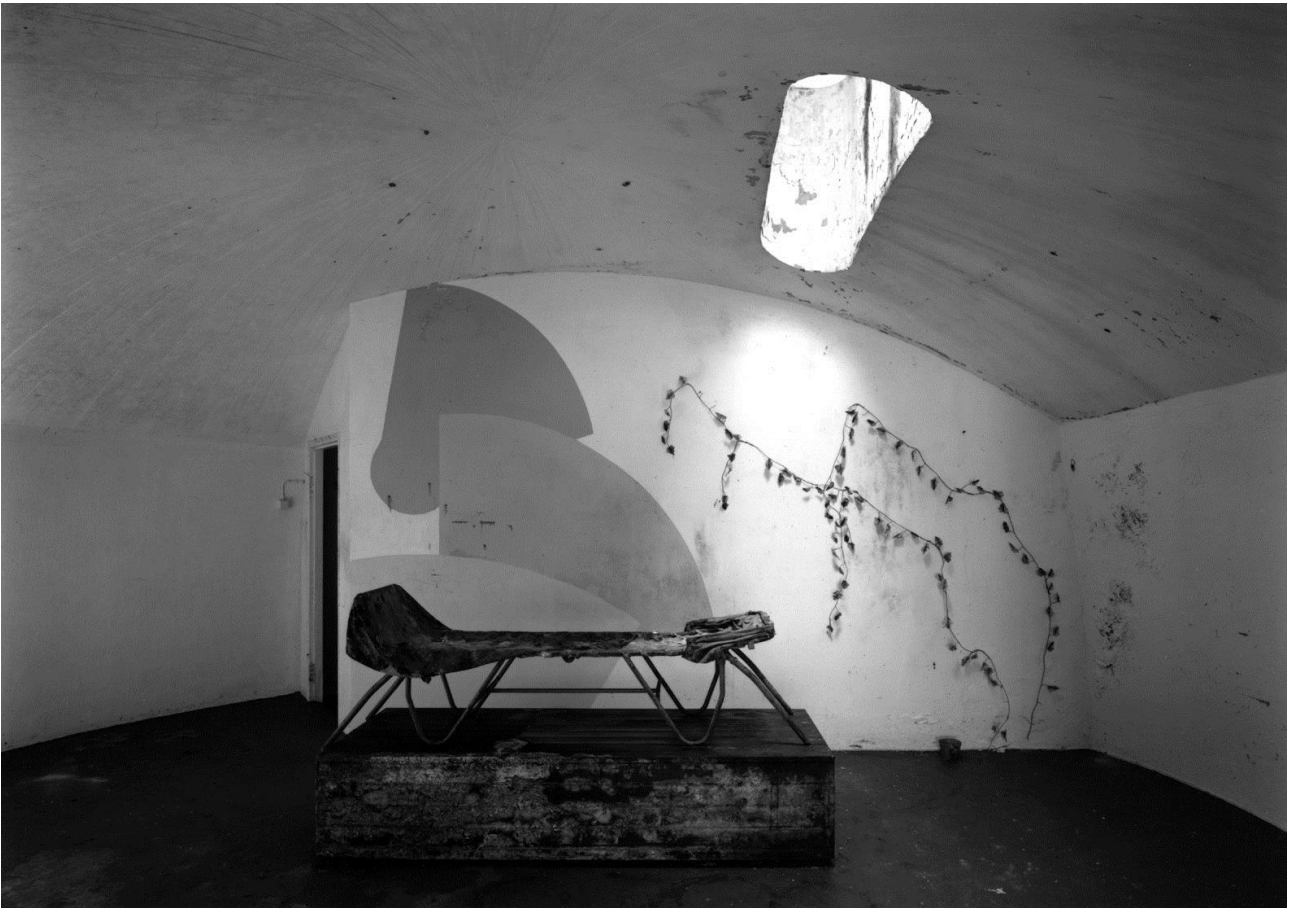
*The Rose cellar in 1986. The now demolished concrete floor of Rose cellar is seen here. Kauria's original mural has been painted over at this stage. The vine on the mural wall is plastic. The catafalque standing in the center was made of wood and apparently painted.<sup>7</sup> AAM. Sign L776.*
