Wreck of an Unknown Three-Masted Sailing Ship, Gulf of Finland

16th Jan 2006

This report briefly describes the first observations from a wreck of an unknown, three-masted wooden ship, located in excess of 60m depth in the Finnish coastal waters in the Gulf of Finland.

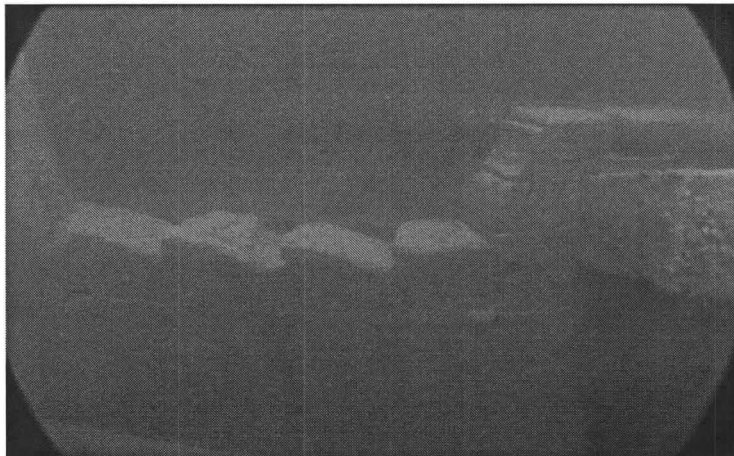
The gunwale in the forecastle area is on a uniform level from the aft end of the forecastle to the catheads. On top of the cathead on each side, there is a snatch block on the gunwale. Between the catheads and the bow, the gunwale is slightly lower, and it has a low sawtooth-like shape.

Picture 1. Gunwale between the bow and the cathead, seen from the port side, from outside of the ship (a snatch block on top of the cathead can be seen on the right). Photo by P. Raasakka & J. Kaasinen.

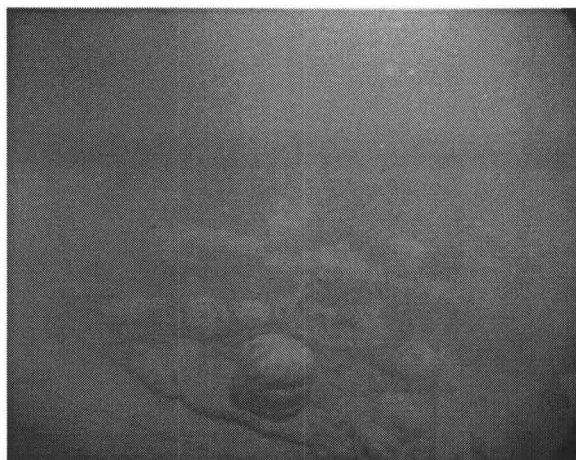
On top of the forecastle gunwale, between the cathead and the aft end of the forecastle, there are seven timberheads on each side. These are marked in the drawings describing the shipwreck.

Picture 2. Starboard side of the forecastle (gunwale timberheads between the cathead and forecastle break). A lot of deadeyes and blocks and some remains of ropes can be seen on the deck. Photo by P. Raasakka & J. Kaasinen.

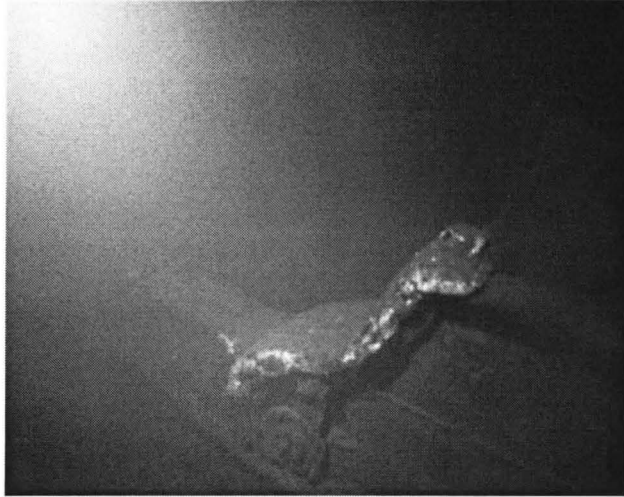
The elevation of the forecastle gunwale is less than one metre from the gun deck gunwale. At the break of the gunwale there is a carved round ornament on the side. The break of the gunwale is protected on the topside with metal lining.

Picture 3. Starboard gunwale at the break of the forecastle, viewed from outside of the ship. Forecastle area on the right. Photo by P. Raasakka & J. Kaasinen.

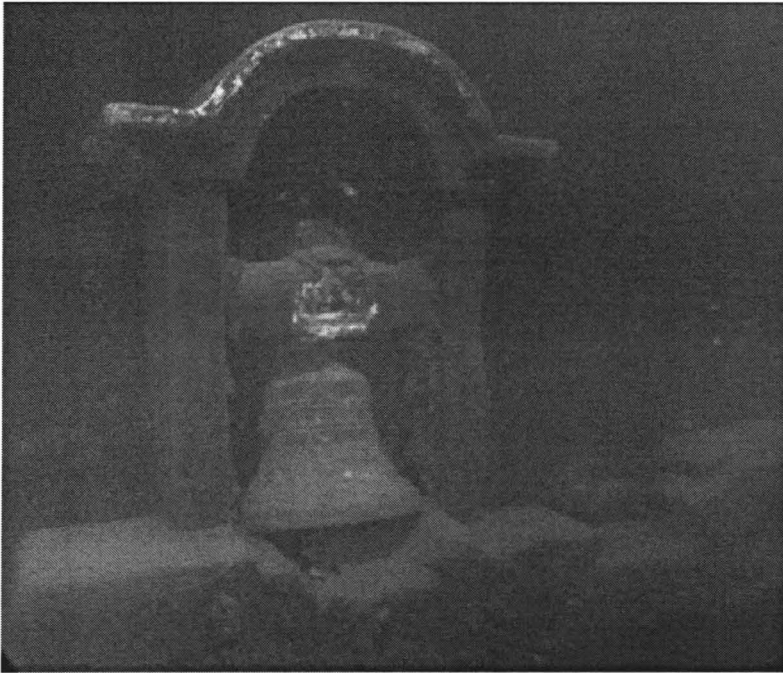
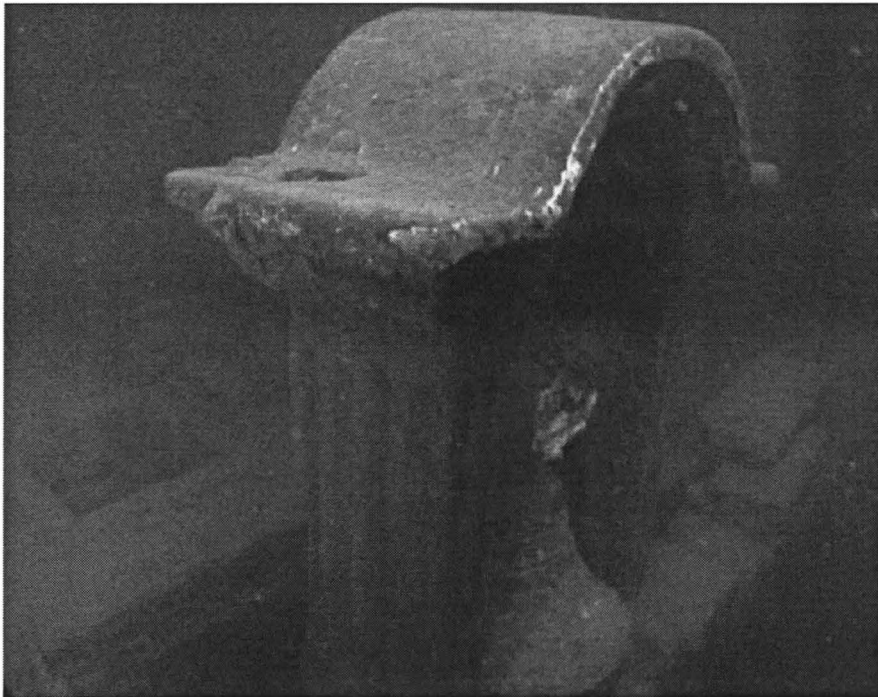
The belfry is located on the break of the forecastle, in the middle of the crossbeam on the forecastle deck. The belfry has two wooden pillars with carved vertical grooves, on top of which there is an arched canopy with metal lining. The headstock of the bell is half-way between the canopy and the deck. The bell lies in its normal position right below the horizontal headstock, but it is apparently no longer attached to the headstock; it has fallen on the deck. There are no visible recognizable writings on the bell.

Picture 5. Belfry on the break of the forecastle, seen from the aft side. Photo by P. Raasakka & J. Kaasinen.

Picture 6. Belfry seen from the port side. Photo by P. Raasakka & J. Kaasinen.

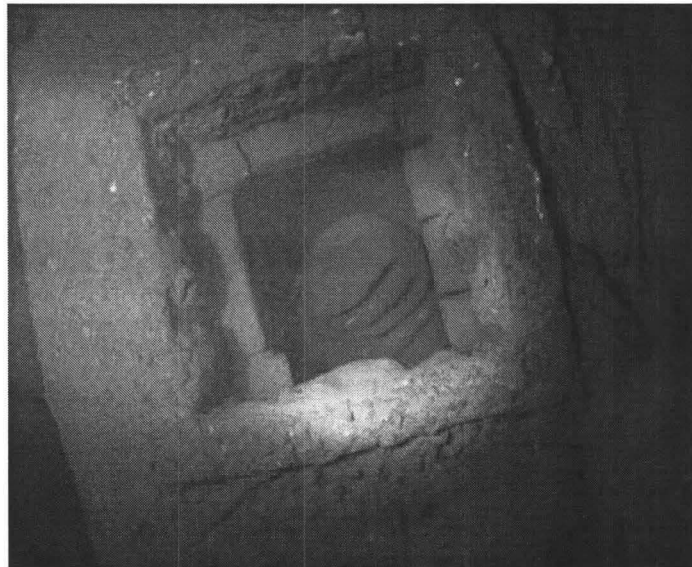
Picture 8. Looking down through the foremost opening on the forecastle. Photo by S. Stockmann.

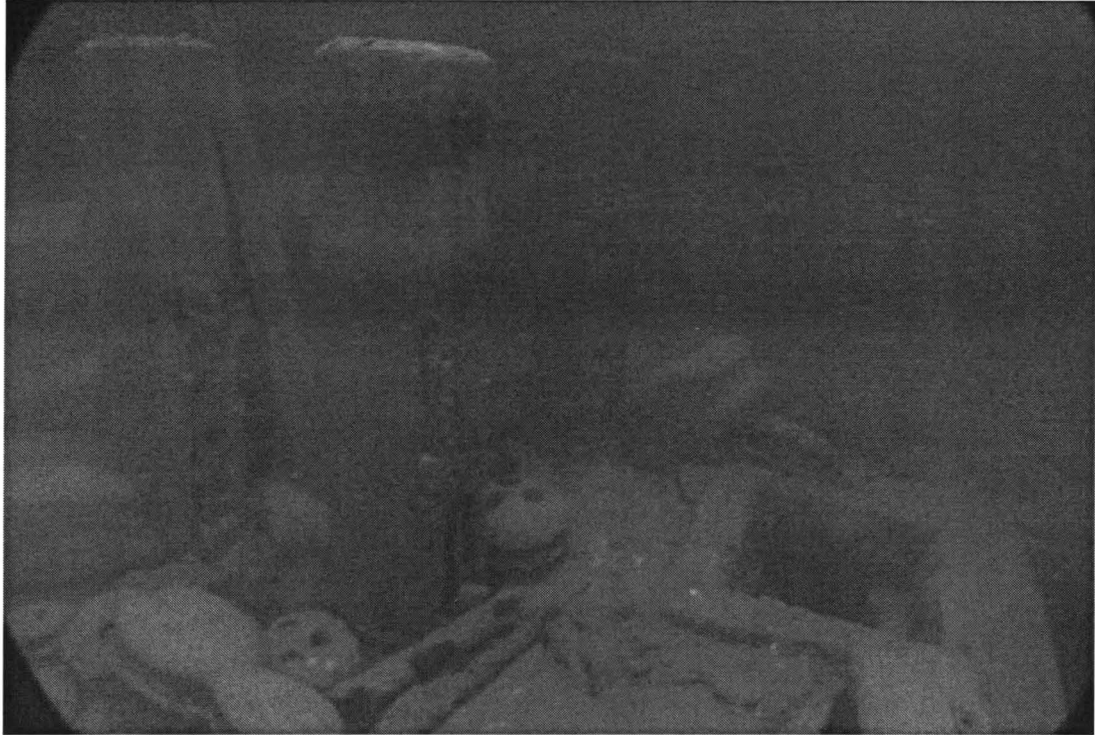
The foremast stub is right fore of the hatchways of the forecastle deck. The foremast is broken on the deck level. The foremast stub is surrounded by four bitts. Each bitt has two sheave holes with sheaves close to the deck level. The bitts have no carvings, and their cross-section is square.

Picture 9. Bitts around the foremast stub on the forecastle deck. Photo by P. Raasakka & J. Kaasinen.

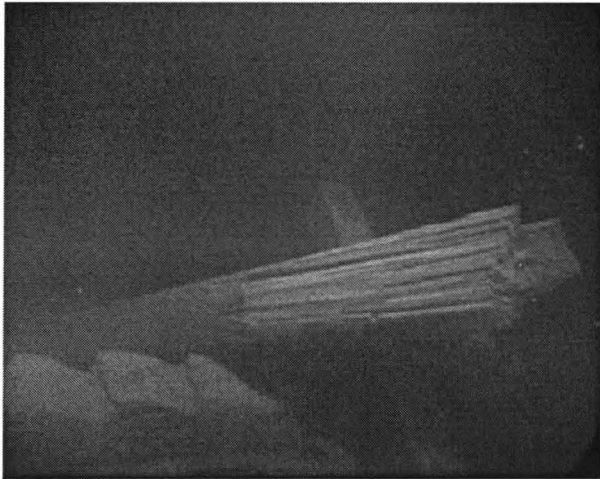
The heel (breakpoint) of the broken foremast lies diagonally on top of the snatch block on top of the starboard side cathead. The head of the foremast lies on the bottom of the sea in front of the bow of the ship.

Picture 12. The heel of the broken foremast lies diagonally on top of the snatch block on top of the starboard side cathead. Photo by P. Raasakka & J. Kaasinen.

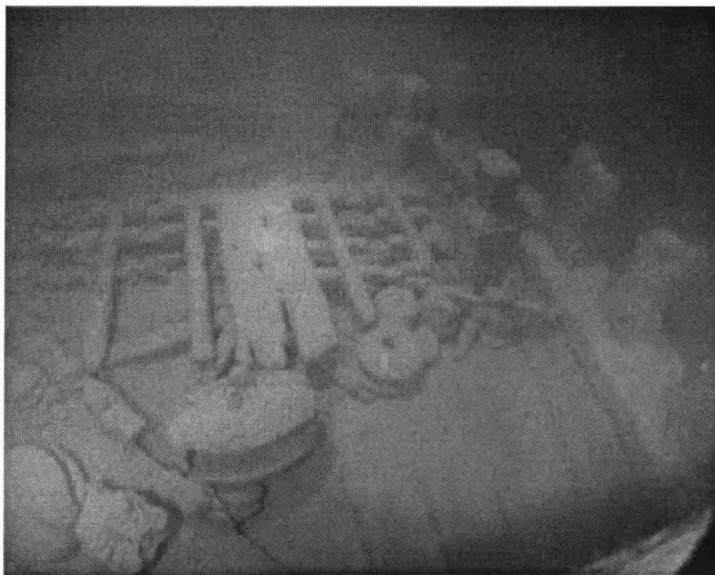
Picture 15. Remains of a wooden grating on the port side of the forecastle deck (seen from the bow towards the forecastle break). Photo by P. Raasakka & J. Kaasinen.

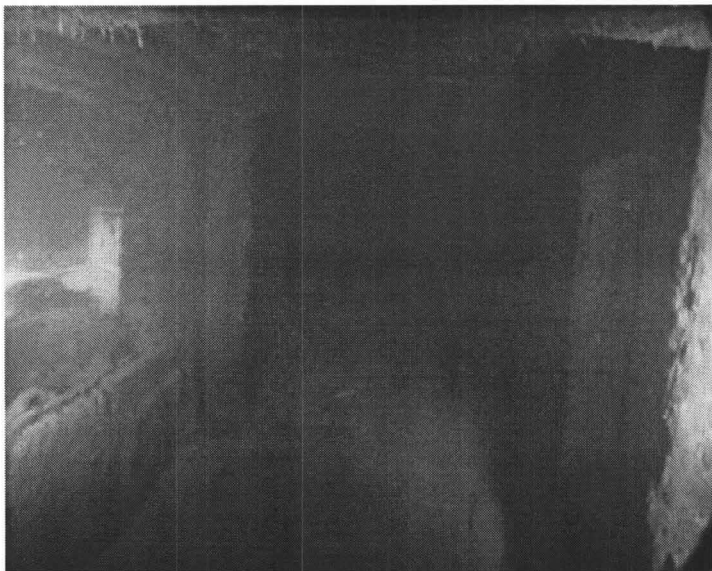
Picture 16. A view from the gun deck towards the bow, below the forecastle deck on starboard side. Photo by P. Raasakka & J. Kaasinen.

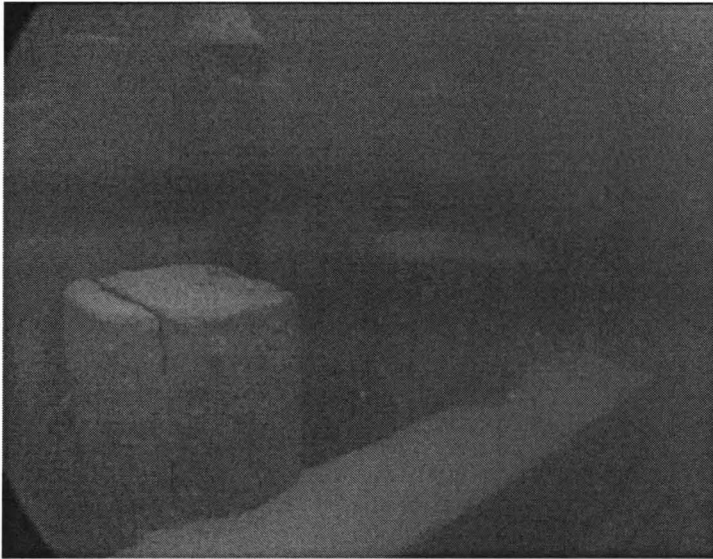
Picture 17. Riding bitts and a crossbeam on the gun deck abaft the forecastle break. Photo by P. Raasakka & J. Kaasinen.

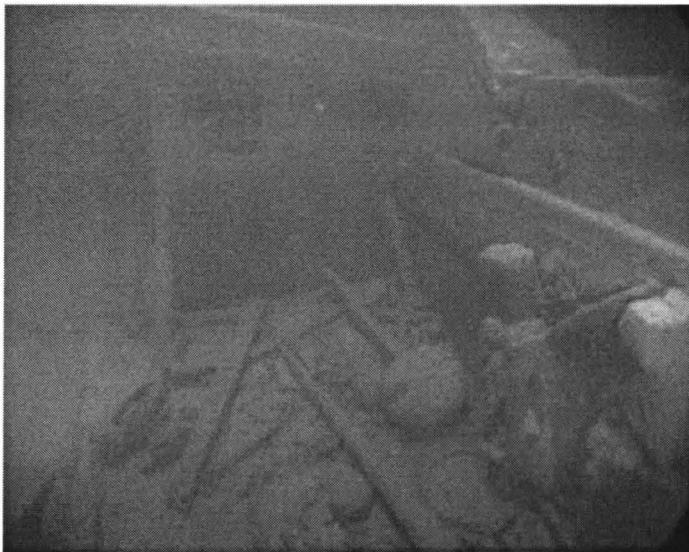
Picture 18. The fore starboard corner of the gun deck, abaft the forecastle break. Photo by P. Raasakka & J. Kaasinen.

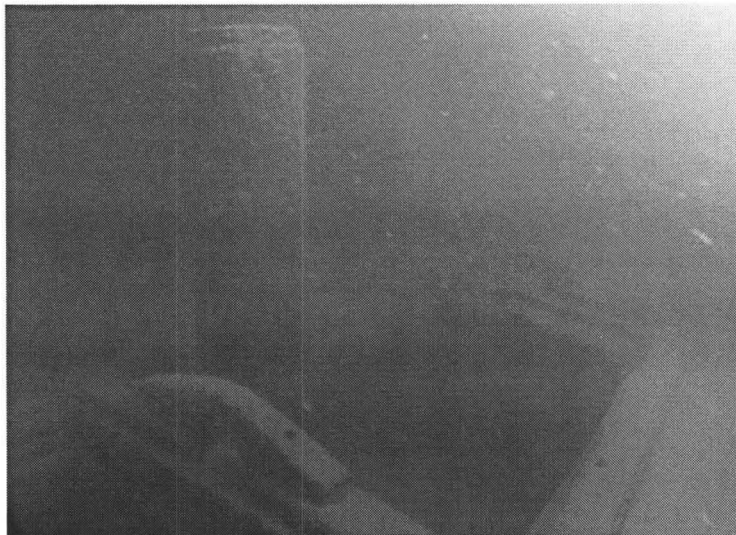
Picture 20. A wooden pump tube rises from the foremost hatchway on the gun deck (viewed from the starboard aft corner of the hatchway, diagonally towards the bow).
Photo by P. Raasakka & J. Kaasinen.

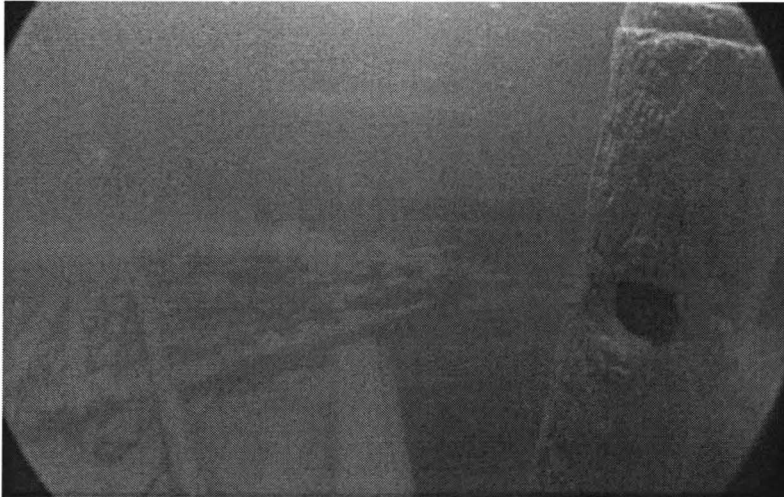
Picture 21. Remains of a wooden grating lie on the gun deck on the port side of the foremost hatchway. Photo by P. Raasakka & J. Kaasinen.

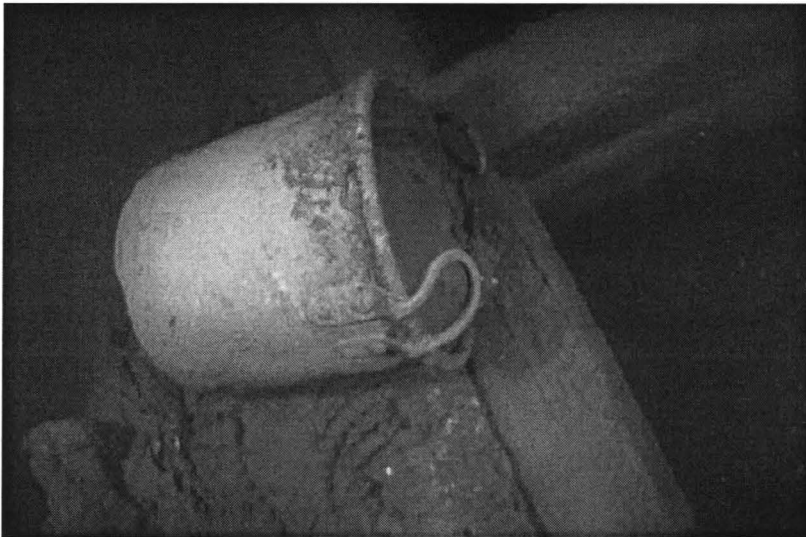
Picture 22. A large, round bucket or tub lies on its side on the starboard side of the third hatchway on the gun deck (viewed towards the aft). Photo by S. Stockmann.

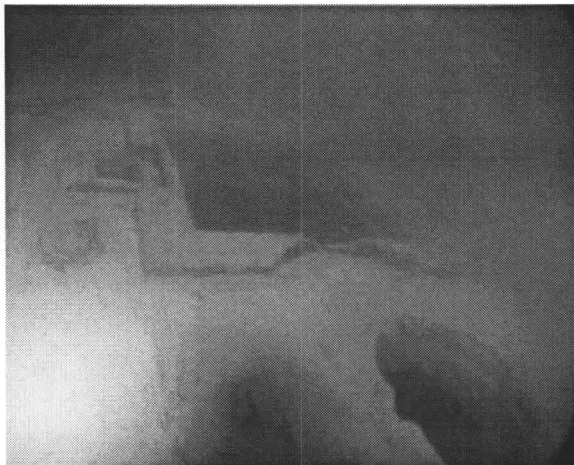
Picture 23. The aftmost hatchway, viewed towards the aft. A small rectangular opening can be seen on the left side of the big hatchway. There is a round hole in the deck between the two aftmost hatchways (in the lower right corner of the picture). Photo by P. Raasakka & J. Kaasinen.

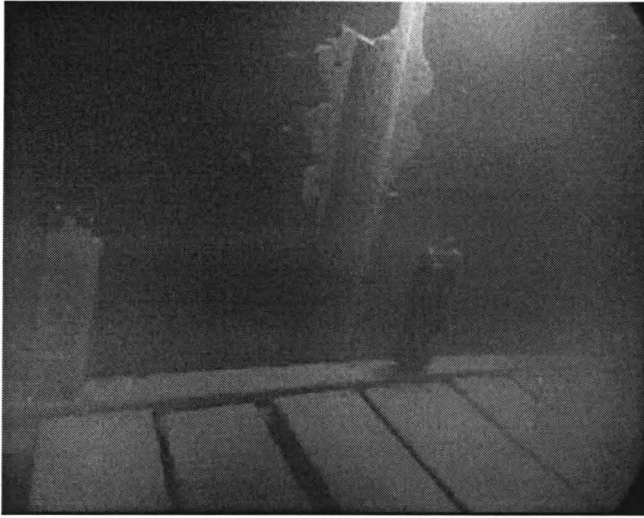
The mizzen mast is located abaft the aft hatchway. The mizzen mast is broken, and it rises roughly three metres above the gun deck. Carved wooden planks (bees?) with curved shape and holes are attached to both sides of the mizzen mast, slightly above the poop deck level.

Picture 24. The breakpoint of the mizzen mast afore the poop deck fore edge, viewed from the poop deck towards the bow. Two vertical planks can be seen on the poop deck fore edge. Photo by P. Raasakka & J. Kaasinen.

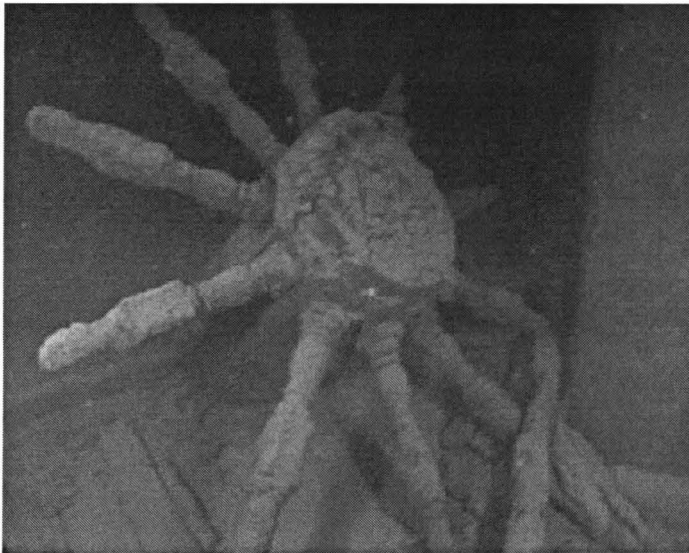
A broken, loose capstan is located on the gun deck, on the starboard side of the mizzen mast. Short capstan bars are attached to the capstan. The capstan has apparently broken loose from the round hole between the hatchways between the main mast and the mizzen mast.

Picture 25. A loose capstan lying on the gun deck on the starboard side of the mizzen mast. Photo by P. Raasakka & J. Kaasinen.

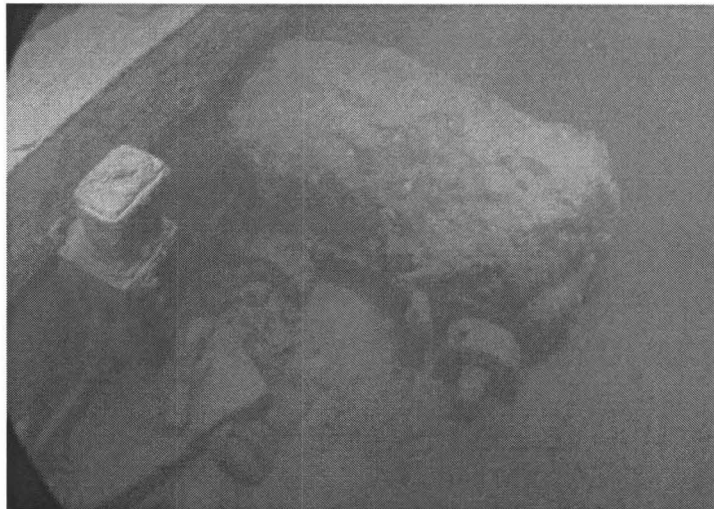
Picture 27. The butt of the foremost gun on the starboard side. Photo by P. Raasakka & J. Kaasinen.

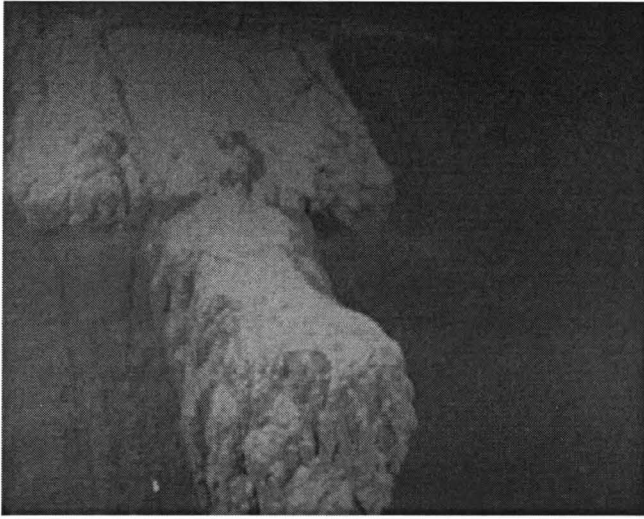
Picture 28. The aftmost gun on the starboard side in its port. Photo by P. Raasakka & J. Kaasinen.

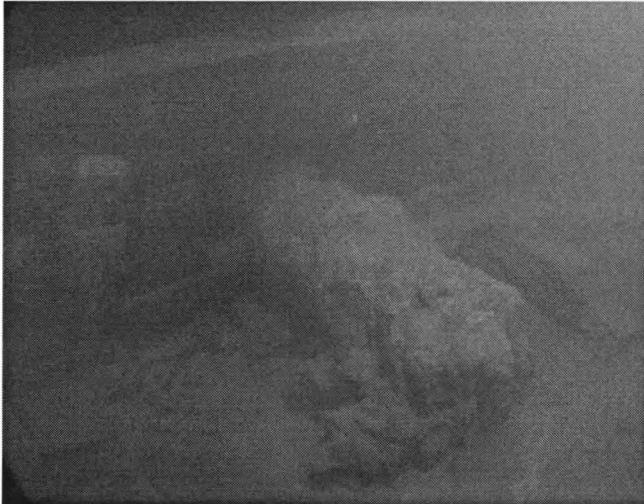
Picture 29. The butt of the middle gun on the port side. Photo by P. Raasakka & J. Kaasinen.

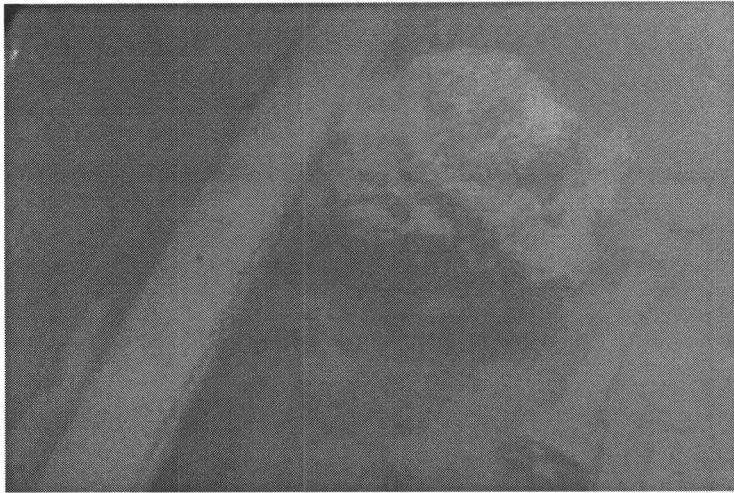
Picture 30. The butt of the aftmost gun on the starboard side has risen up from its carriage.

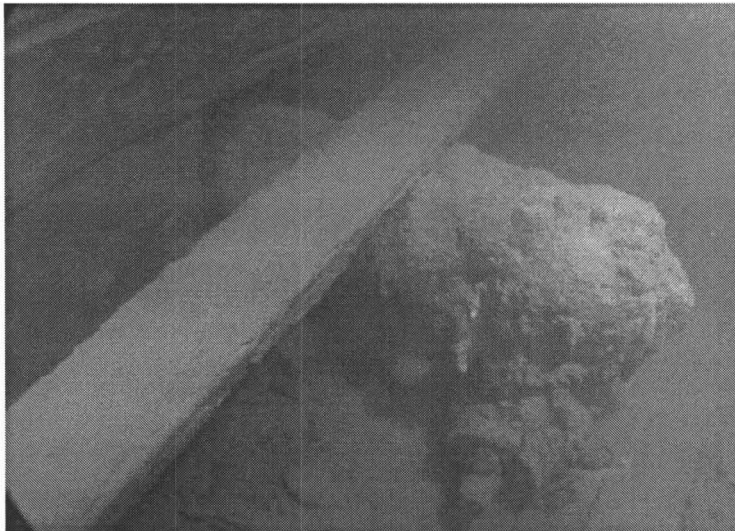
A plank has fallen on the starboard guns. The size and length of the plank would indicate that it can be one of the missing poop deck planks.

Picture 31. The butt of the middle gun on the starboard side. Photo by P. Raasakka & J. Kaasinen.

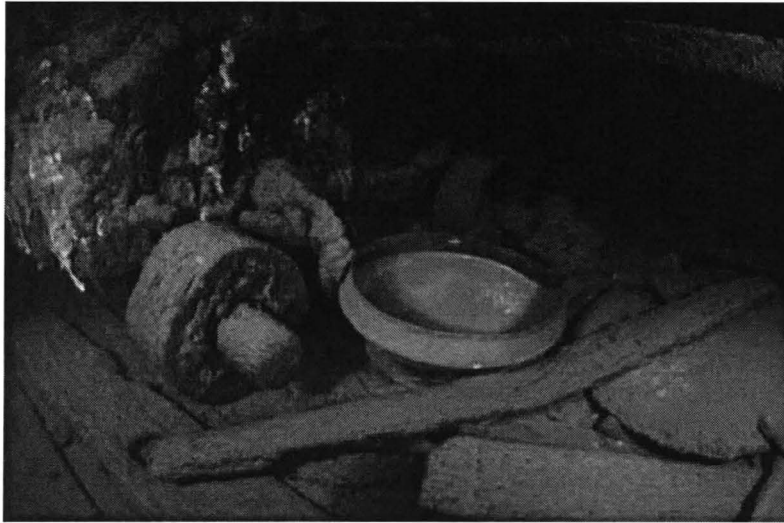
Picture 32. A round, lipped metal plate on the aft side of the foremost gun of the starboard side. Photo by S. Stockmann.

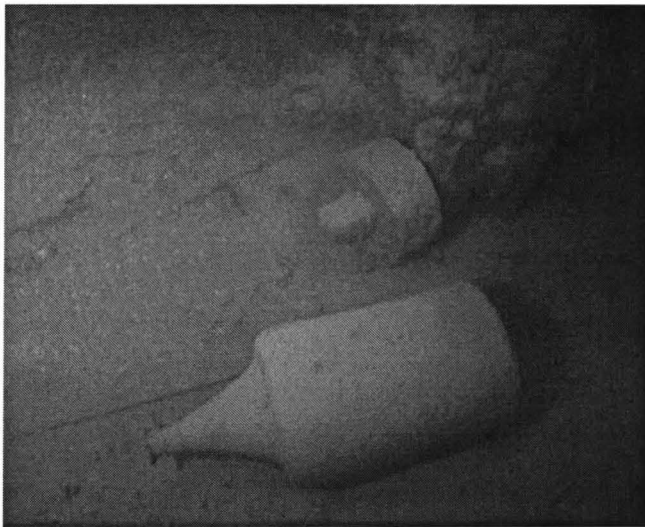
Picture 33. A large bottle on the gun deck behind the foremost gun on the port side. Photo by S. Stockmann.

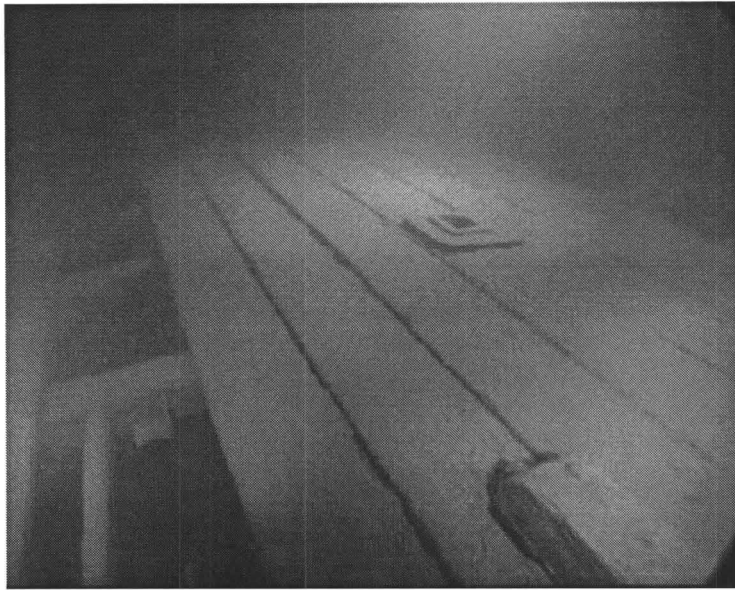
The leftmost (=port side) deck plank of the poop deck is still in its place, but two planks by its side are missing. Apparently three rightmost deck planks are missing from the starboard side of the poop deck. Otherwise the planking of the poop deck is intact.

Picture 36. The poop deck viewed from the aft port side corner. A rectangular opening can be seen in the middle of the poop deck. A port side transom knee can be seen in the forefront. Photo by P. Raasakka & J. Kaasinen.

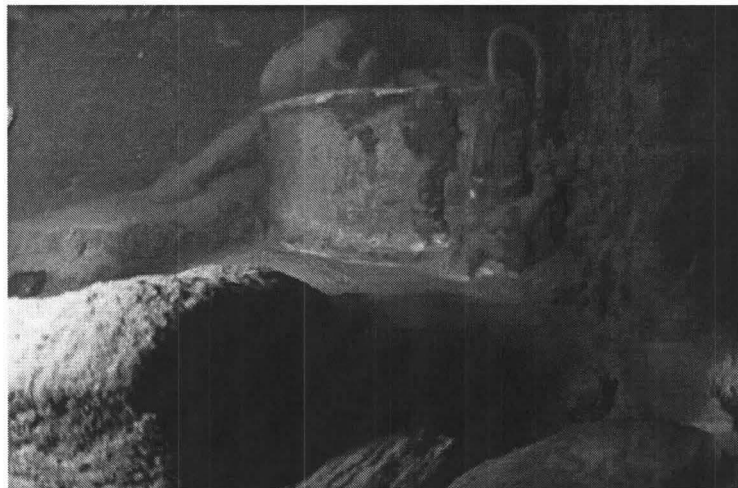
Picture 37. A kettle lying below the forecastle deck, below the small opening abaft the fore mast location. Photo by S. Stockmann.

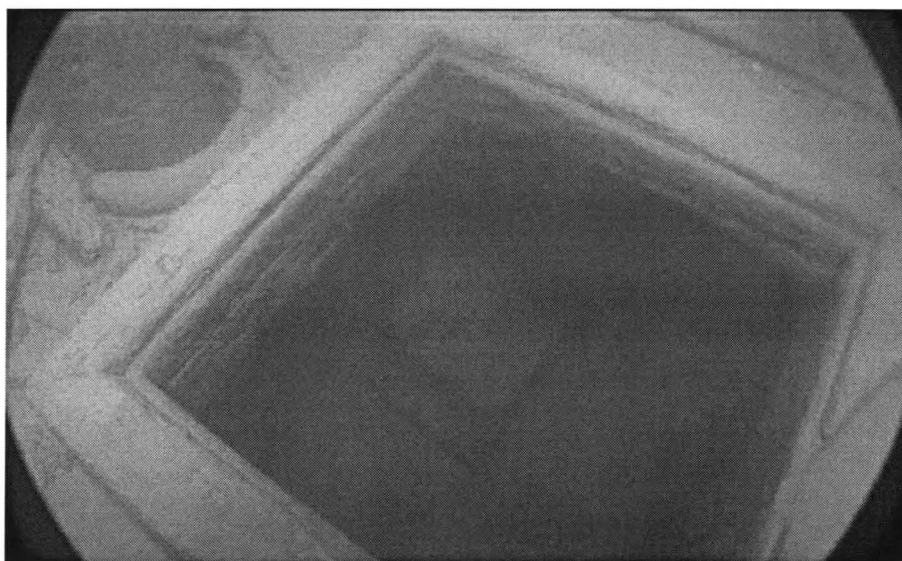
Picture 38. A box visible from the aftmost hatchway. The mizzen mast can be seen in the top left corner. Photo by P. Raasakka & J. Kaasinen.

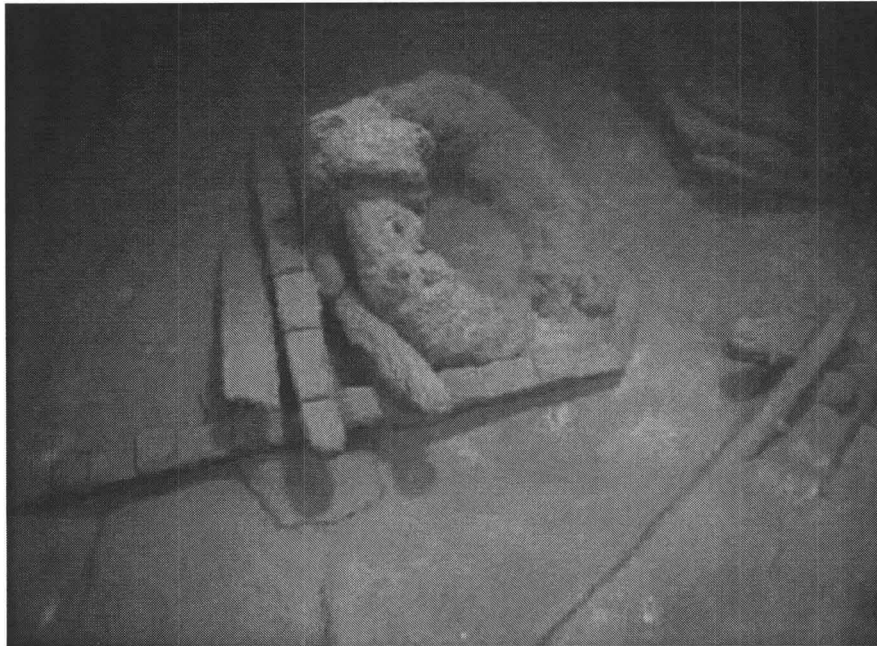
Picture 39. A large metal ring seen belowdecks, from the aftmost hatchway between the main mast and the forecastle. Photo by S. Stockmann.

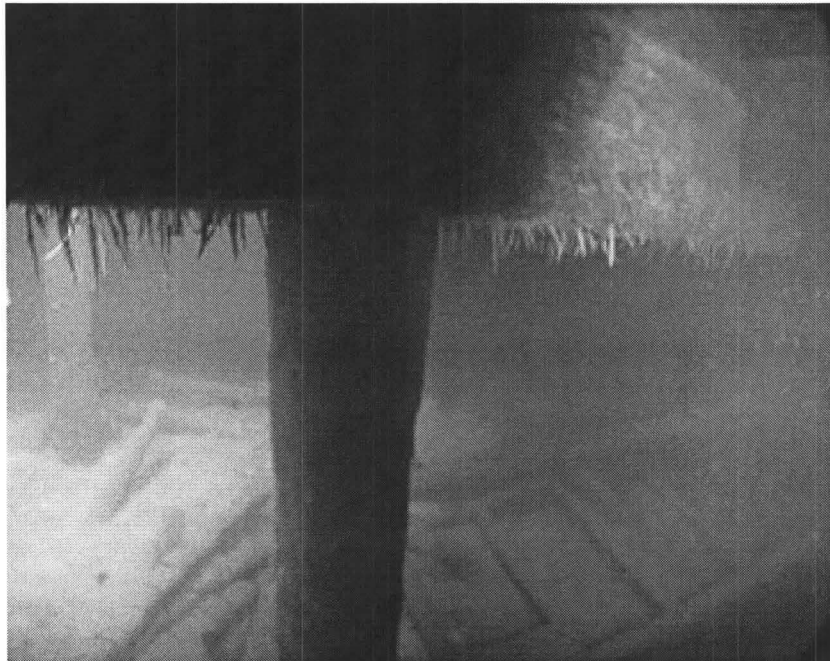
Loose stairs are lying in the room below the third hatchway between the forecastle and the main mast.

Picture 40. A view belowdecks (towards two-o'clock direction) from the fourth hatchway between the forecastle and main mast. Photo by P. Raasakka & J. Kaasinen.

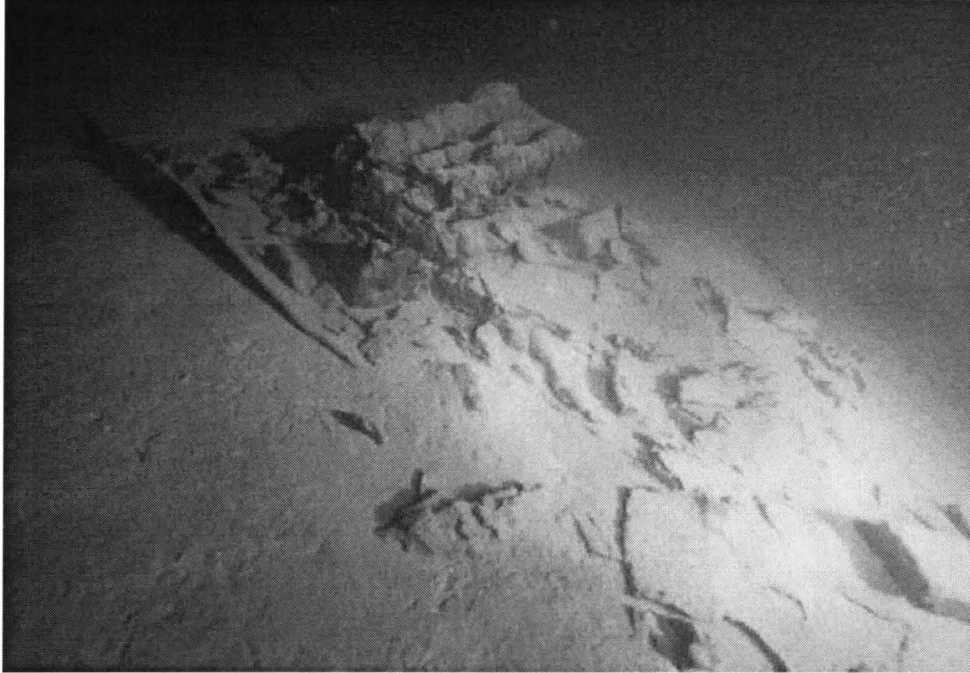
Some loose planks reside below the poop deck. Remains of a stove or fireplace of some kind are in the middle of the area below the poop deck.

Picture 41. Remains of a stove-like object below the poop deck. Photo by J. Polkko.

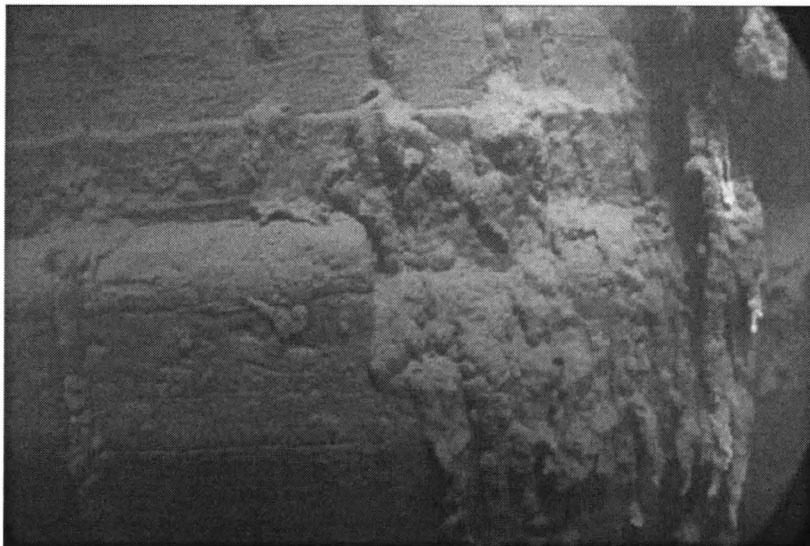
Picture 44. The upper edge of the main wale close to the aftmost gun on the starboard side. An insertion in the wale can be seen close to the centre of the picture. Some crust hanging from the gun (on the right). Photo by P. Raasakka & J. Kaasinen.

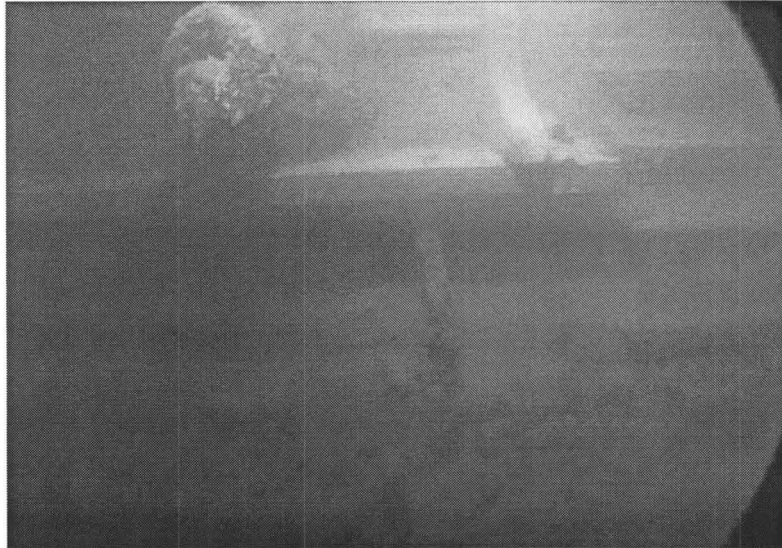
Picture 45. The channel below the foremost gun on the starboard side. Stairs can be seen on the right. Photo by P. Raasakka & J. Kaasinen.

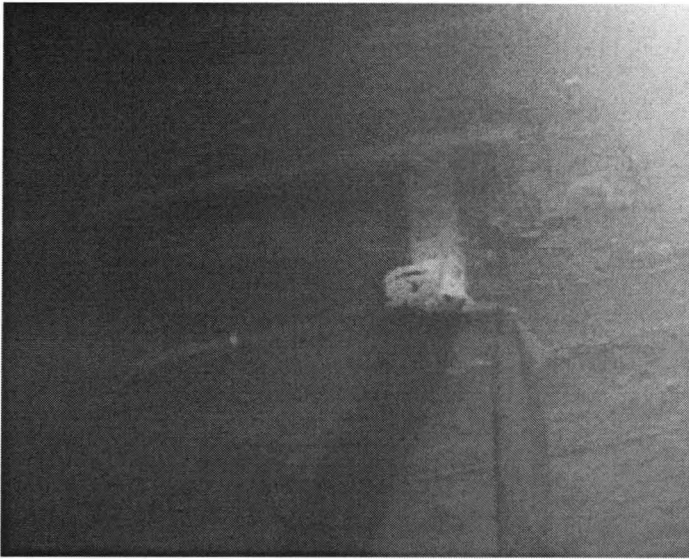
Picture 46. A knee for attachment of a channel on the starboard side close to the fore mast area. The channel is missing. Photo by P. Raasakka & J. Kaasinen.

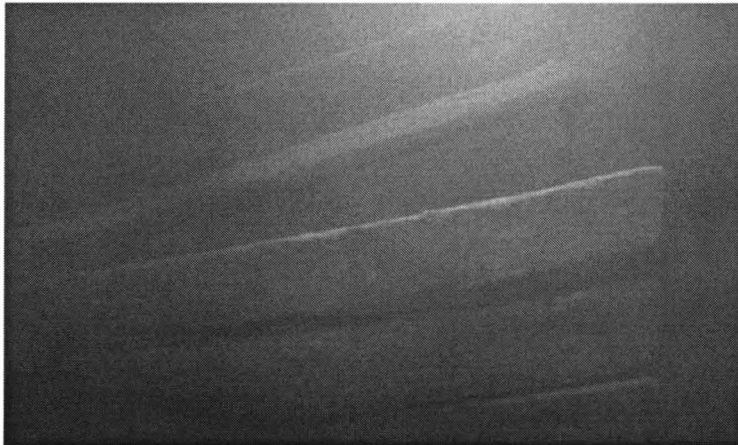
At the bow of the ship, the fore ends of the main wale strakes have become loose from the stem and the side of the ship, except for the uppermost, rounded strake. The uppermost, rounded strake is still attached to ship's side and stempost.

Picture 47. The main wale on both sides has become loose from the stempost. Picture taken from the starboard side. Photo by P. Raasakka & J. Kaasinen.

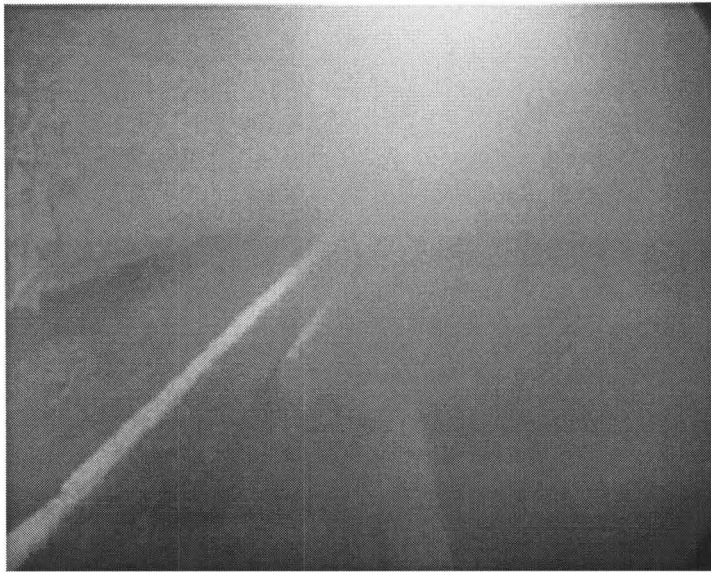
Several side planks on the port side have become loose from their fore end below the main wale level. However, the vertical timbers of the hull are not visible under the loose planks; only horizontal planks can be seen. This seems to be an indication of existence of **a second layer of planking below the main wale level**.

Picture 48. Loose planks on the port side below the main wale in the mid-ship area (view from the bow towards the aft). Photo by P. Raasakka & J. Kaasinen.

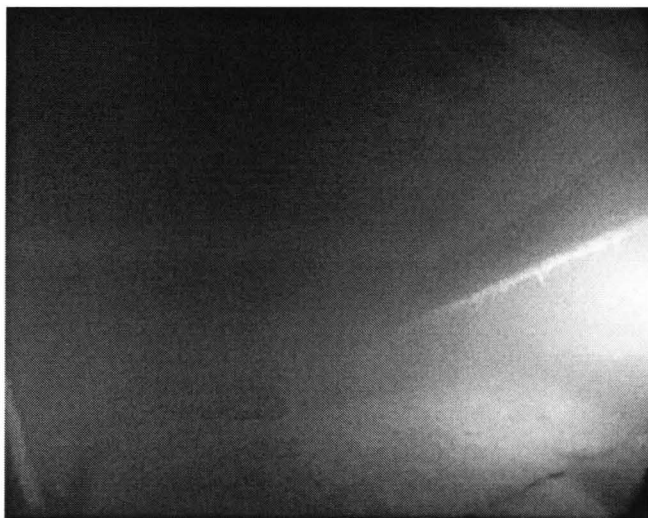
Picture 51. The tiller at the stern below the gun deck. Photo by P. Raasakka & J. Kaasinen.

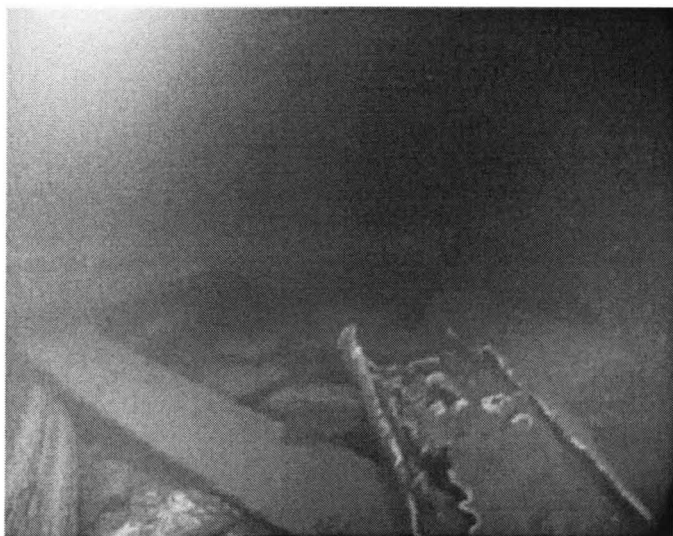
Picture 53. Some objects on the seabed behind the stern. Photo by P. Raasakka & J. Kaasinen.

There are a lot of loose planks on the seabed behind the stern. Some of the wooden artifacts on the seabed on the starboard side behind the stern have carved ornaments in them. Apparently these are from the framework of the square stern.

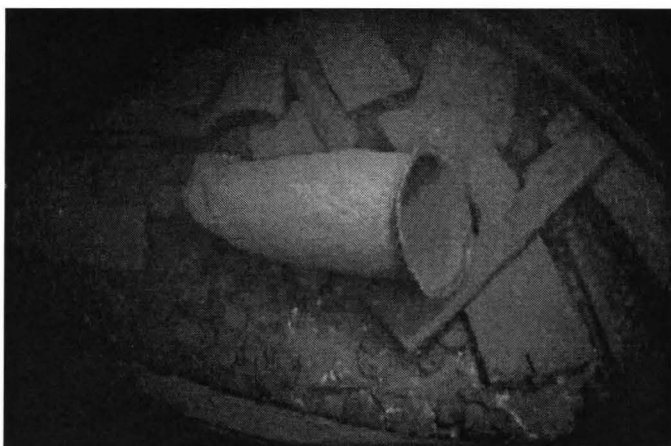
Picture 54. A horn-like object on the seabed behind the stern. Photo by S. Stockmann.

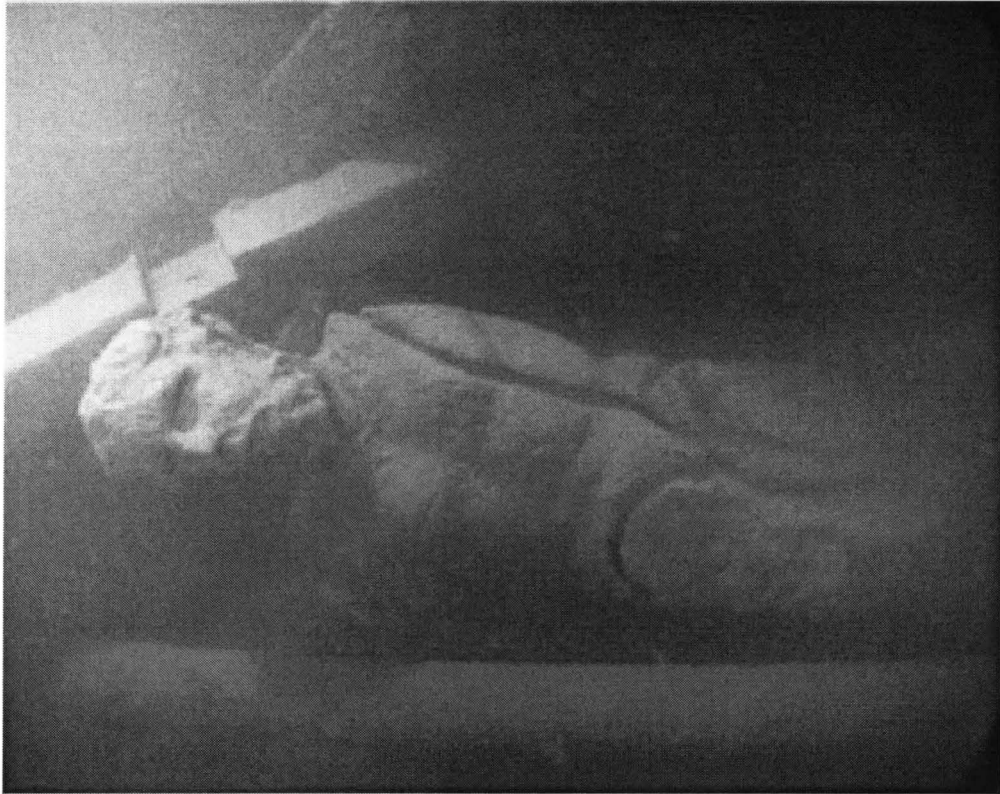
The figurehead is attached to the top end of a large, curved head that lies on the seabed below ship's bowsprit. The head itself has become loose from ship's stempost and dropped on the seabed. The figurehead represents a bearded man. The figurehead's face is towards port.

Picture 59. The figurehead is lying on its side on the seabed, facing towards port. Photo by P. Raasakka & J. Kaasinen.

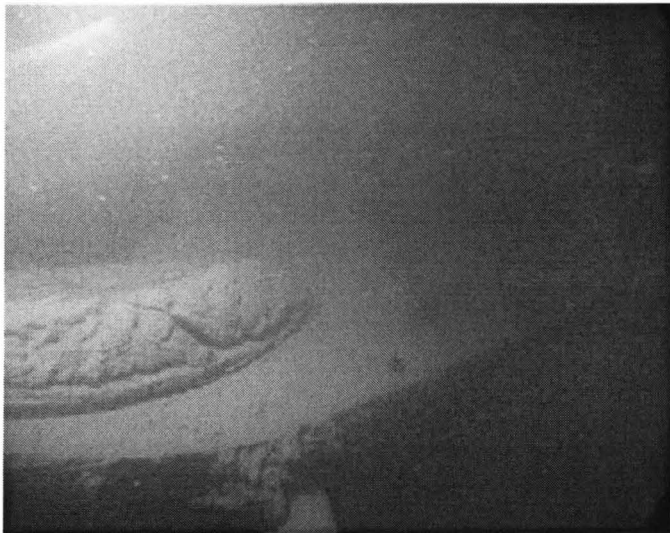
Picture 60. The side of the figurehead. The straight attachment surface is barely visible in the background. Photo by P. Raasakka & J. Kaasinen.

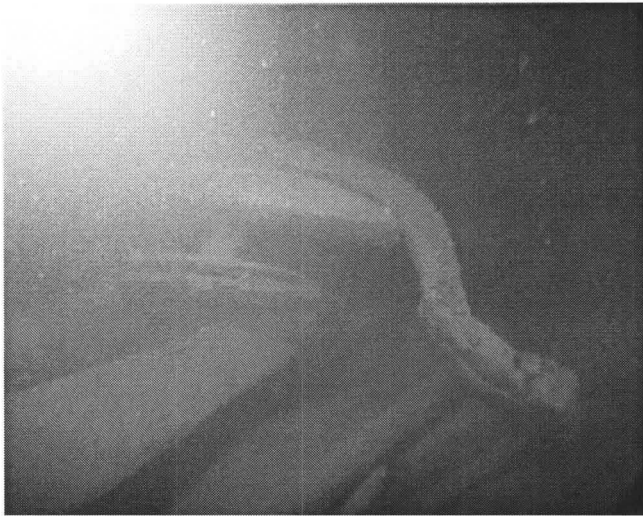
Picture 61. Objects in front of ship's stempost (viewed towards the stempost). Photo by P. Raasakka & J. Kaasinen.

The figurehead lies on top of two loose spars. One of these has a u-shaped attachment in its other end.

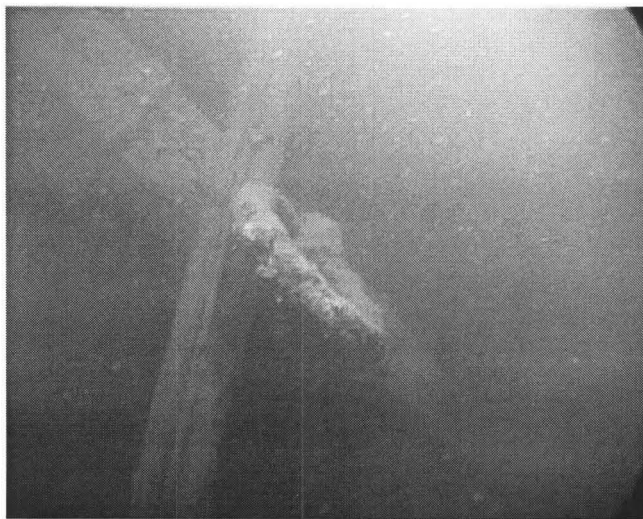
Picture 62. The ring of the stocked anchor lying on the seabed, close to the location of the port side cathead. A wooden rail is lying diagonally against the anchor stock. Photo by P. Raasakka & J. Kaasinen.

A loose wooden rail has become loose from the ship's side, and lies now diagonally against the anchor stock.
