Wreck of an Unknown Armed Three-Masted Sailing Ship, Gulf of Finland

Badewanne Research Reports 1-2021

18th April 2021
Copyright © Badewanne Oy
Finland

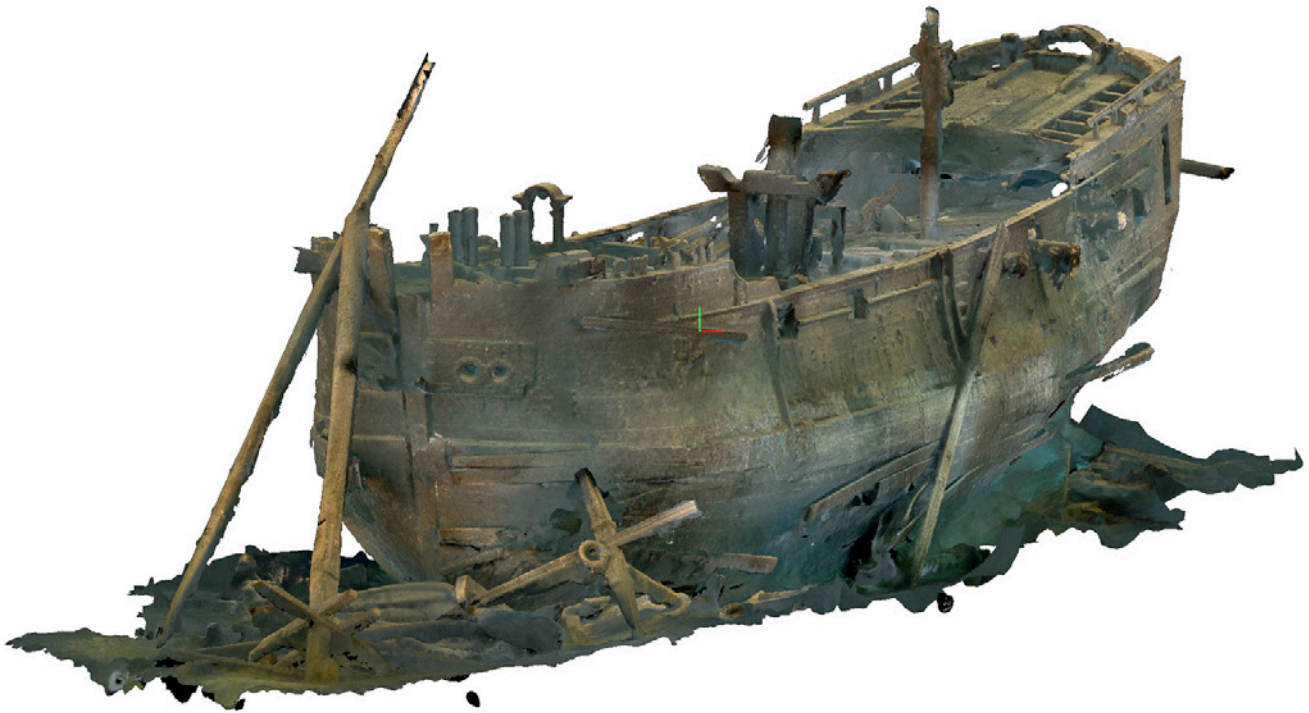
Figure 2: *an ortographic view of the wreck from the port side.*

The most visible alterations have been around the bow with the bowsprit, foremast and a yard, which have been relocated. As found, the bowsprit was in the bow in its place, between the bow bitts rising up in what seemed to be as-built-angle of about 30 degrees. The current location of the bowsprit is unknown, but it is probably somewhere on the seabed close to the bow. The current state of the bow is shown in the Figure 2 and 26.

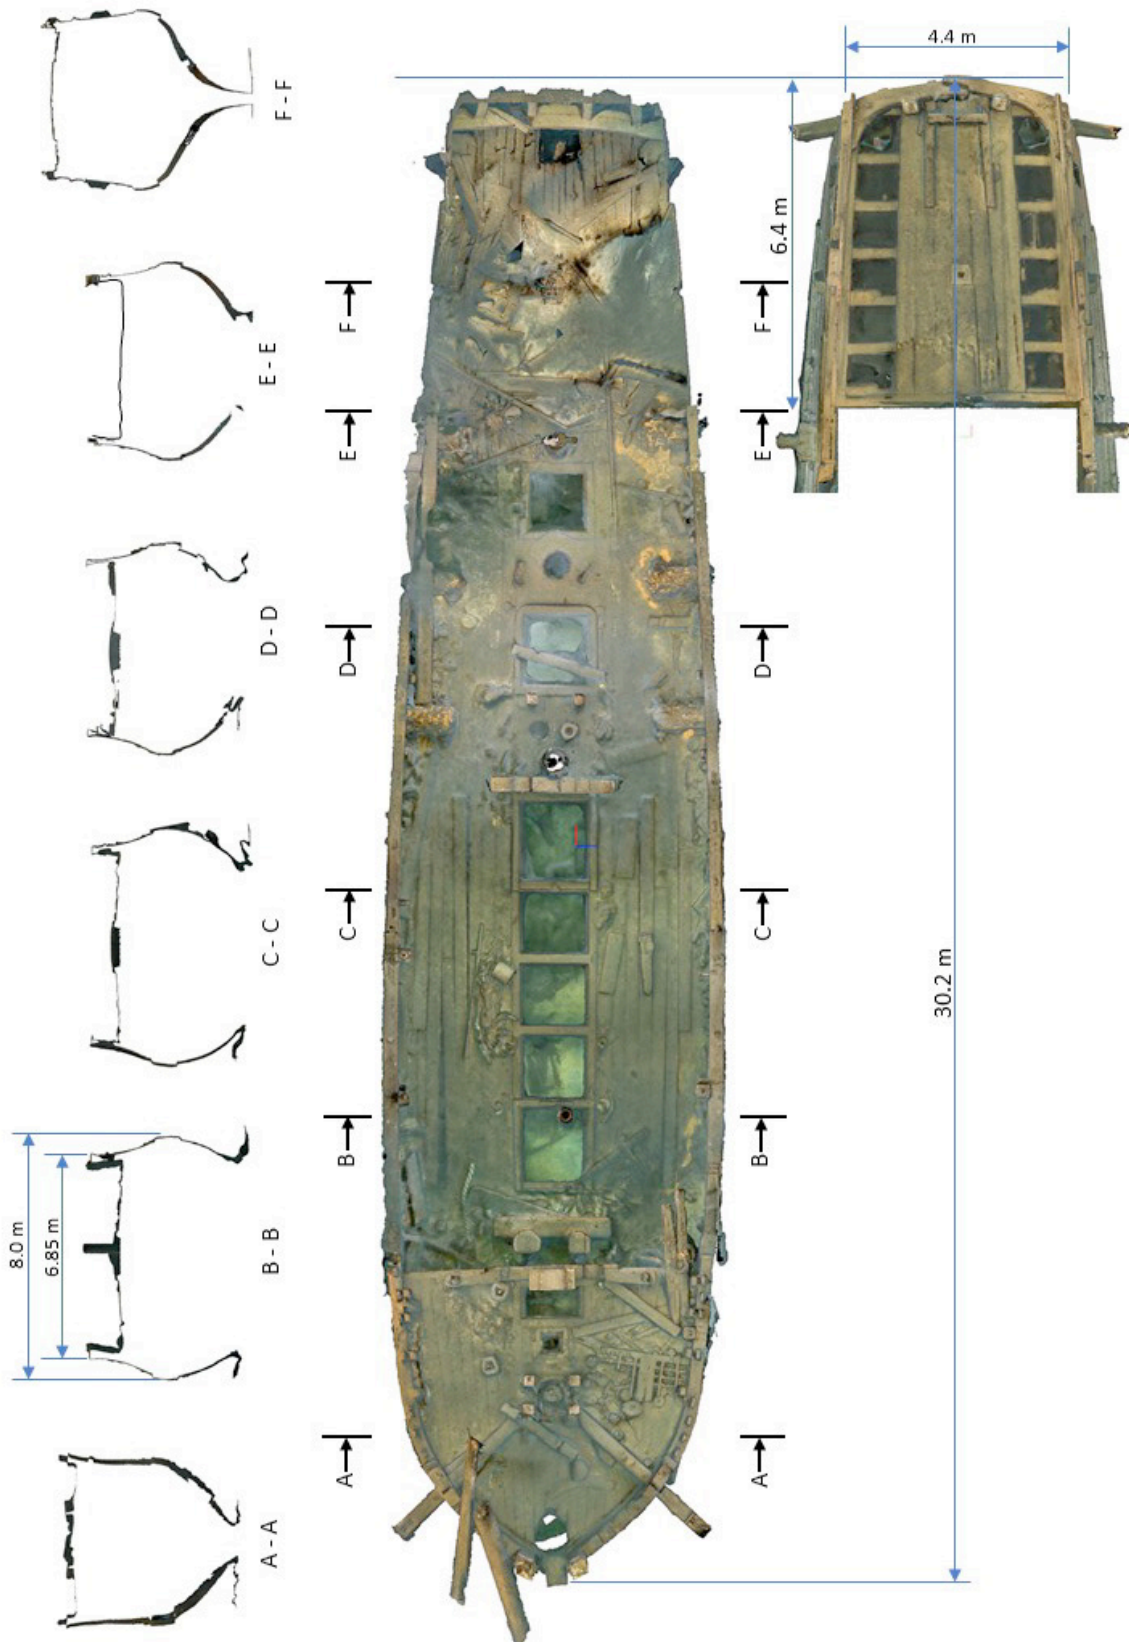
Figure 4: The deck plan including the rear cabin floor (shown without the wales bulging outwards), poop deck (above the rear cabin) and the cross-sections/frames with dimensions. Port sides of the cross-sections are on the right side, that is view is towards the stern. Some loose planks in the port side hull interfere little bit the cross-section images in the right sides. Generally the starboard side of the hull is slightly in a better condition, with less loose planks.

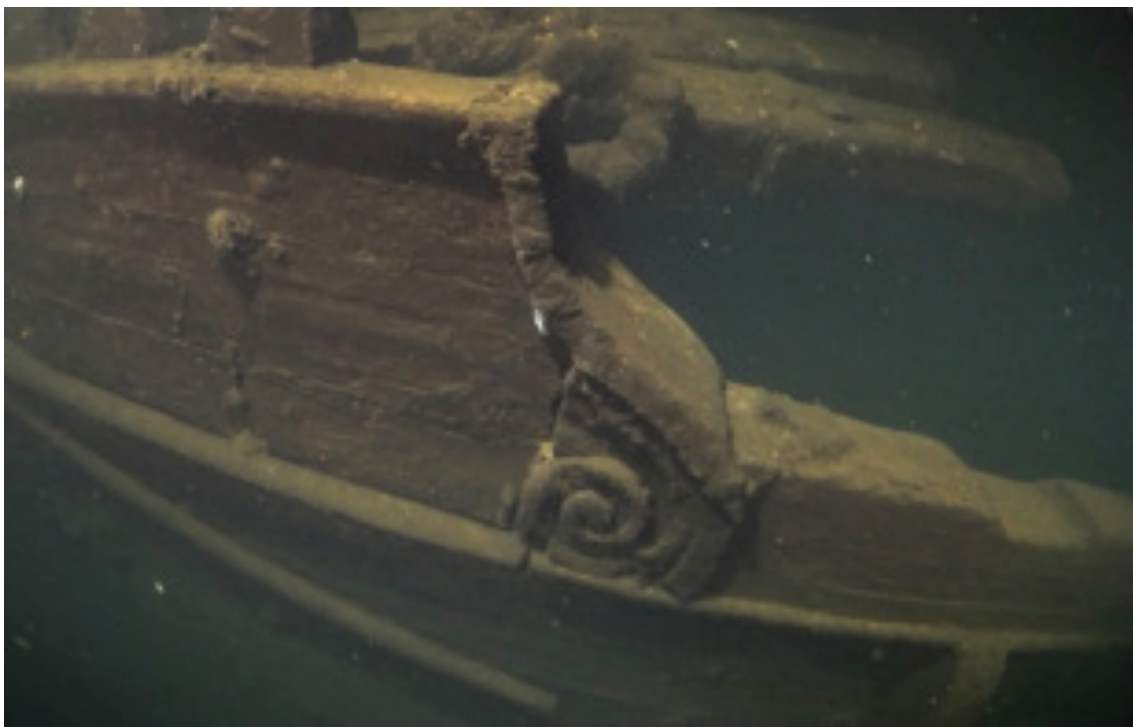
Figure 10 shows the carved round ornament on the port side in the break between forecastle and gun deck gunwales. Originally there has been a similar ornament on the starboard side, as can be seen in the photo taken in 2006 (see Figure 11).

Figure 8: *A carved round ornament on the port side in the break between the forecastle and gun deck gunwales. Videocapture 26th Jul. 2018.*

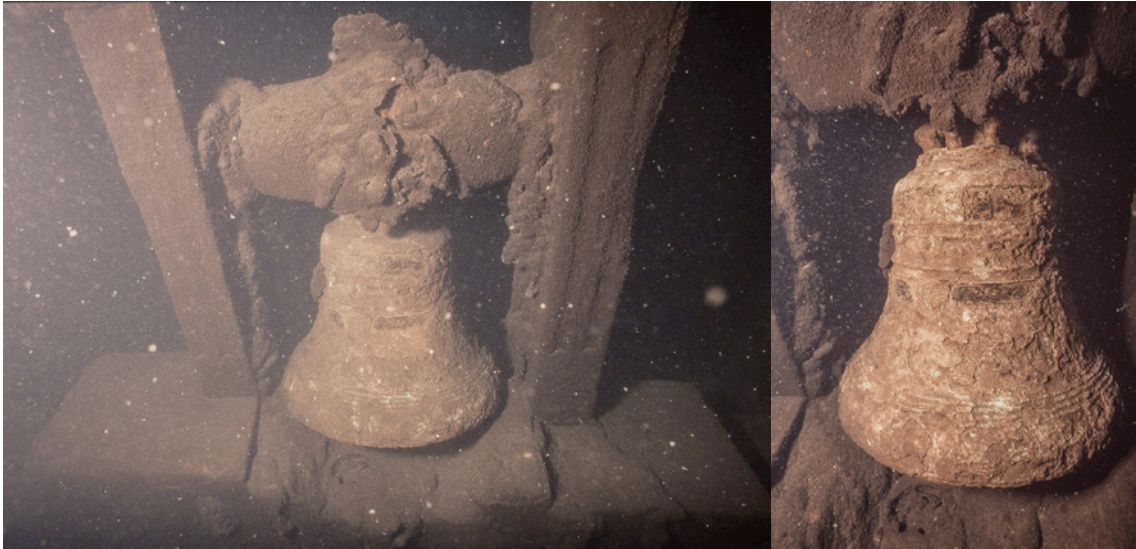
Figure 16: *The ship's bell in the belfry in its original state on 22nd July 2003 and 24th August 2003, documented during the first dives.*

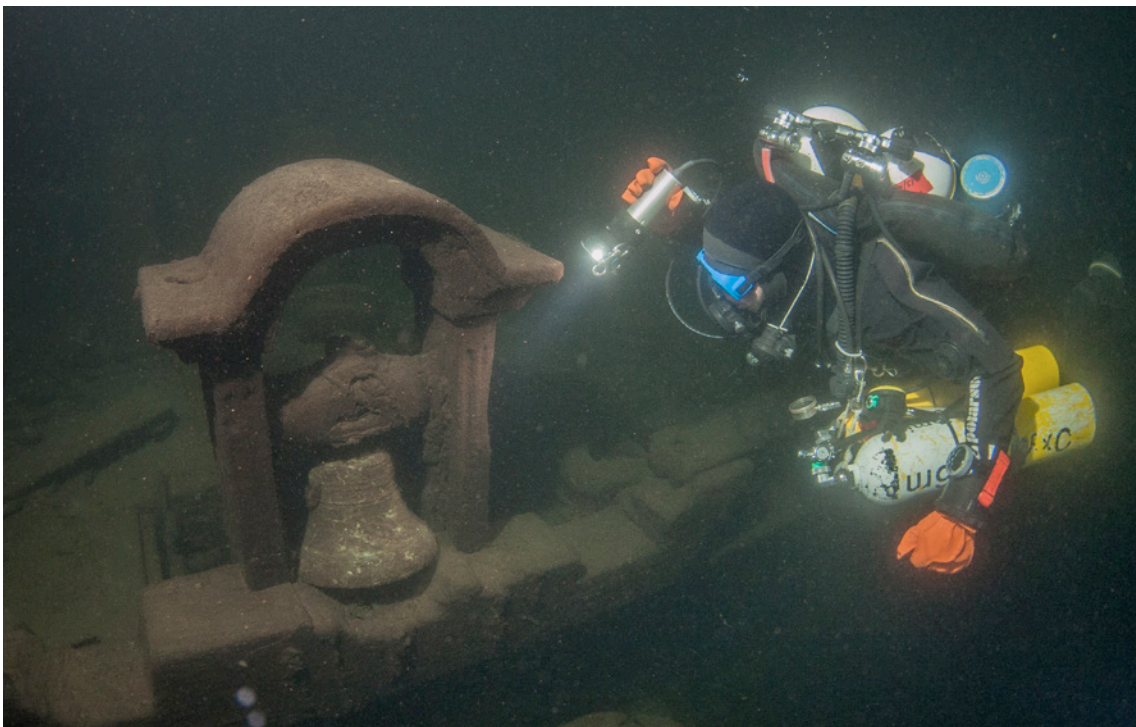
Figure 17: *The belfry with the bell in 11th August 2007 (view towards bow).*

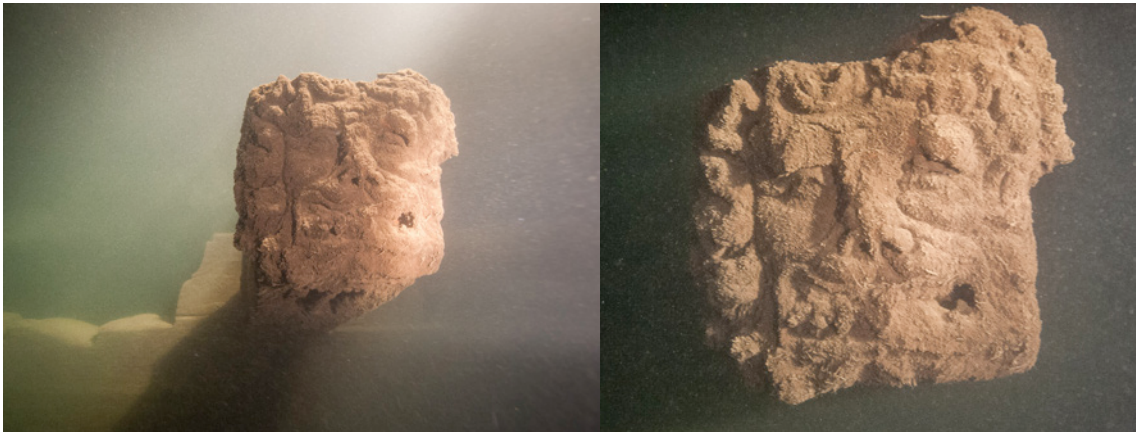
Both catheads are structurally intact. At least the cathead on the portside had originally a cat/lion-faced figure on the end. This figure has since then fallen down or disappeared from the site. It is possible that the figure lays now on the seafloor just below the cathead. A similarly shaped flat object was found on the port side during 2019. It is probably the missing figure that has turned upside down.

Figure 20: *The port side cathead with a wooden carving of a cat or a lion faced figure. Photos taken 10th September 2005.*

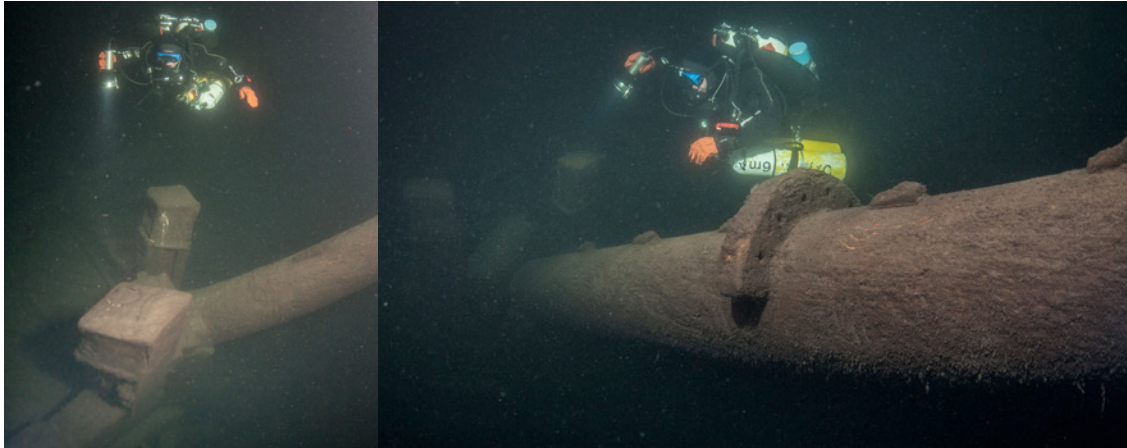
The bowsprit was originally in place when the wreck was discovered. The bowsprit rose from the peak of the bow (above the bow stem) in an angle of approx. 30 degrees (estimated, not measured). The length of the bowsprit was measured by tape, and it was 7.7 metres. The measurement was taken on 3rd September 2011, one day before the bell recovery operation.

On 11th Sep. 2011 the bowsprit was gone, and there was no sign of it on the site. Thus, the current location of the bowsprit is unknown. The bowsprit has not fallen down, since it has not been located anywhere near the bow on the seabed.

Figure 23: The bowsprit still in its original place rising upwards from the bow between two metal-lined bitts. The bowsprit had six small “steps” on the top, and in between three steps an U-shaped wooden block with holes (on the right). There was also a metal semi-cylindrical lining, approx. 50 cm long after the steps, and a low cut-out neat the end of the bowsprit. Photos taken 11th August 2007.

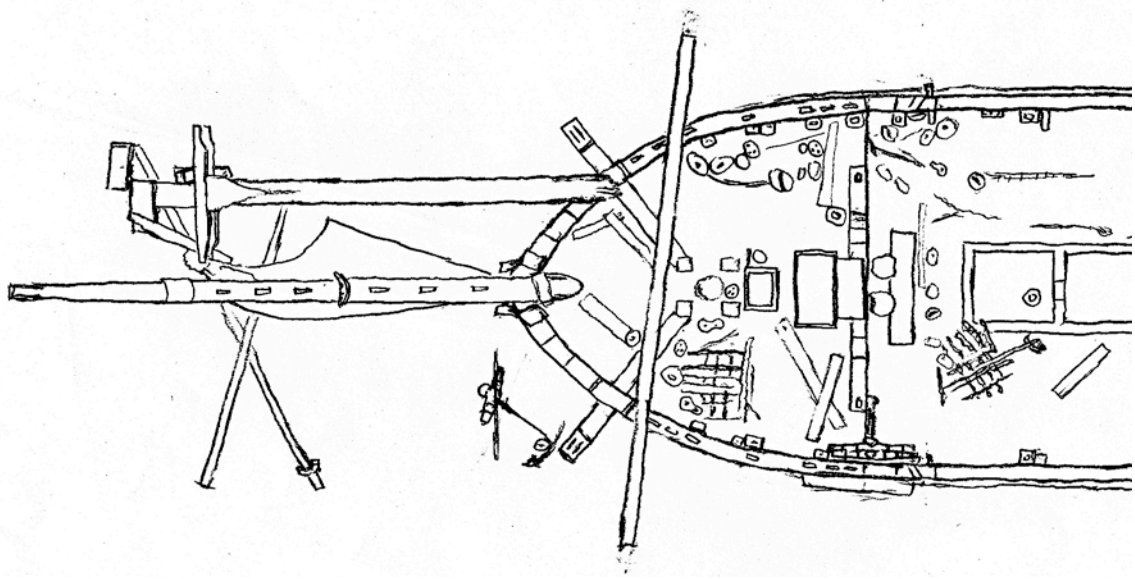
A yard was laying diagonally across the forecabin when the wreck was found. The fore mast had been broken at the deck level, and was hanging on the gunwale over the cathead on the starboard side. These were the location of the mast and booms at least until the 3rd September 2011 (see Figure 25). Observations made during the dive on 11th September 2011 are shown in the Figure 26. The bowsprit had disappeared and the yard and fore mast were relocated. The fore mast has also rotated 120 degrees along its axis as can be seen from the -trees.

Figure 25: This drawing shows how the bowsprit, yard and foremast were located still on the 3rd September 2011. The bowsprit was intact and in its place pointing up in an angle of 30 degrees. Drawing: courtesy of Pasi Raasakka (2006).

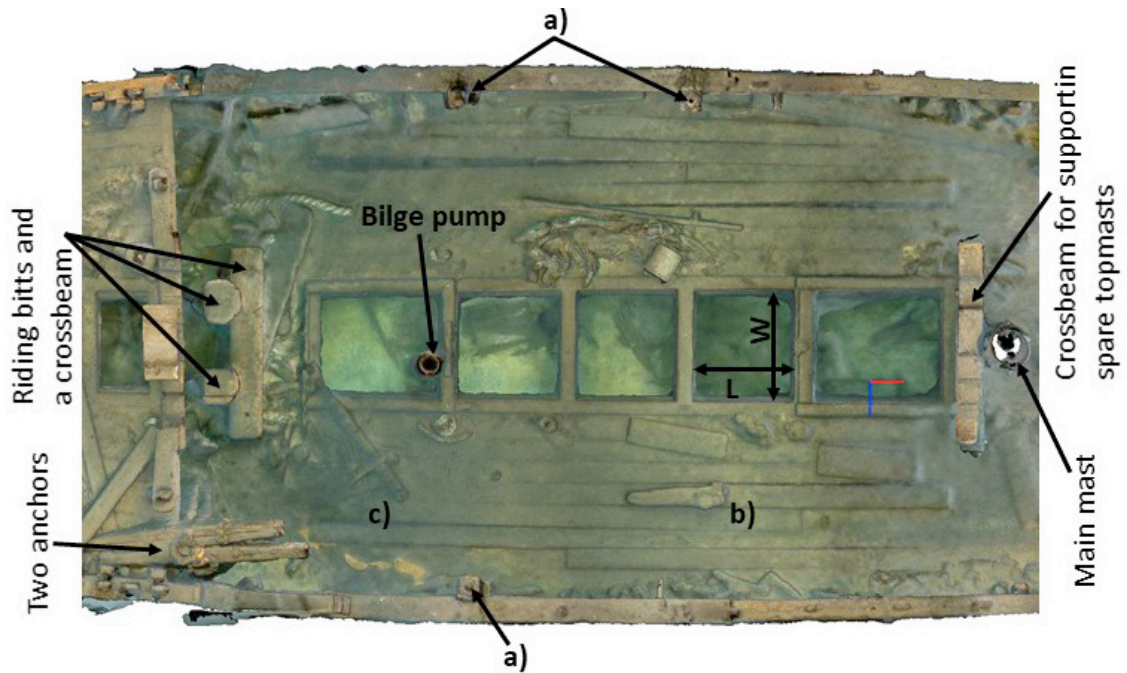
Figure 28: Deckplan of the 'gun deck' between the forecastle and the main mast. The length of the fourth hatchway is 120 cm, and width 135 cm \pm 1 cm (measured). The gunwale has bitts (a) for operating the guns. One bitt has fallen off and lays loose on the port side on the deck (b). 3D model orthometric view.

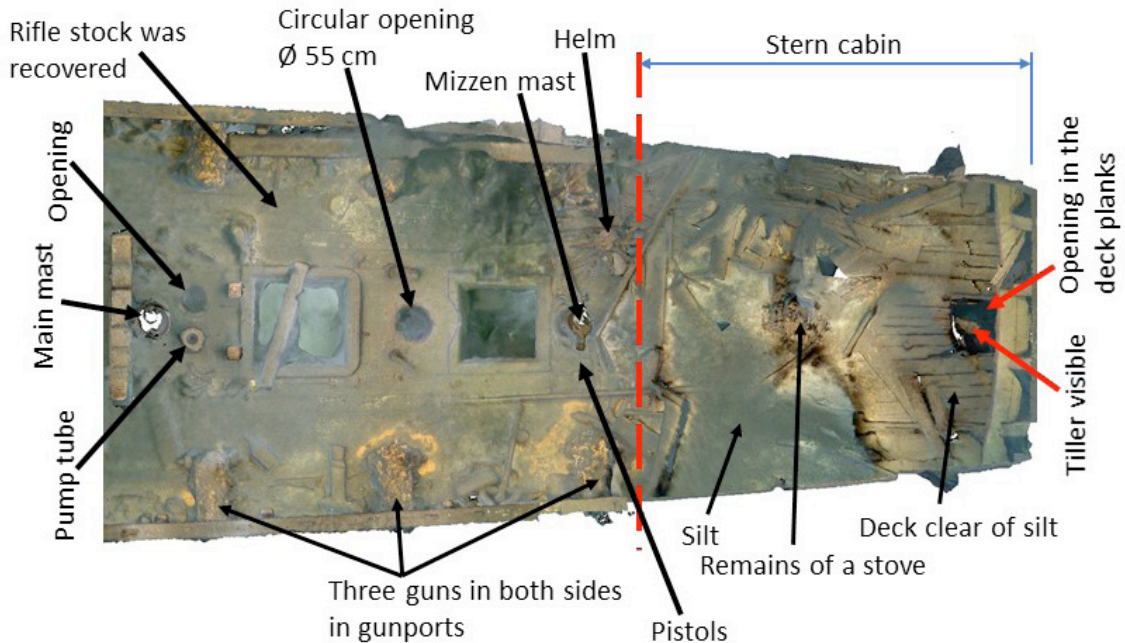
The gun deck continues below the poop deck. There is a small angle on the deck, but the deck is continuous, as there are no steps nor breaks between the gun deck and the deck of the stern cabin. The stern cabin has been isolated by a wall, which has now collapsed. Today, some loose planks mark the place of the original wall.

Figure 32: The deckplan of the gun deck abaft the main mast including the stern cabin. The gun deck continues without any steps or a break below the poop deck as a part of the stern cabin. Orthometric caption from 3D photogrammetric model (wales are not shown for clarity).

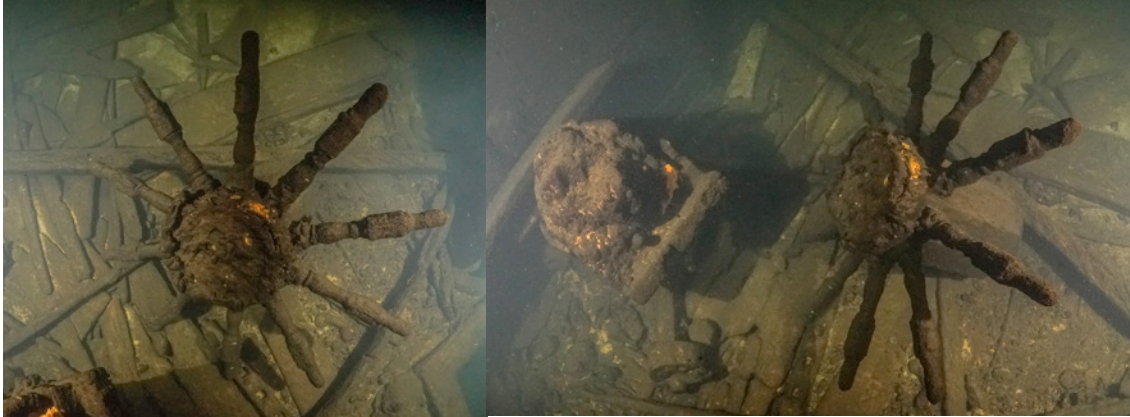
A broken, loose wheel of the ship is located on the gun deck, on the starboard side of the mizzen mast. The wheel has been located probably abaft the mizzen mast, in front of the stern cabin. The center part of the wheel has a diameter of 32 cm (measured by tape). It has 10 spokes, which are 44 cm long (measured by tape). The rim of the wheel has not survived.

Figure 33 (left): The wheel of the ship. The root of the mizzen mast is visible on the right image. The loose planks behind the wheel are possibly the remains of the stern cabin wall. Videocapture 6th August 2019.

Figure 34 (right): Wheel barrel visible behind the spokes. There is a gun in the left. The gun is the first of the three guns on the starboard site counting from the stern. Carriage has lost rear wheels and axel. Gun is listing downwards. Videocapture 6th August 2019

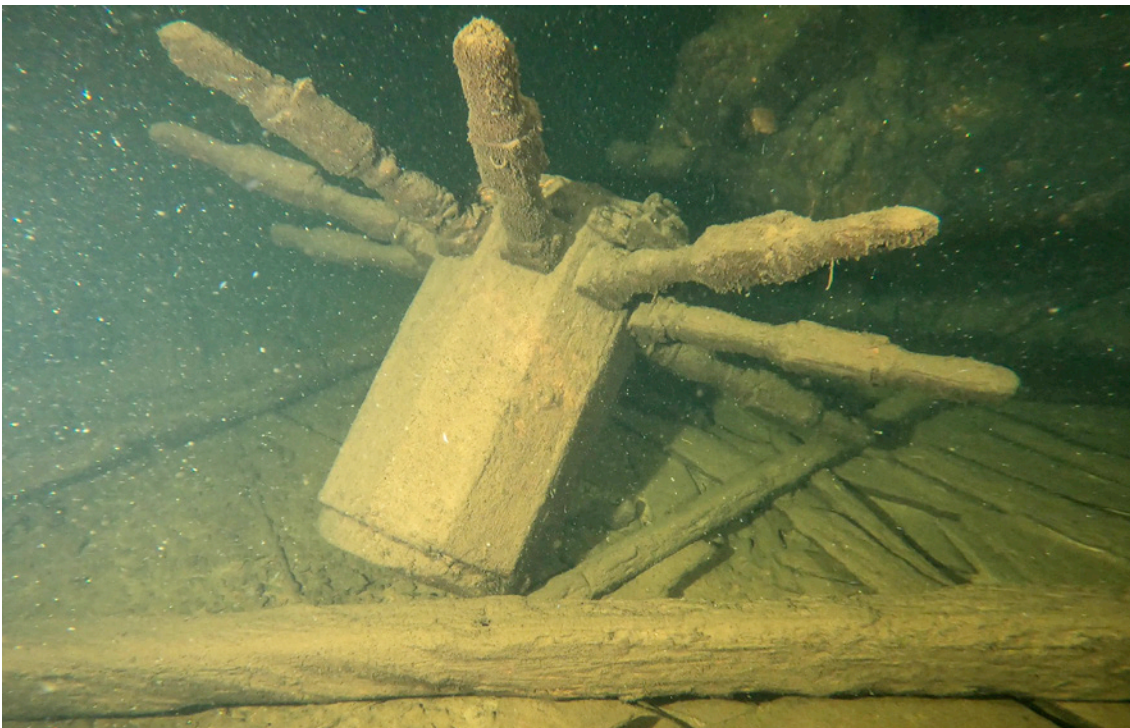
Figure 35: Wheel viewed from the stern cabin side, view towards starboard side bow. Videocapture 13th October 2020, video: Mikko Koskinen.

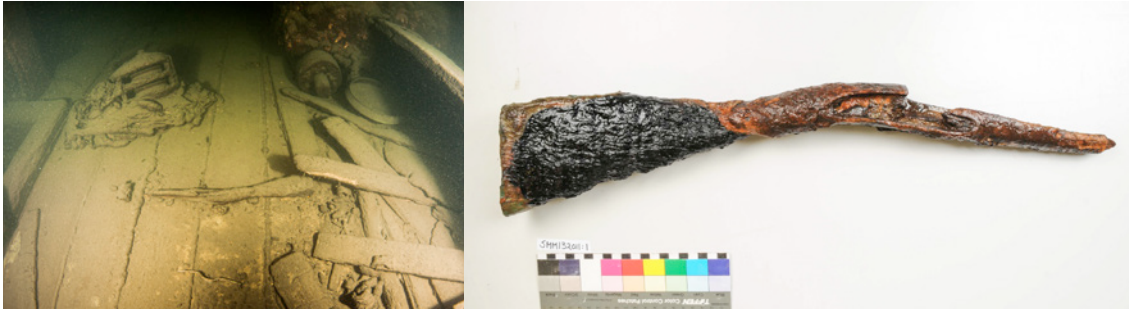
There was a rifle stock on the gun deck in the starboard side between the two foremost guns. Rifle was recovered by Finnish Heritage Agency in July 2011.

Figure 36: Left: rifle stock on the deck on 16th July 2011. Photo & copyright: Lauri Näreneva. Right: The recovered rifle during conservation in Finnish Heritage Agency. Photo & copyright: Lauri Löfgren/FHA.

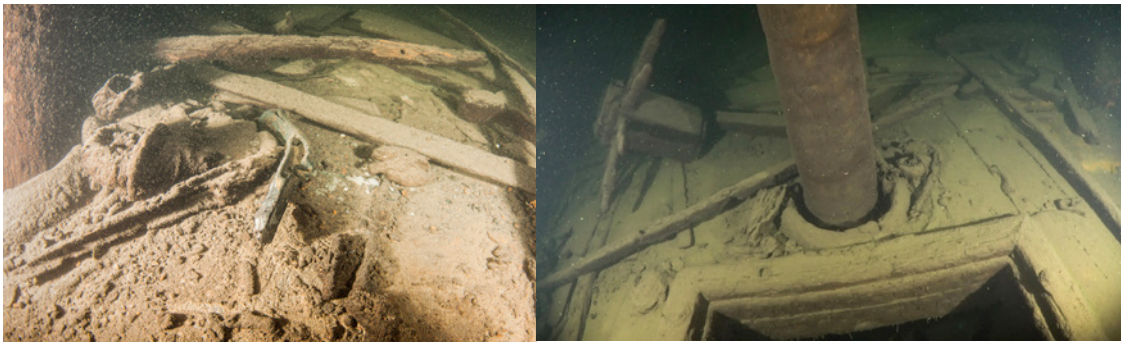
Figure 37 (left): Two pistols on the deck just beside the mizzen mast on port side on 16th July 2011, Photo & copyright: Lauri Näreneva.

Figure 38 (right): Today, there is only one pistol left, videocapture 8th August 2020.

- A small glass bottle from the deck which was found from the port side afore the first gun (counting from the bow).
- A few deadeyes and blocks have disappeared from the starboard side forecastle deck between the cat-tail and forecastle break (see Figure 9 and Figure 27).
- One pistol close to mizzen mast has disappeared (see Figure 37 and Figure 38).

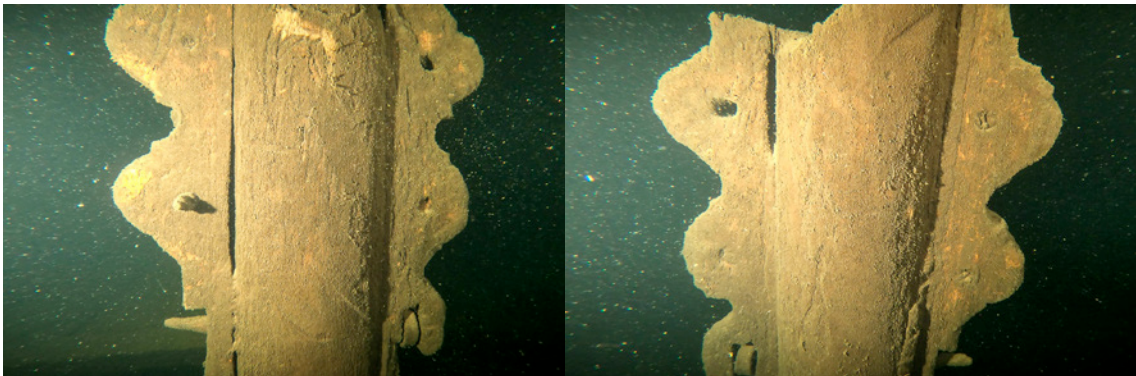
Figure 39: The mizzen mast is located in front of the poop deck on the gun deck. Mizzen mast has cut from ca 3 m from the deck (not measured). Just below the cut point, there are these features. The left image is towards the stern and the other towards the bow. Videocapture 13th October 2020, Mikko Koskinen.

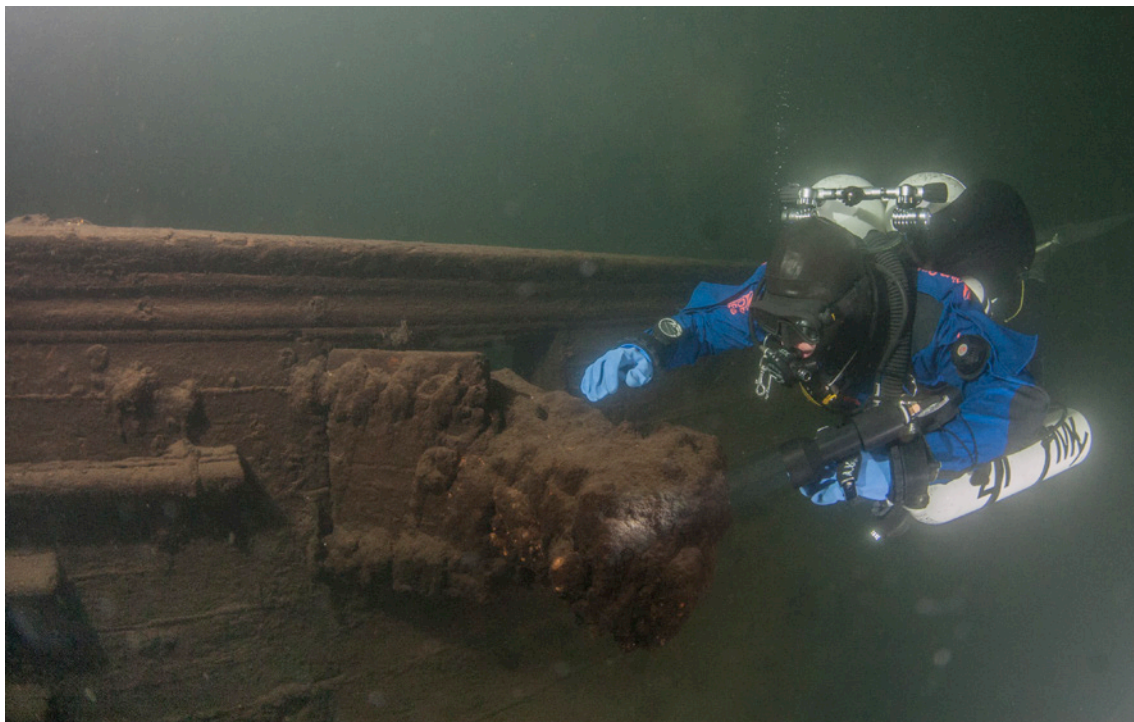
Figure 40: Diver inspects the first gun (counting from the bow) on the port side (4th gunport counted from the bow). On this gunport the lid hinges are on the bow side. Photo taken 11th September 2011.

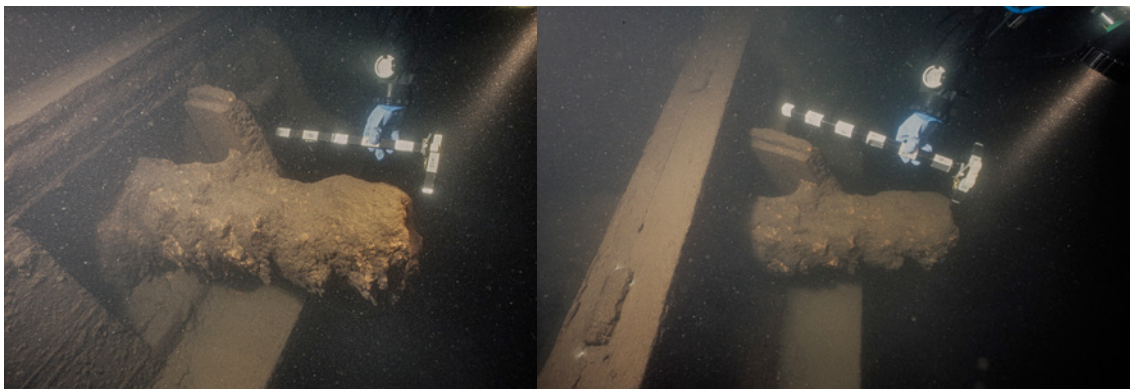
Figure 44: The first starboard side gun (counting from the bow). The main channel is visible below the gunport and gun. Measurement scale is 60 cm. Photo 18th July 2005, photo Jouni Polkko.

- The main channel on the starboard side has fallen (see Figure 44 and Figure 71).
- The fore channel on the port side has fallen.
- The curved ends from the poop deck fife rails have disappeared (see Figure 60).
- The decorated ornament piece from the starboard side gunwale break between the gun deck and the forecastle has fallen off (see Figure 11 and Figure 12).
- The port side lion head carving on the cathead has fallen down onto the seabed (see Figure 20 and Figure 21).
- The relocation of the the bowsprit, foremast and a yard (see Figure 25 and Figure 26).

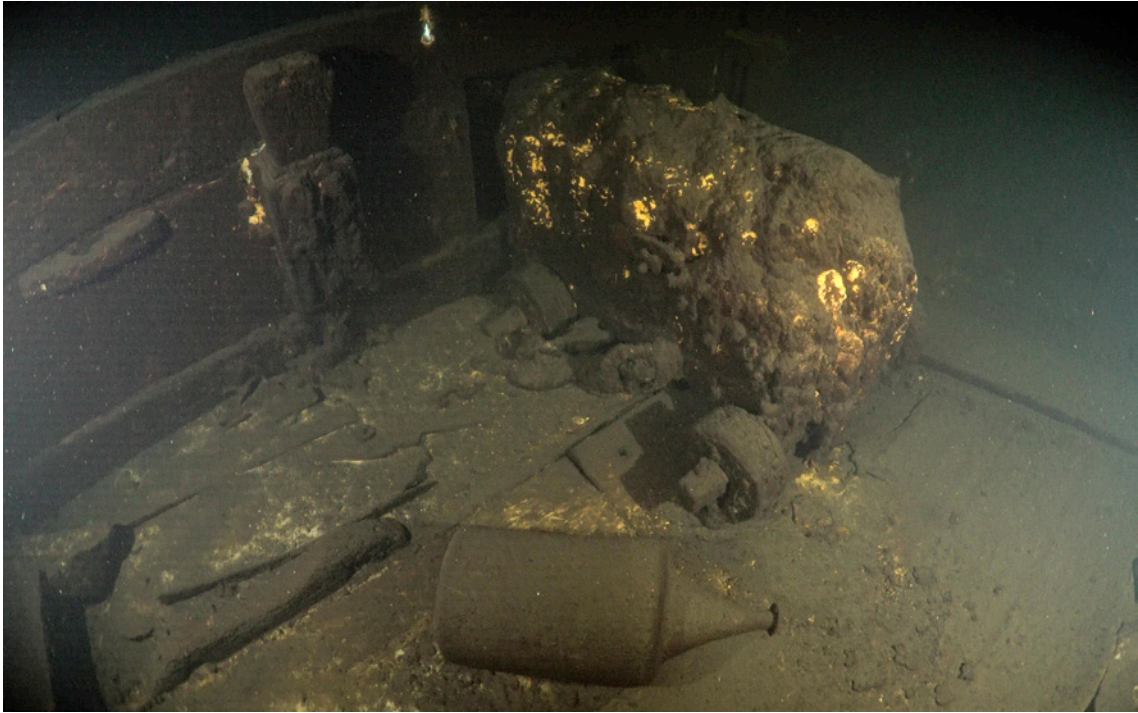
There are some equipment and/or accessories near the guns, that are related to them. For example a large bottle is located close to the port side first gun. This bottle may have been used for gunpowder. On the starboard side, there is a dish with a tip beside the first gun. Another more corroded dish can be found close to the middle gun.

Figure 46: *The first gun on the port side (counting from the bow). There is a large bottle beside the gun. Videocapture 23rd July 2018.*

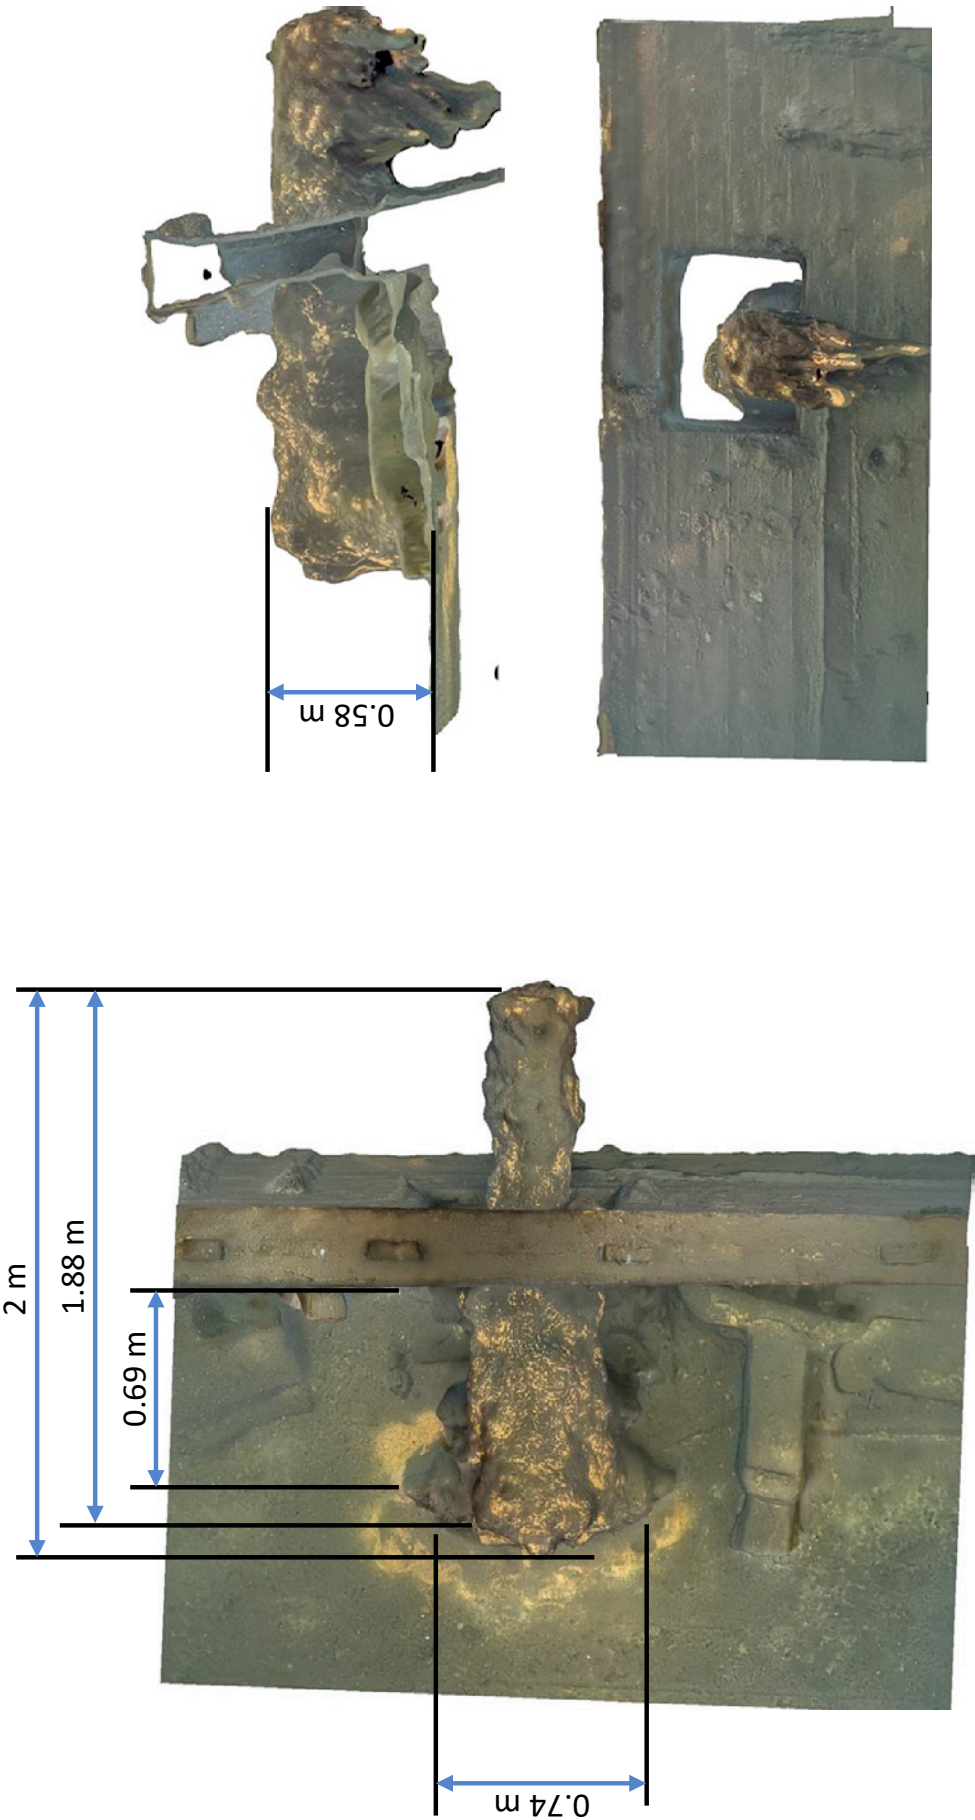
The length of one gun is approximately 2 m including cascable (measured & calculated from the 3D model). The length from the rear of the base ring to the face of the muzzle is 1.88 metres. The exact length is difficult to estimate, because all guns are seriously corroded. There is a thick layer of crust around them, and especially the face of the muzzle is very difficult to see. The cascable is rather clear, but again, the base of the ring is difficult to see. An assumption is made, that the inaccuracy of the abovementioned lengths is about ± 0.1 m.

The carriage axel length is 69 cm \pm 1 cm, and the track width measured from the wheels' outer surface is 74 cm \pm 1 cm. The axel length was measured from the second starboard side gun, and the track width from the third gun, counting from the stern. It is assumed, that all guns and carriages are identical. The size of the guns and carriages suggest a small calibre naval gun. Thus, the guns are probably 3 pounder or 4 pounder guns. The measured dimensions also comply with some 'finbanker' guns. However, to assess their origin is very difficult because of corrosion. As guns were sold, the designs were copied. Furthermore, guns were captured as prize of war, and used virtually by every navy. Current the limited data that has been gathered does not point to any precise origin, type or user, nor any manufacturer.

Figure 48: 3D photogrammetric model of the middle gun (2 nd from the stern) on the port side showing the axel length, track width (between the wheels' outer surface), height including the carriage and the length of the gun. Because of the corrosion especially on the muzzle face, the exact length of the barrel is difficult to judge. The accuracy of the lengths is approx. ± 0.1 m, and thus the gun could be roughly 1.9 m long. The location of trunnions are difficult to see. Orthometric view.

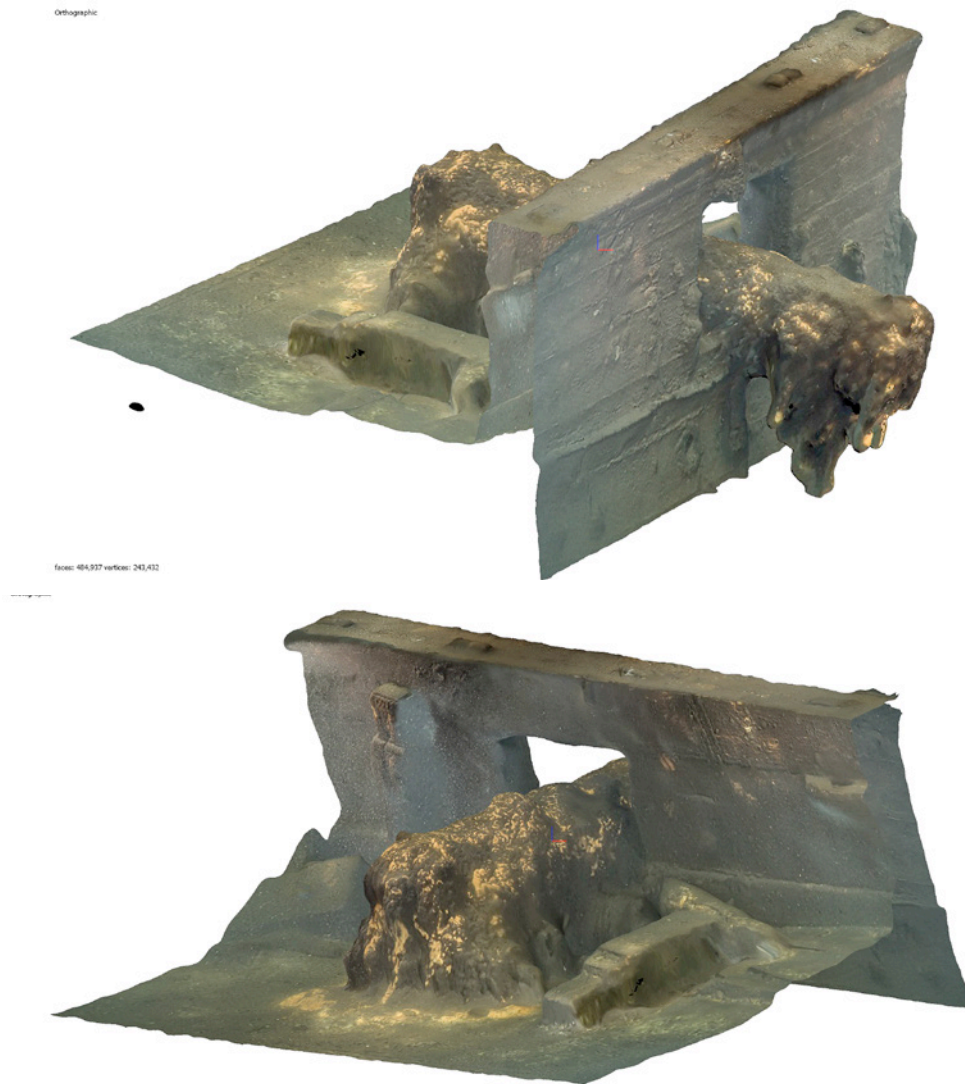
Figure 49: The middle gun on the port side (2nd from the stern). 3D model imagecaptures. Orthometric view.

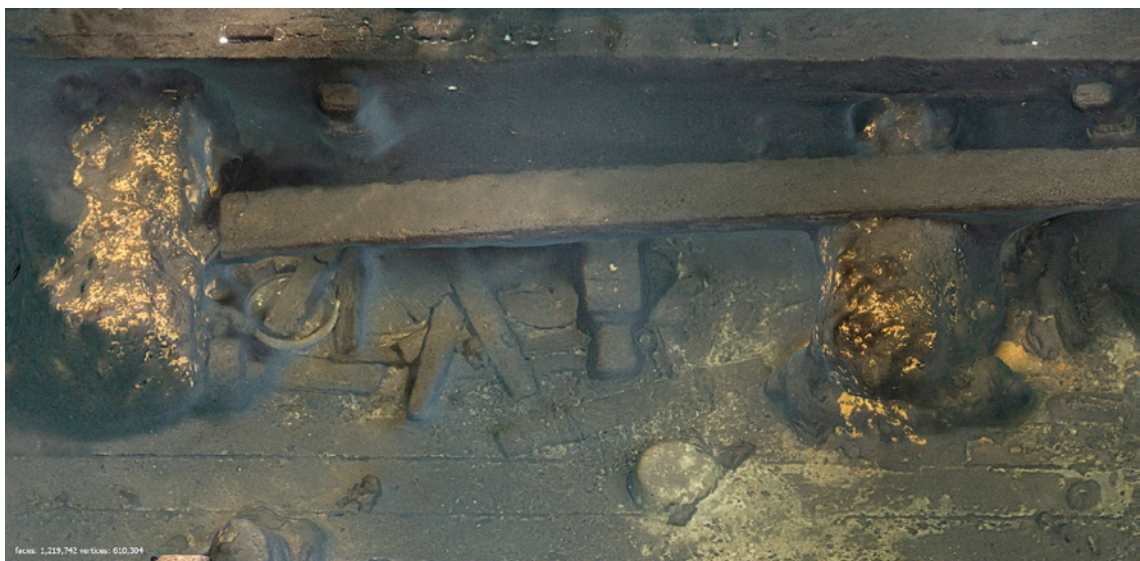
Figure 50: The two first guns on the starboard side counting from the bow (the bow is on the left). There are two round plates, possibly used for operating guns. It is also possible that the other plate is a lid for the other. The plank over the right gun is possibly from the poop deck. 3D model orthometric view.

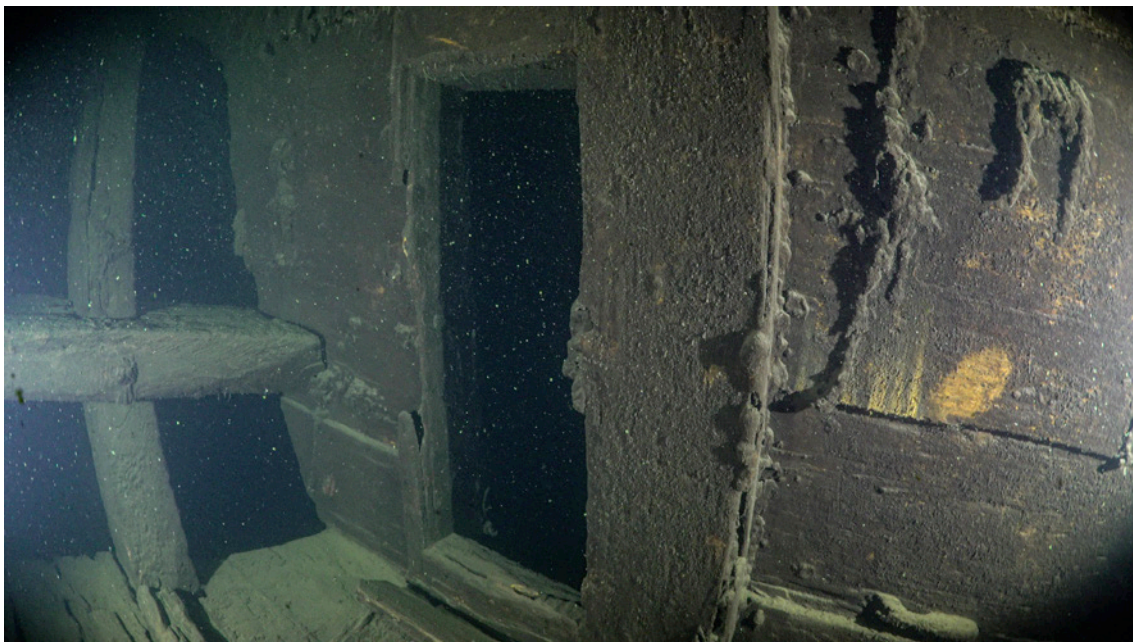
Figure 52: A view inside stern cabin. The access hatchway into the port side quarter gallery can be seen in the middle. Stern lights on the left. Videocapture 25th August 2019.

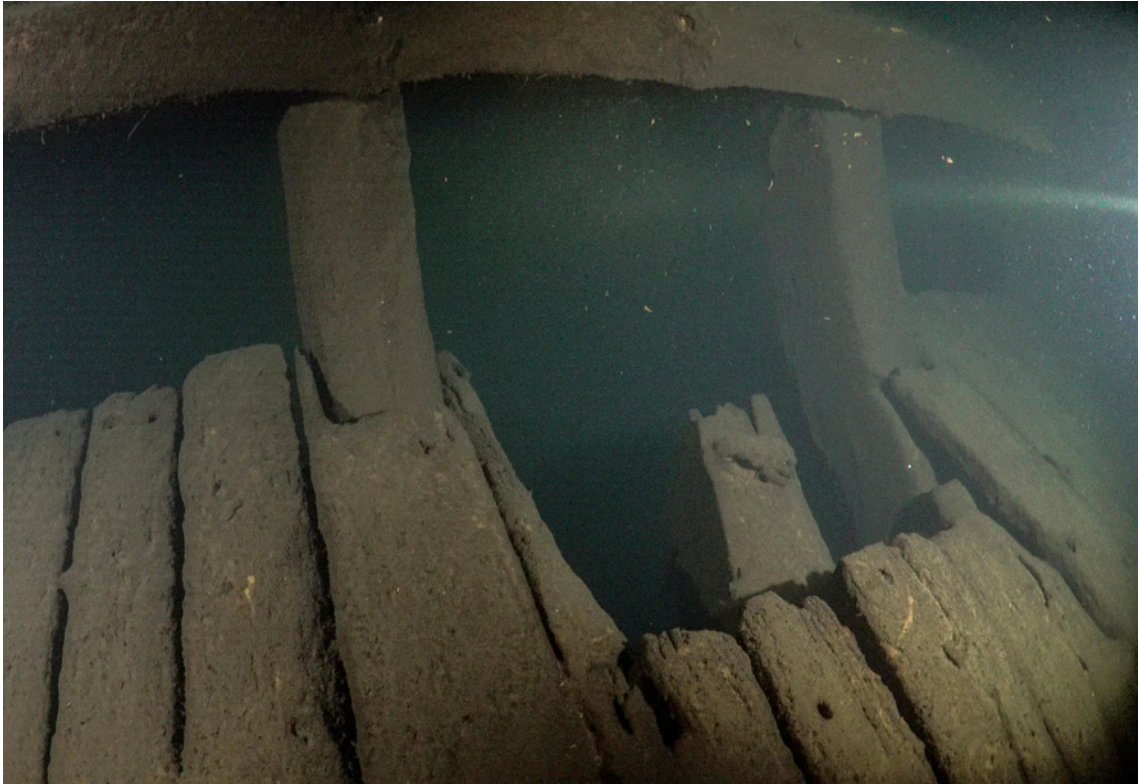
Figure 53: *Inside the stern cabin (view towards transom). The tiller is still visible inside the deck plank cutout. The helm port has been here.*

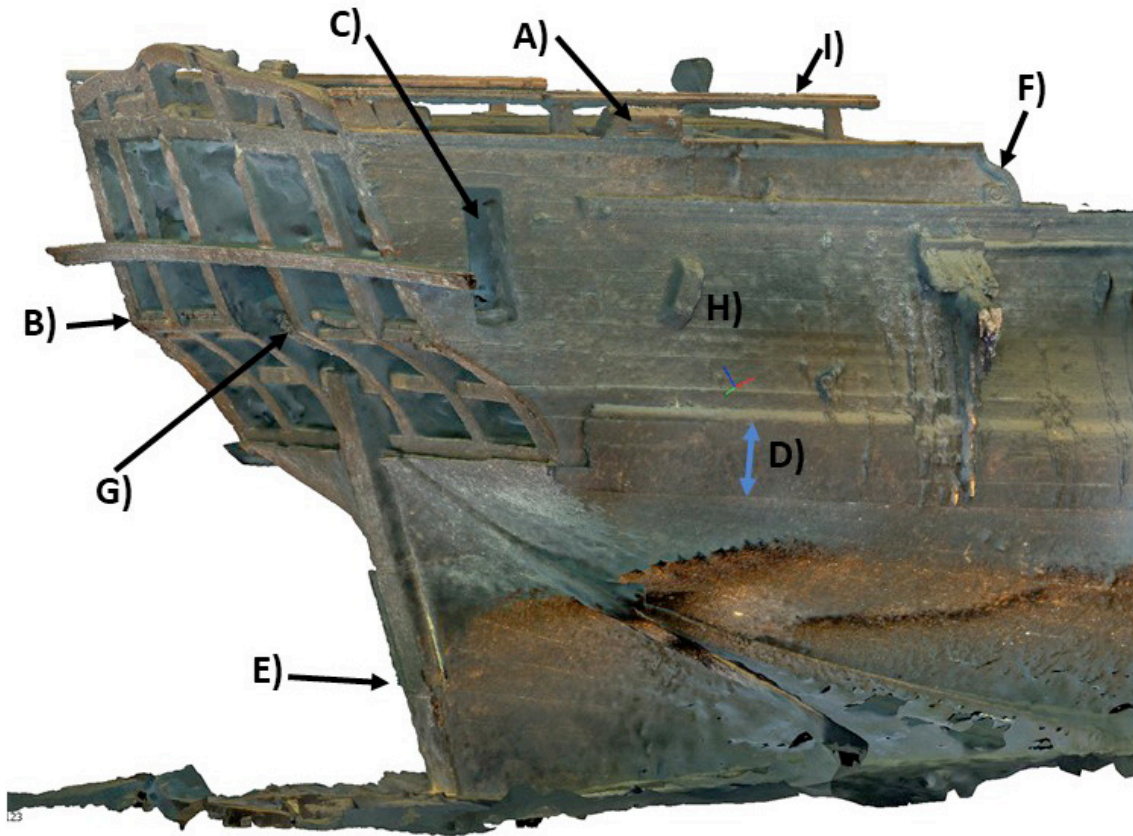
The hull in the lower parts of the stern is mostly intact. However, there are a couple of loose planks on both sides. There is no sign of a rudder, and no remains of a rudder have been observed anywhere at the bottom.

Figure 54: The stern (3D model, orthometric view):

- A) A block with shieves
- B) The level of the stern cabin deck
- C) Entrance hatchway into the quarter gallery (quarter gallery has collapsed to the seabed)
- D) Main wale
- E) Stern post
- F) The break of the gunwale is protected by metal lining
- G) The tiller is visible.
- H) A block with shieves
- I) Fife rails.

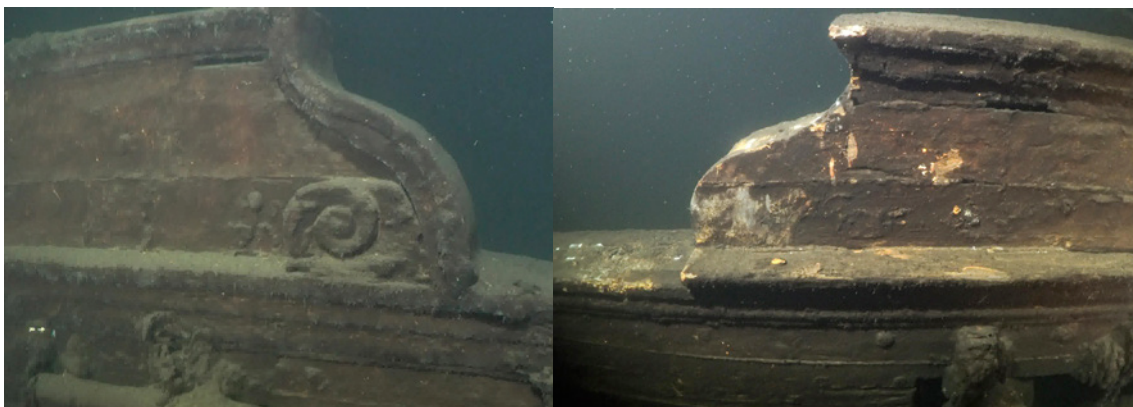
Figure 55: The left image shows the break of the gunwale (on the starboard side) which is protected by a metal lining and an ornament carving. Videocaption 26th July 2018. The right image shows the port side, where the ornament and metal lining are missing. There is an ornament on the seabed on the port side just near/below this point, which is probably the missing ornament. Videocaption 23rd July 2019.
