Wreck of an Unknown Armed Three-Masted Sailing Ship, Gulf of Finland

Badewanne Research Reports 1-2021

18th April 2021
Copyright © Badewanne Oy
Finland

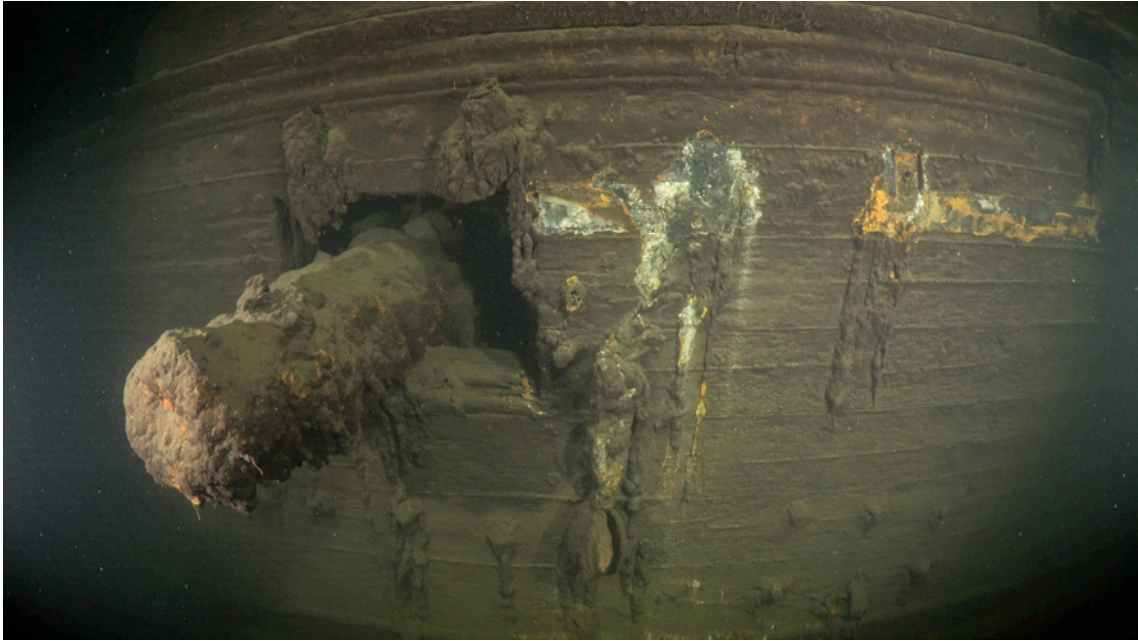
Figure 56: The port side gun closest to the stern. The marks on the right next to the upper edge of the gunport mark the location where the mizzen channel has been, and a deadeye is still hanging from it on a remains of a rope. The channel has fallen down and is probably on the bottom below. The channel has fallen before the discovery of the wreck. Videocaption 23rd July 2019.

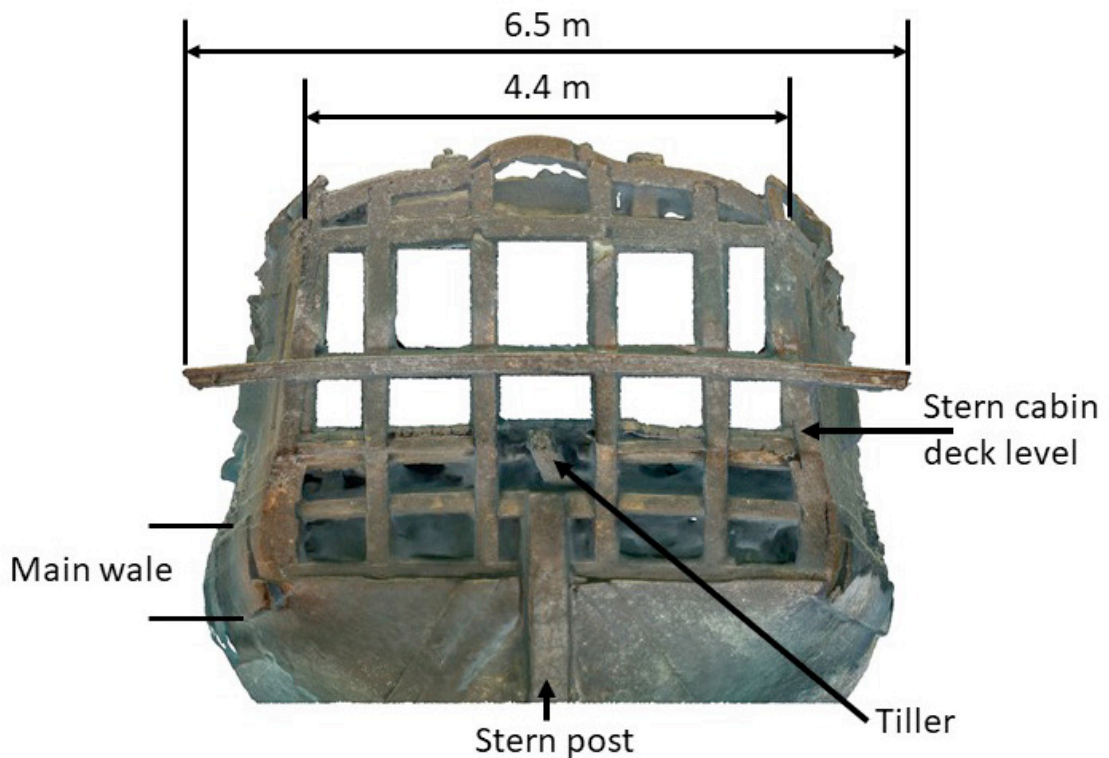
Figure 57: Orthometric view (3D model) of the stern and the transom. A 6.5 m wide crossbeam has supported the quarter galleries. All wing transom (below the stern cabin deck level) planks have fallen away, giving a view into the space where the tiller has been operated.

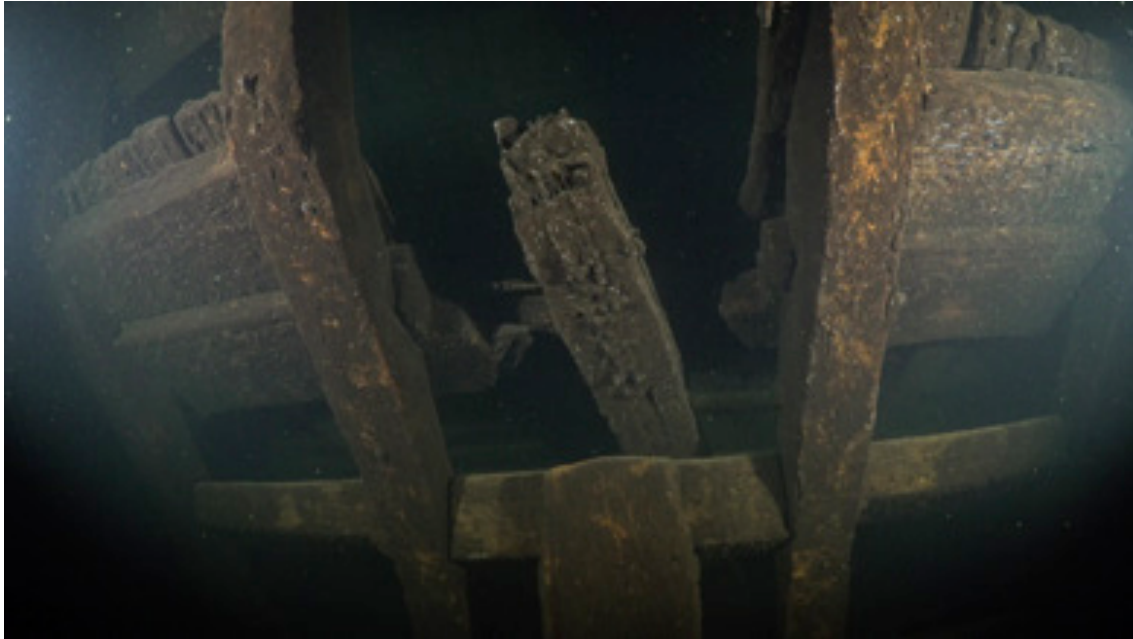
Figure 58: A view upwards below wing transom, towards the tiller and and the tiller port. The tiller is in the middle and the stern post below. Videocapture 8th August 2020.

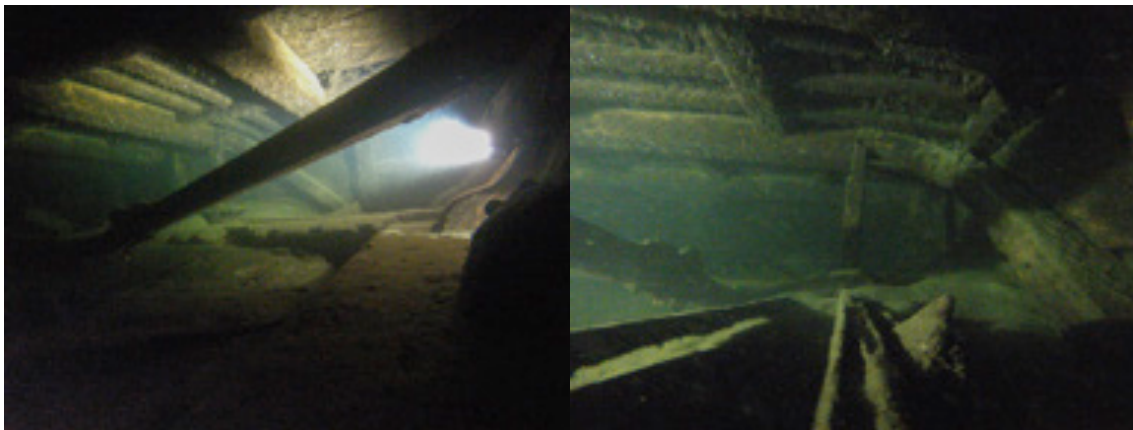
Figure 59: The views below the stern cabin through the wing transom. The left photo shows a view from the port side towards the starboard side. The tiller is visible in the middle. On the right, a view from the starboard side towards the bow. Tiller is visible here on the left. There are some fittings/hardware in the tiller, that are probably related to the turning mechanism. Videocapture 12th August 2020, video Jani Tattari.

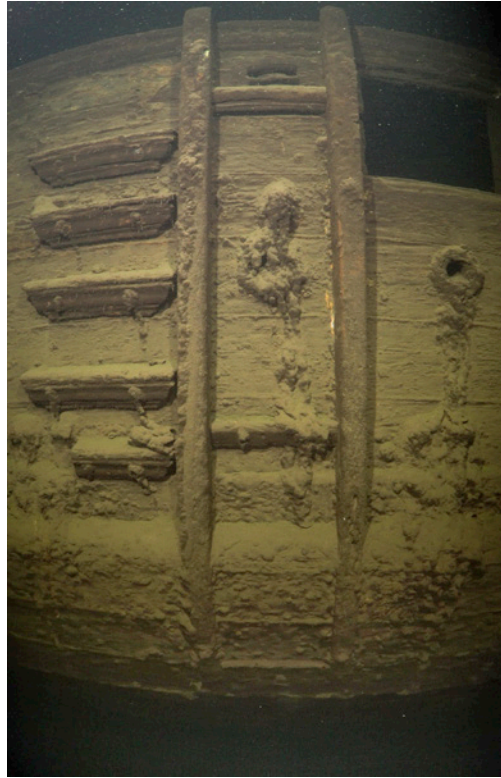
Figure 66: Details on the starboard side of the hull, a little bit forward from the main mast. Entry steps can be seen on the left. In the middle, there are two fenders. Between these fenders, the gunwale has two embedded sheaves for the fore sheet. Drain holes can be seen below the gunport there and between the fenders (for letting water out from the deck). The main wale is just under the entry steps. Above the main wale, there are two small lids with two corroded hinges. These features look like sweep ports. Videocapture 12th August 2020

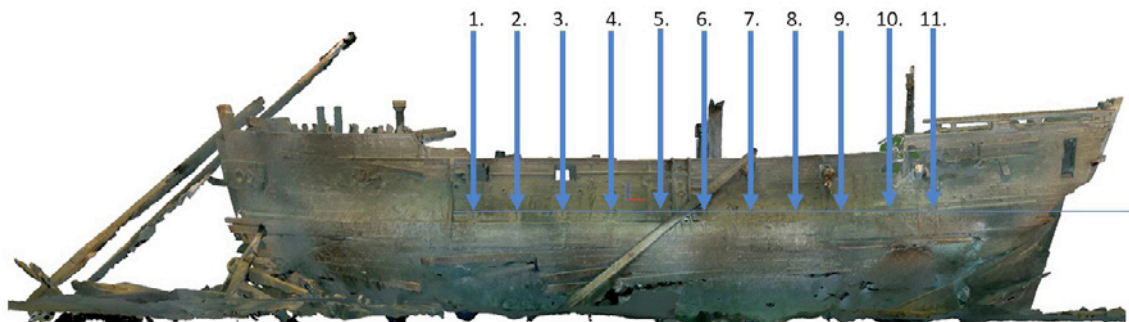
There appears to be hinged lids along the hull, above the main wale. They are most probably sweep ports. There are 11 of these 'sweep ports' on both sides. These sweep ports seem to be located on a constant level above the waterline. Equal intervals and locations of these features strongly points to sweep port function. As the main wale rises a bit towards the stern, the main wale below the last sweep ports have cutouts. It looks like the cutout is for both the lid, and for allowing the movement of an oar. It is possible that shorter oars were used in the stern, requiring a steeper angle to reach the water.

Figure 67: Location of the sweep ports in the port side. There are 11 sweep ports in the same locations in the starboard side. Orthometric view, 3D model.

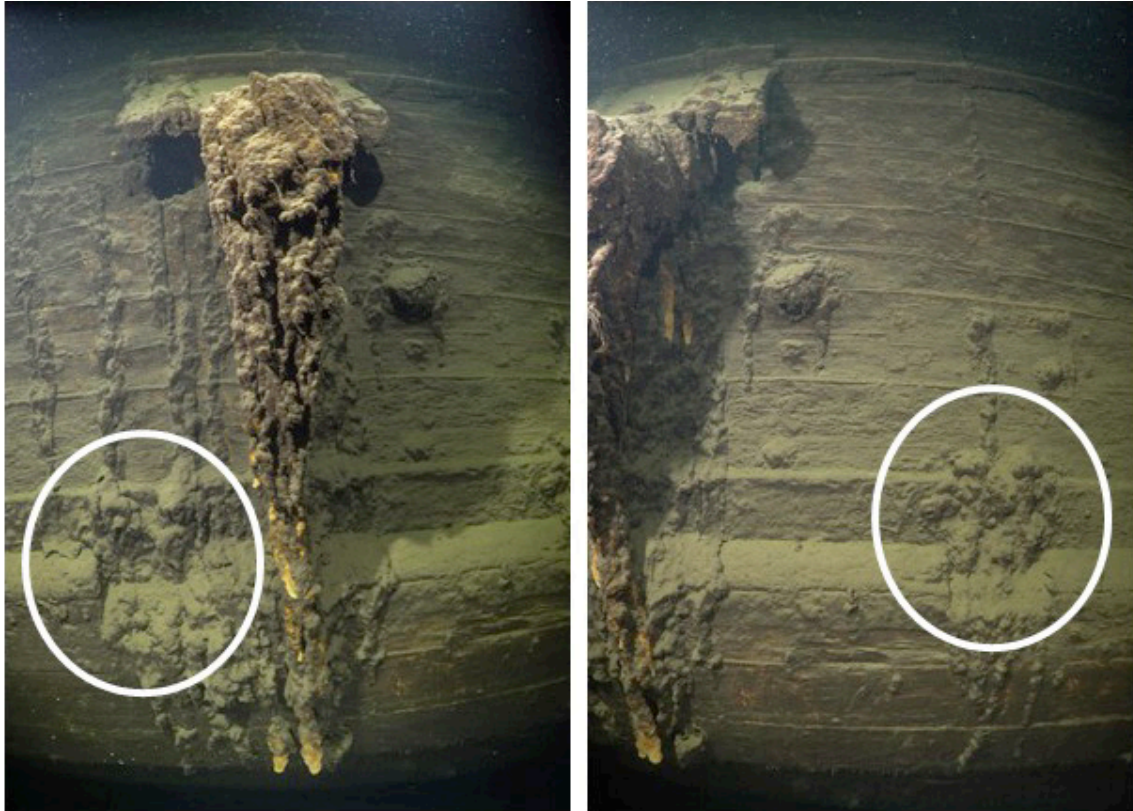
Figure 68: Presumed sweep ports closest to the stern on the starboard side. There are cutouts in the main wale, which could be for allowing the movement of the oars and the sweep port lid to open. It is also possible, that shorter oars were used in the stern, where the ship is narrower, requiring a steeper angle downwards for rowing. Videocapture 12th August 2020.

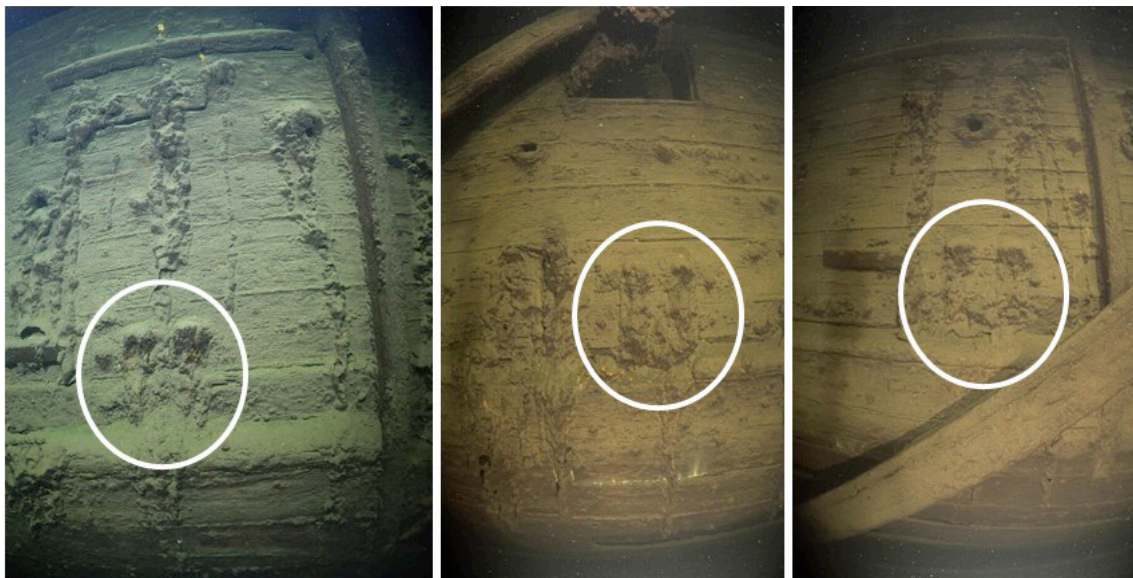
Figure 69: On the left, there is the first (recognized) sweep port from the bow on the starboard side. On the right, there is a single fender, located bit abaft the forecastle gunwale break. In the middle and on the right there is a sweep port below the first port side gun (counting from the bow), and on the right another sweep port beside the first of mid-ship double fender.

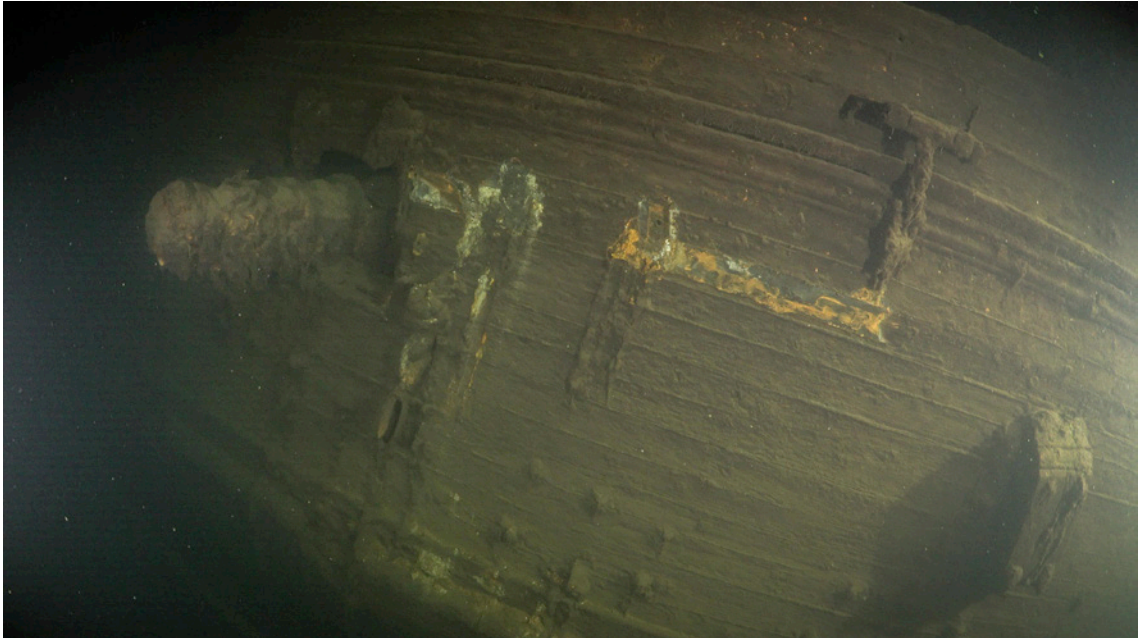
Figure 70: *The first gun from the stern on the port side can be seen on the left. There are clear marks where the mizzen channel has been (on the level of the gunports' upper edge). It looks like the mizzen channel has had two separate channel plates. The small dark dots are probable attachment point for chain plates. There is a fixed rectangular block with shieves on the right corner. Videocapture 23rd July 2019.*

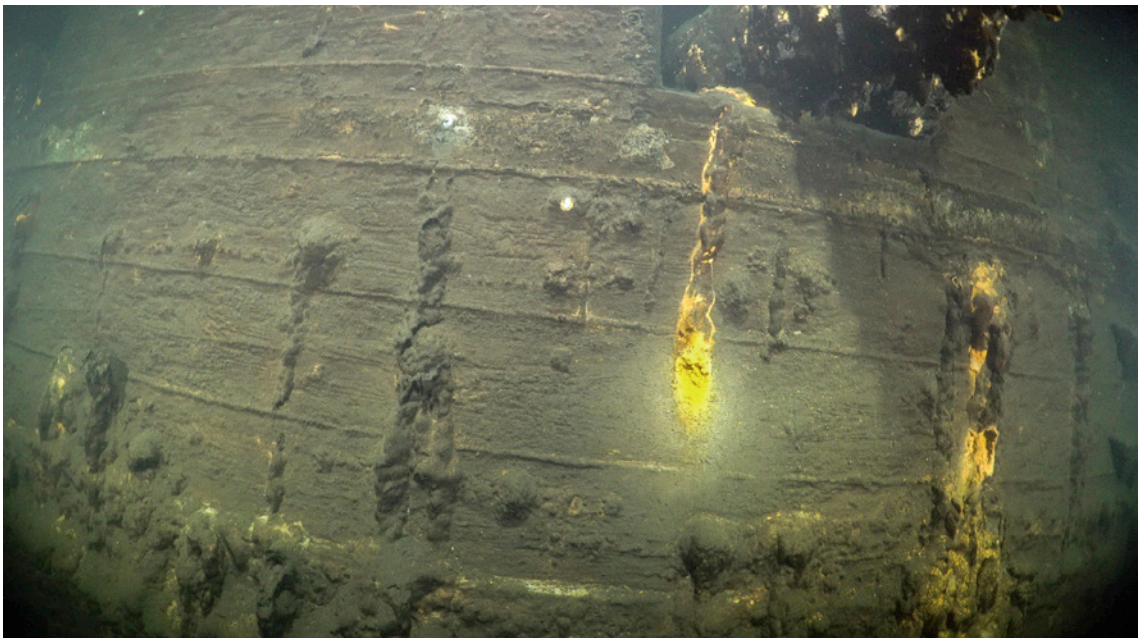
There were two channels still in place when the wreck was discovered in 2003. The main channel was on the starboard side and fore channel on the port side. Today, they have fallen down probably because of aging.

Figure 71: *The third gun from the stern on the starboard side is in the up right corner. The main channel has been below the gunport. There are various probable attachment points for the chain plates/shrouds. Below the gun in the bottom of the picture there are corroded hinges of a sweep port lid.*

- The main channel on the starboard side has fallen (see Figure 44 and Figure 71).
- The fore channel on the port side has fallen.
- The curved ends from the poop deck fife rails have disappeared (see Figure 60).
- The decorated ornament piece from the starboard side gunwale break between the gun deck and the forecastle has fallen off (see Figure 11 and Figure 12).
- The port side lion head carving on the cathead has fallen down onto the seabed (see Figure 20 and Figure 21).
- The relocation of the the bowsprit, foremast and a yard (see Figure 25 and Figure 26).

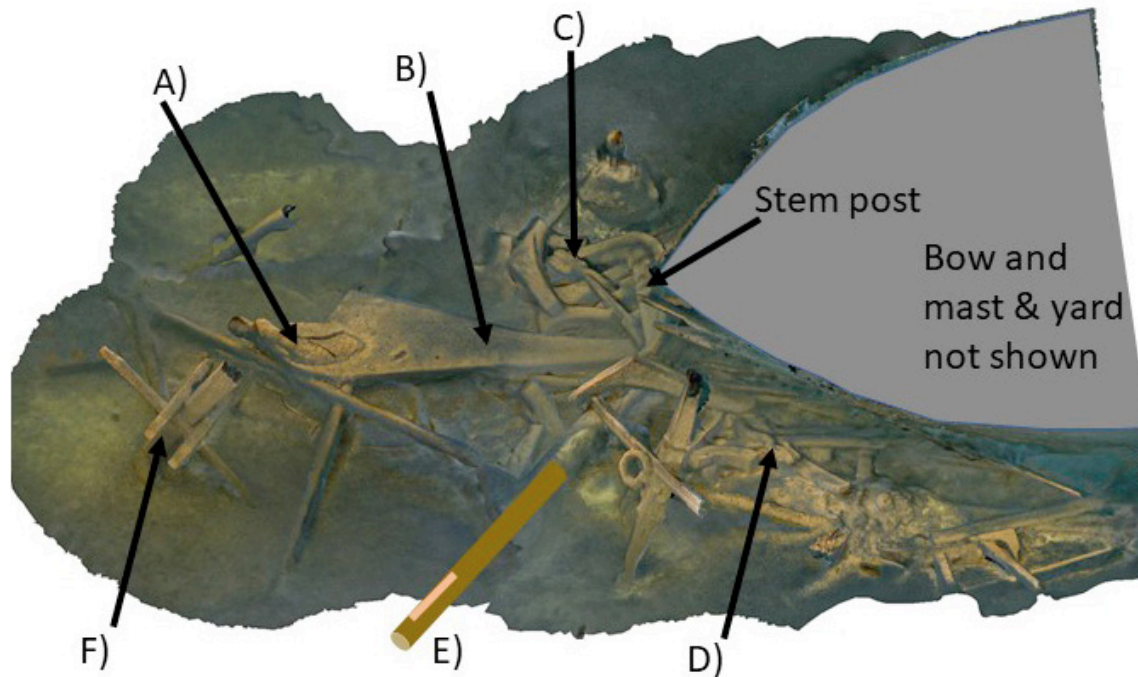
There are plenty of unidentified wooden objects and parts of the head assembly, laying in front of the stem post. There include objects such as head rails, head timbers and brackets. Some parts have matching marks on the hull planks above.

Figure 72: The orthographic view of the 3D model shows the debris field below, and in front of the bow.

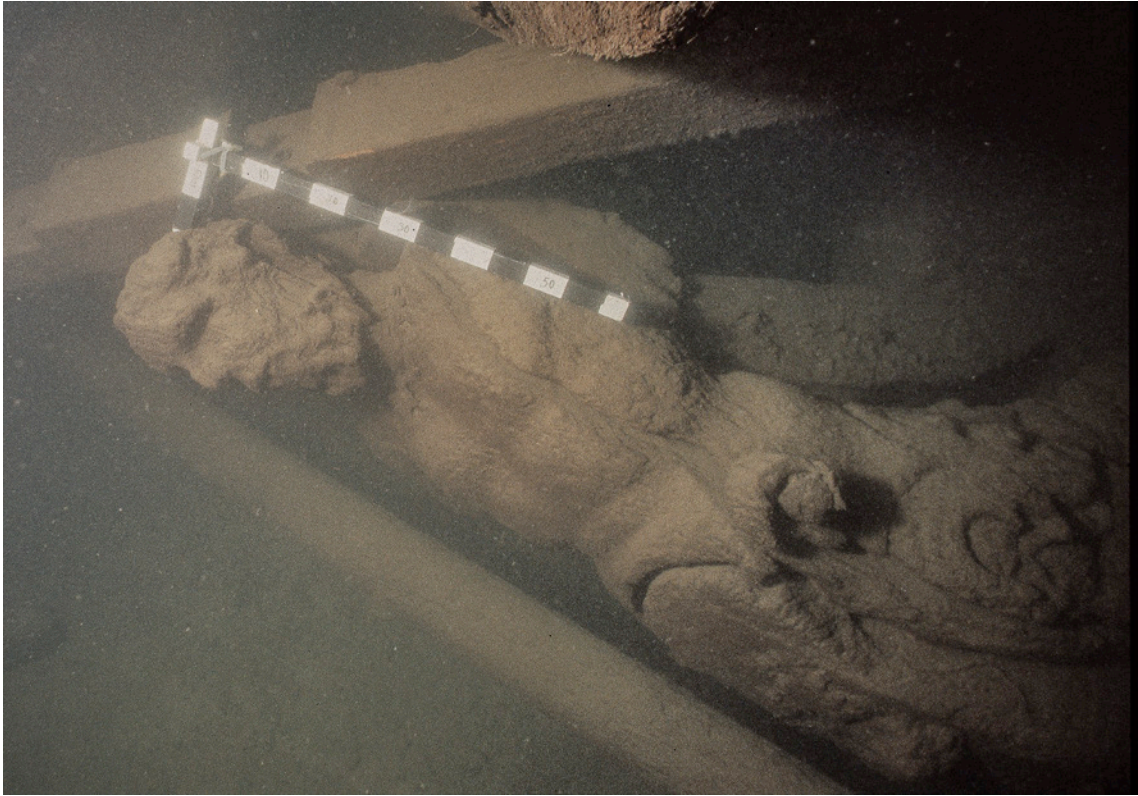
Figure 73: *The figure head as discovered (18th July 2005).*

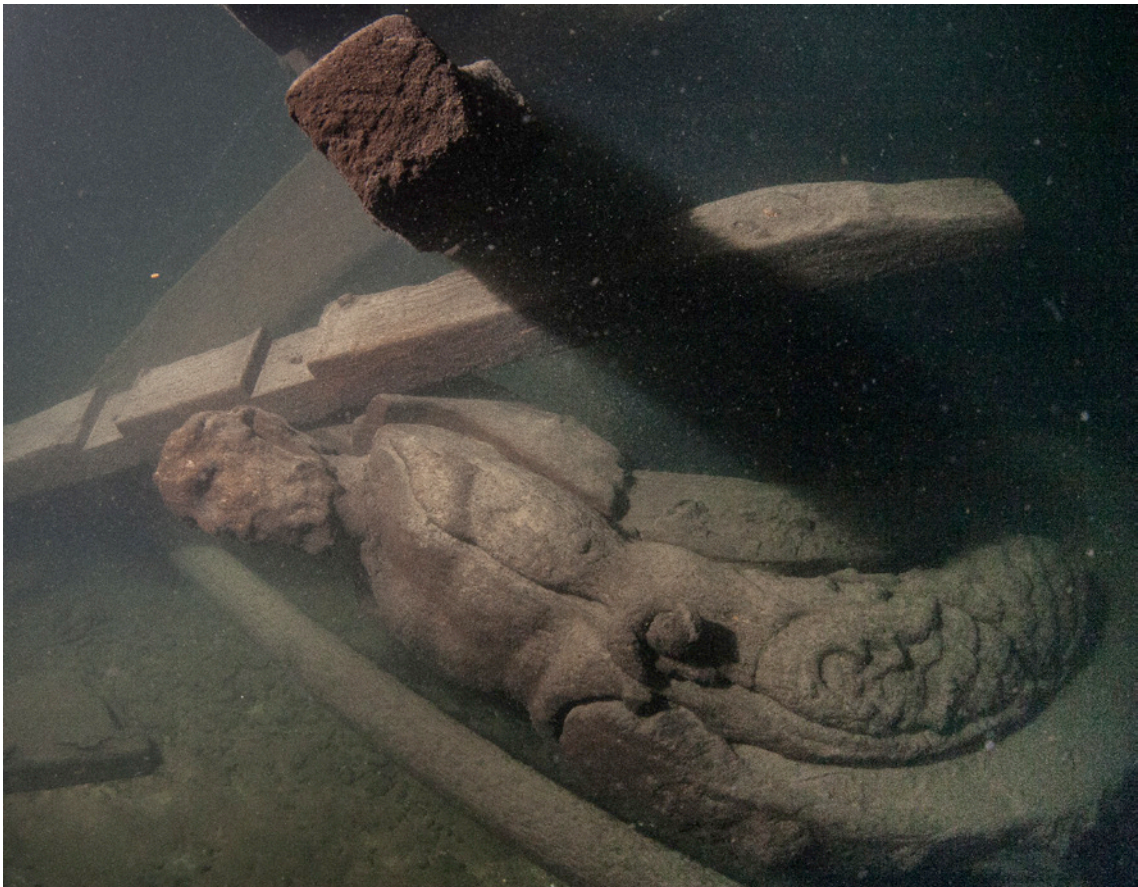
Figure 74: *The figure head still in the condition it was found (11th August 2007, photo Jouni Polkko). The beam pointing towards the camera is one of the trestletrees of the fore mast. In front of the figure head is a loose crosstree from the fore mast. The fore mast is behind the head figure.*

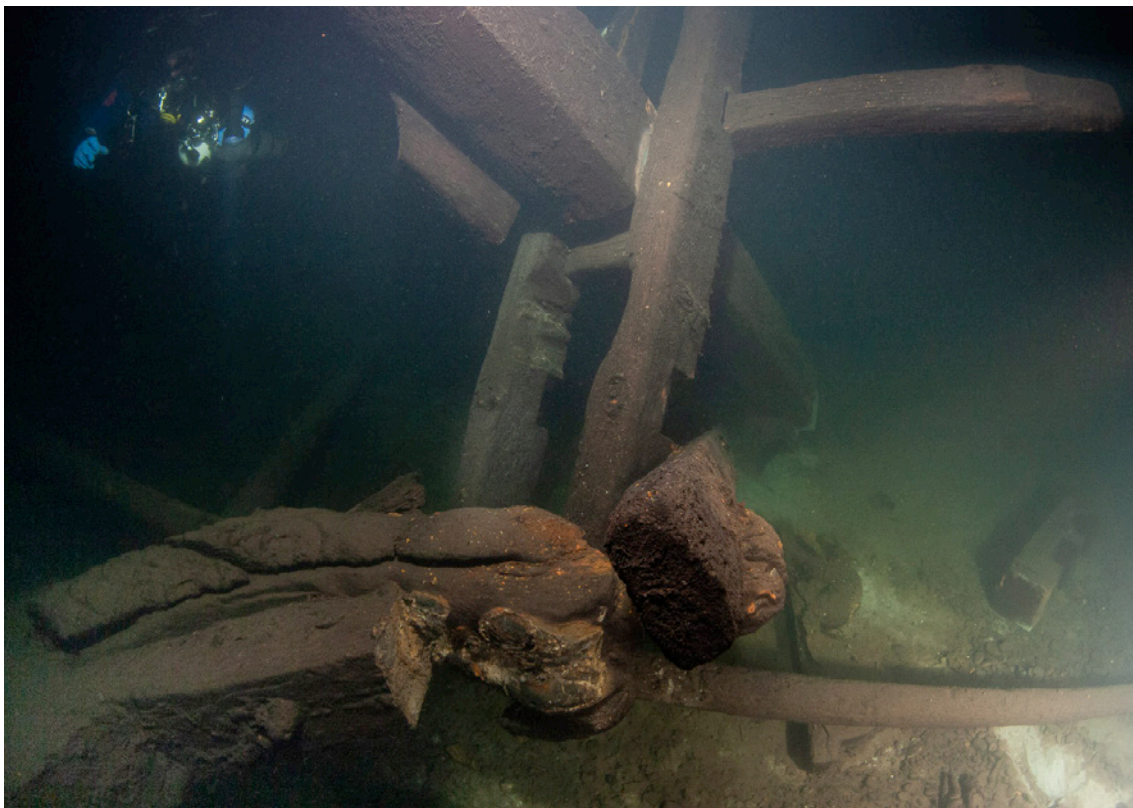
Figure 76: The details on the trestletrees on the fore mast are visible. There is one crosstree in place. The back of the head figure is facing the camera on the bottom. A beam is over the figure head. Later it was removed by an unknown diver possibly to save the neck of the head figure from the weight. Photo 11th September 2011.

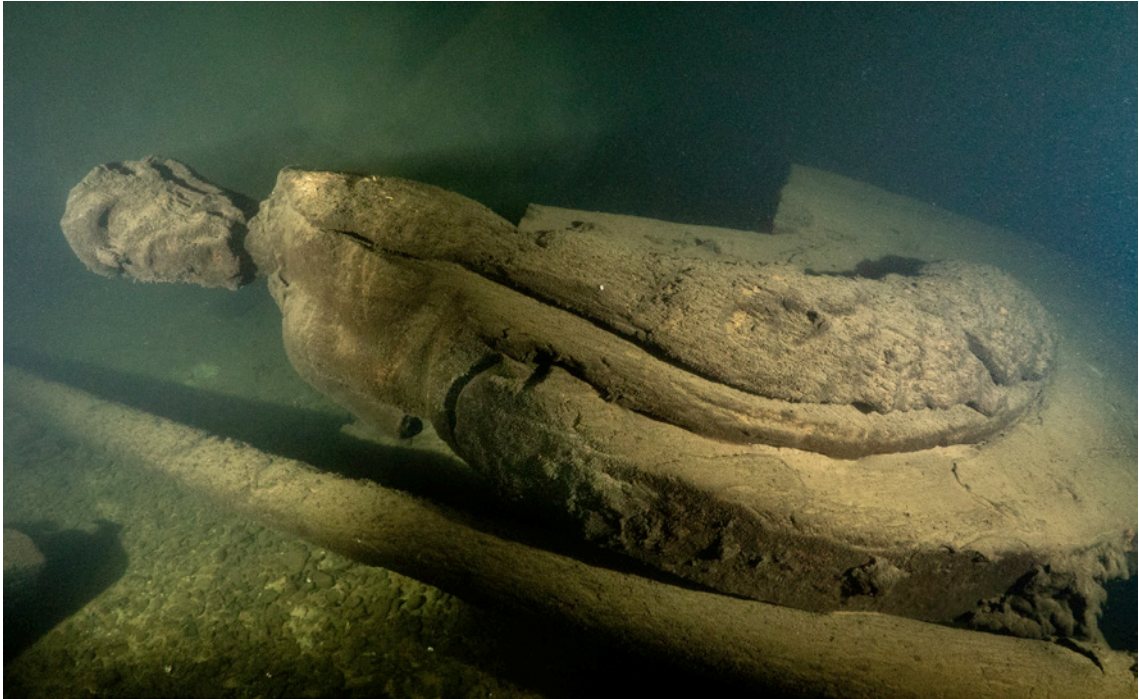
Figure 77: (A) *The figure head (present day) Photo 30th November 2020.*

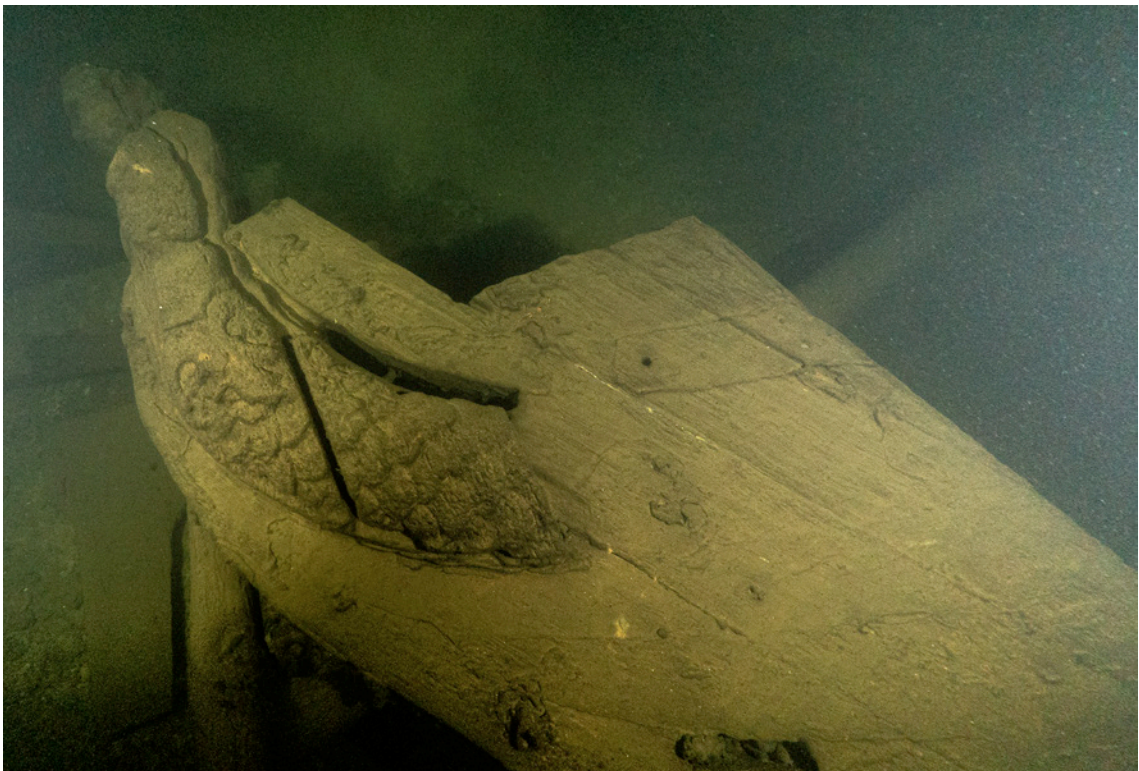
Figure 78: (B) *The knee of the head. Photo 30th November 2020.*

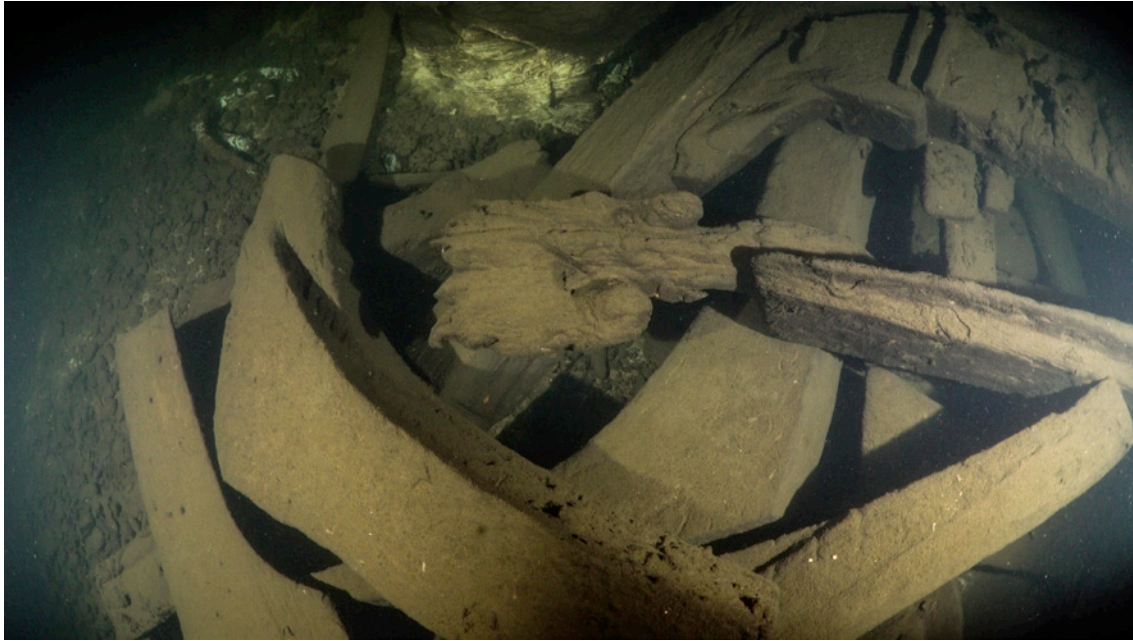
Figure 79: (C) A wooden carving in the middle is probably the starboard 'foot' of the head figure. Photo 30th November 2020.

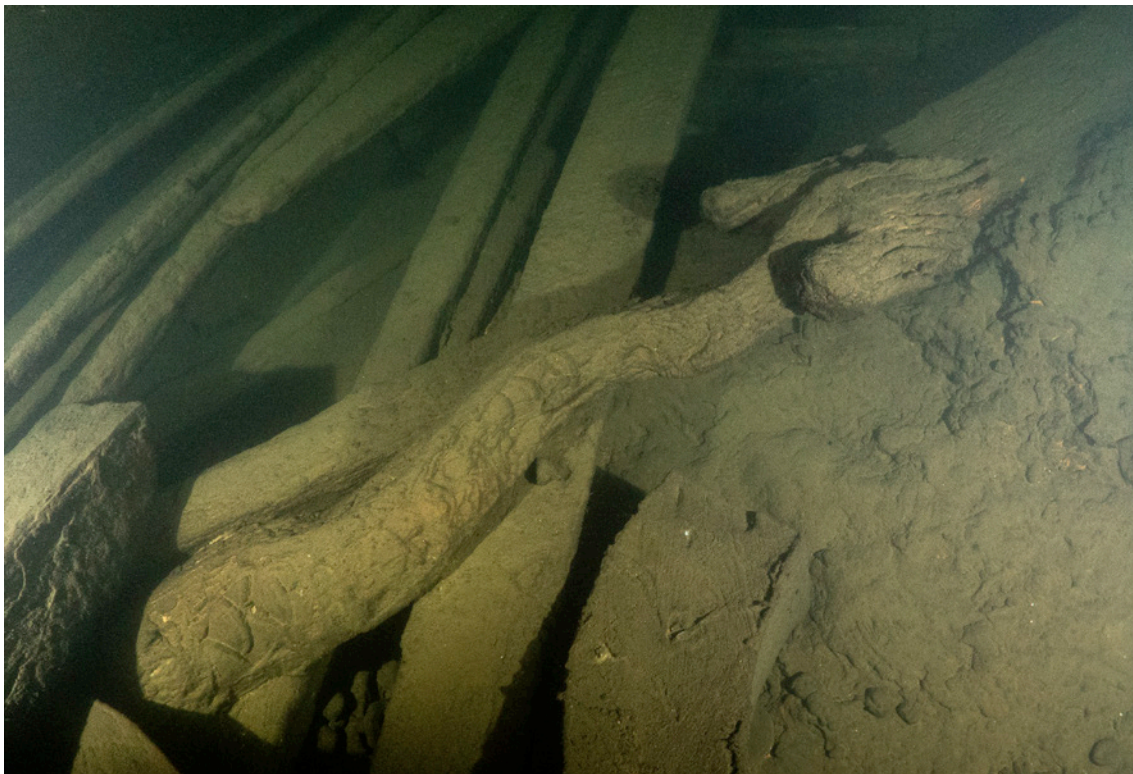
Figure 80: (D) The possible the port-side-foot of the head figure. Photo 30th November 2020.

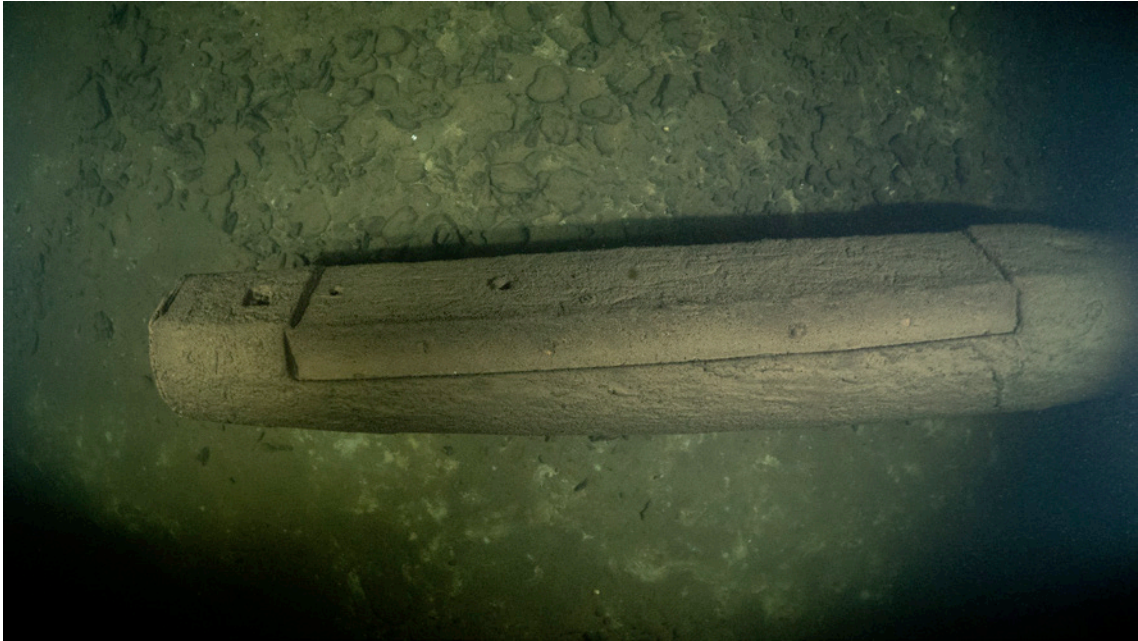
Figure 81: (E) The end of a boom. Whether this is part of fore mast, or something else, is not known. The missing bowsprit had a very similar cut cutout in the end. However it is unlikely that this object could be the bowsprit as it lacks some of the features of the bowsprit, and because the other end is below several objects in front of the stem post. It could be an extension of the bowsprit, i.e. a jibboom. Photo 30th August 2020.

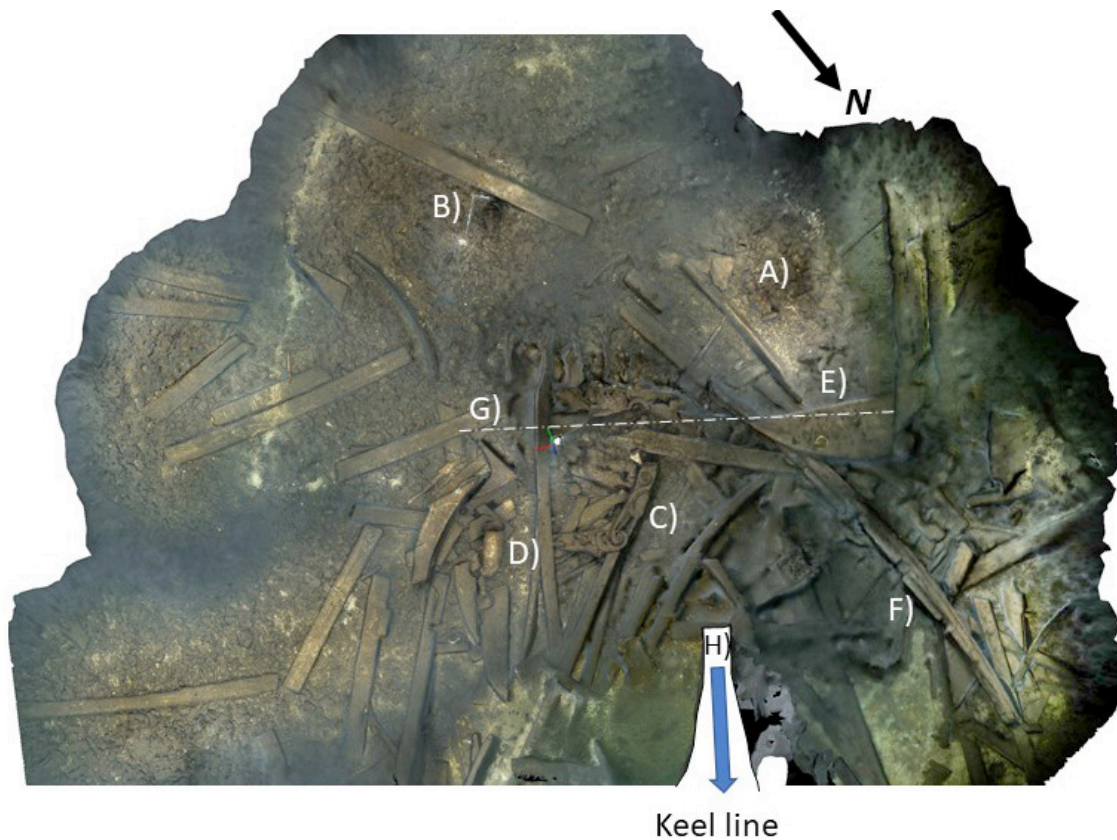
- A) A wooden bust sculpture (possibly a woman)
- B) A wooden sculpture head with a Roman or a Greek style looking helmet
- C) Lots of carvings, including a half of a head and a torso figure in a carved frame, and a carving looking like mens' feet
- D) Remains of the quarter gallery wood work, an object looking like a toilet
- E) A possible floor or a ceiling piece of the the quarter gallery
- F) A curved crossbeam with slots, matching with stern timbers
- H) The stern post

Figure 82: Orthometric map from above of the debris field below and behind the stern. H) is the stern post at seabed level. G) marks about the level where the end of the poop deck extends. There are lot of carved woodwork around C, which is just below the stern lights. Details explained in the text.

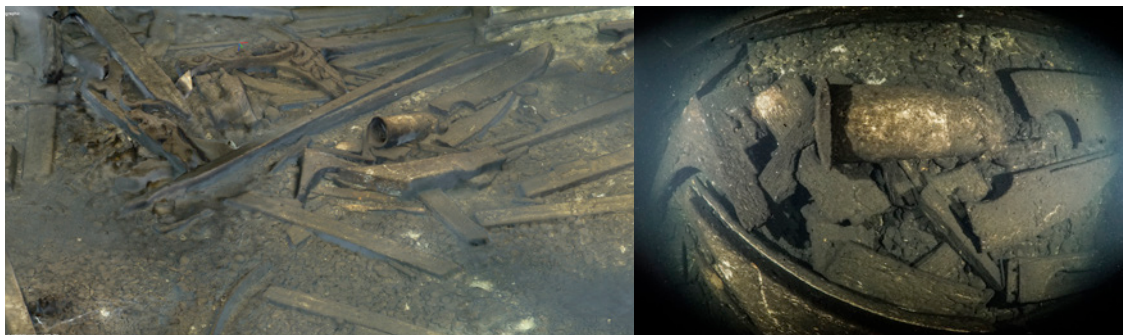
Figure 83: On the left, a 3D model orthometric viewcapture, toilet bowl and remains of the starboard side quarter gallery. Wooden carvings can be seen in the left corner. On the right, a photo of the toilet bowl. Photo 4th August 2019.

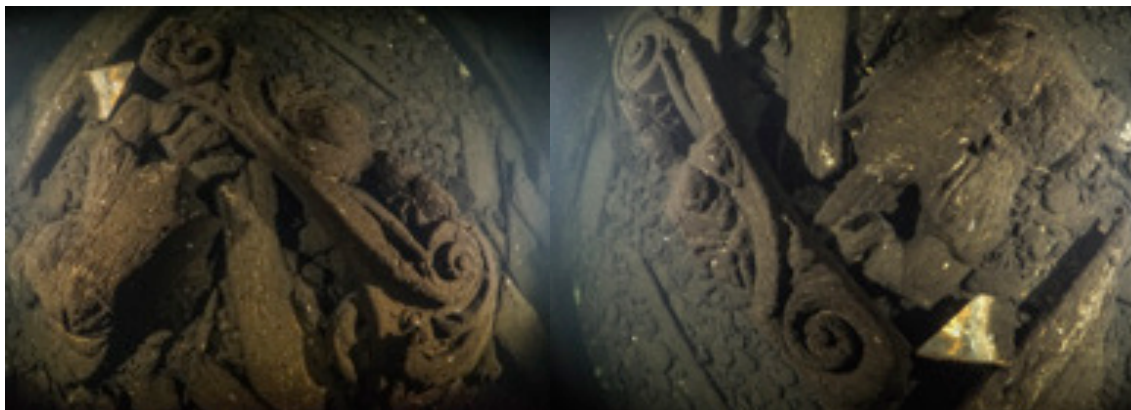
Figure 84: (C) Carved woodwork decorations with human figures. Photos 4th August 2019.

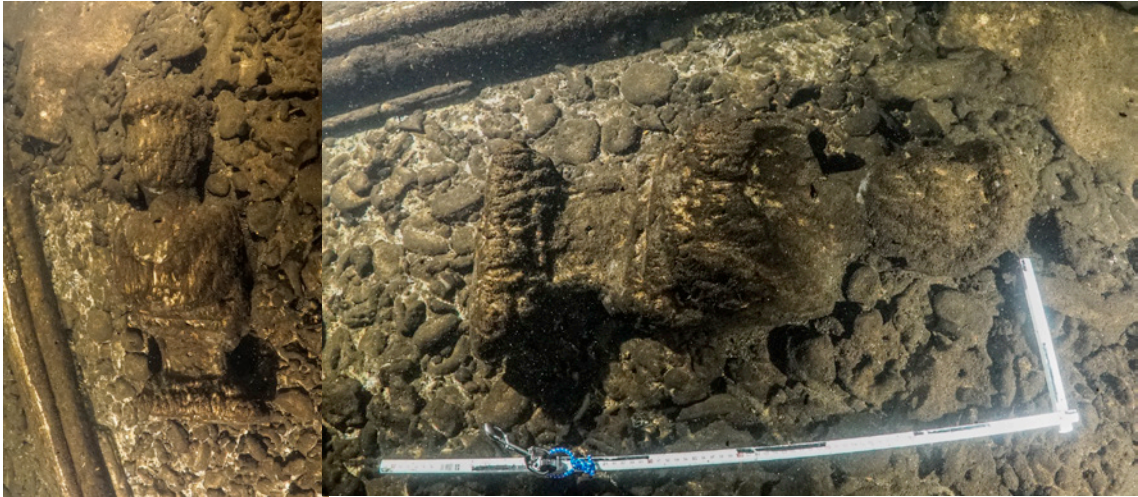
Figure 85: (A) Wooden bust sculpture. Photos 4th August 2019.

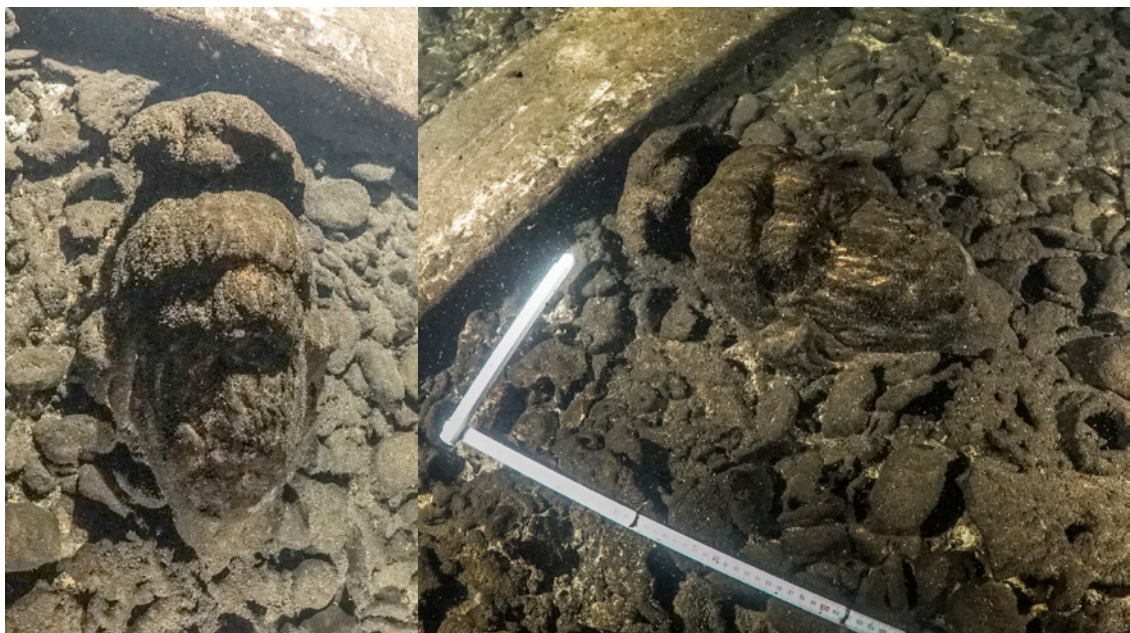
Figure 86: (B) Wooden sculpture head figure with some kind decorated helmet. Photos 4th August 2020.

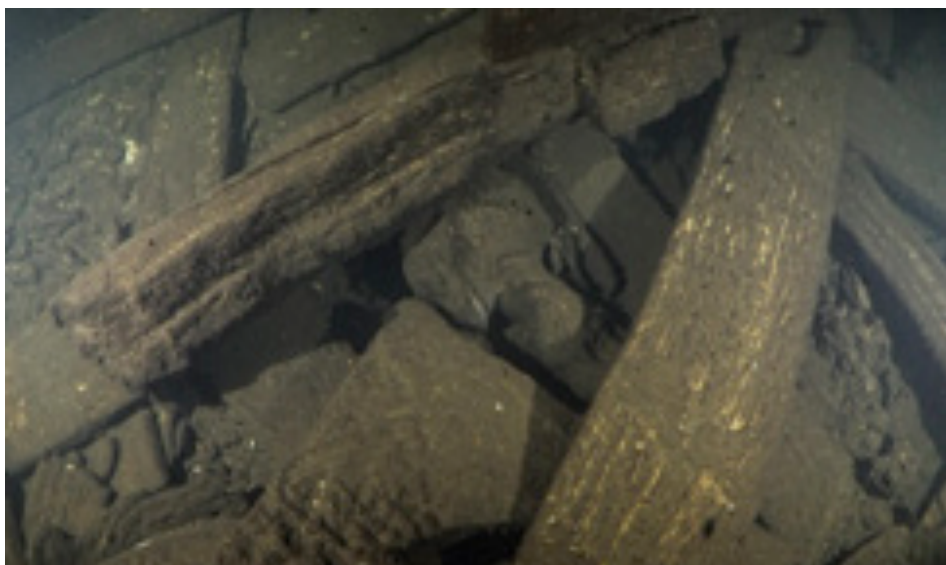
Figure 87: A small wooden bust sculpture in the debris field. Videocapture 4th August 2019.
